THE CORPORATION OF THE CITY OF ST. THOMAS
AGENDA
THE SEVENTH MEETING OF THE MUNICIPAL HERITAGE
COMMITTEE

**Application to Demolish
Re: 40 Alma Street St Thomas (designation Heritage)**

INSPECTION REPORT

Re: Bldg Inspection – Structural
40 Alma Street
St. Thomas, Ontario
June 3, 2015

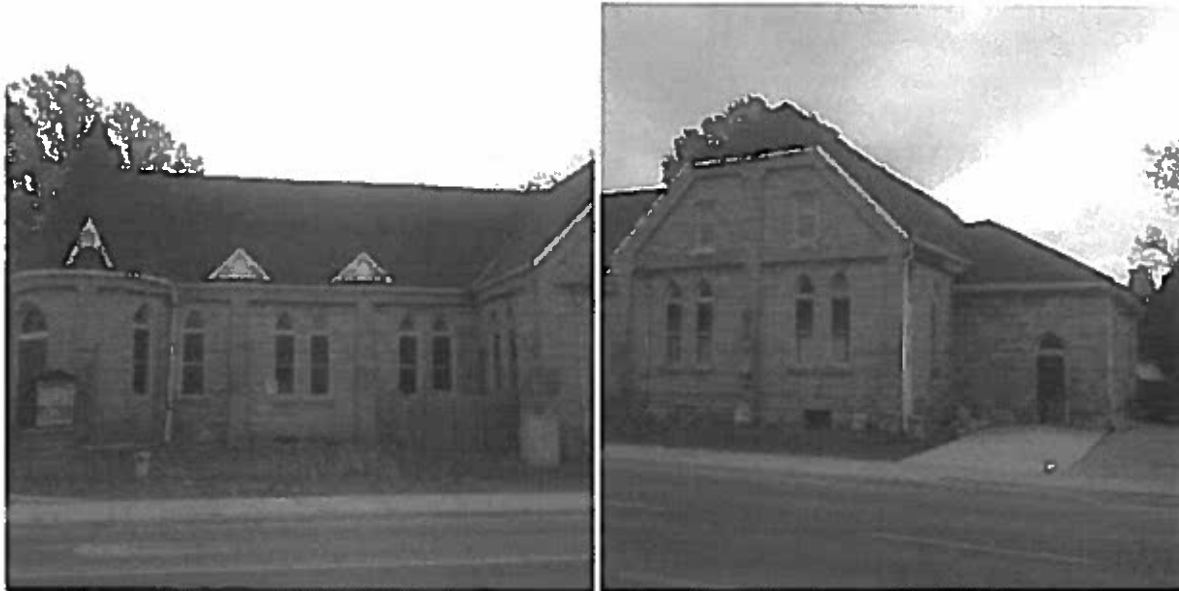
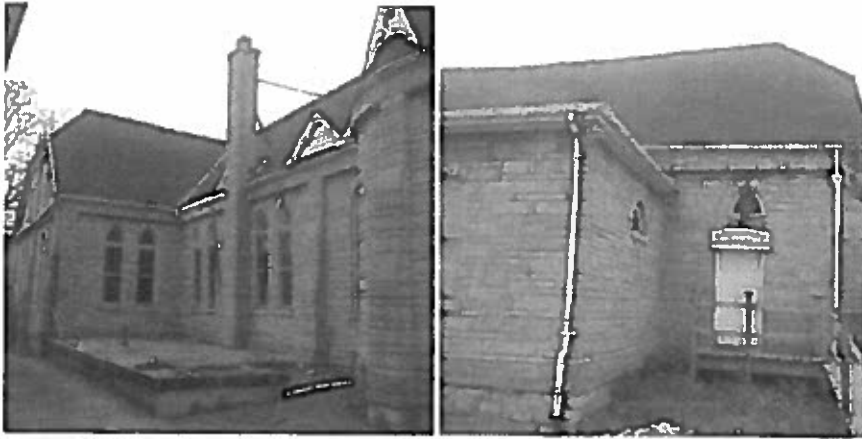
Exterior Elevations

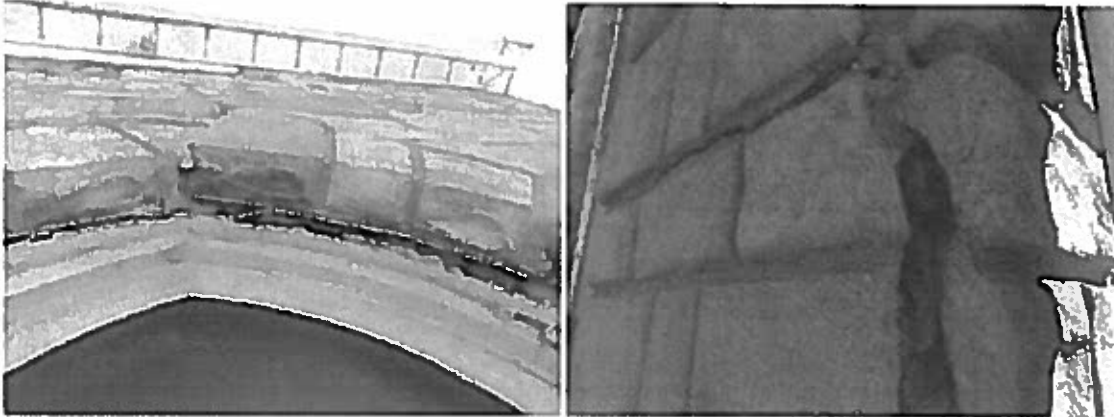
Exterior faux stone pulling away from brick behind (both pics, water infiltration)

2. The existing damages consisting of faux stone and brick damages are all related to water infiltration which caused frost expansion damages and weakening of the mortar joints. Recommendations for repairs would be to remove all the existing faux stone exterior and then repair any damaged brick areas and re-point the entire structure. Refinishing options would have to be reviewed.

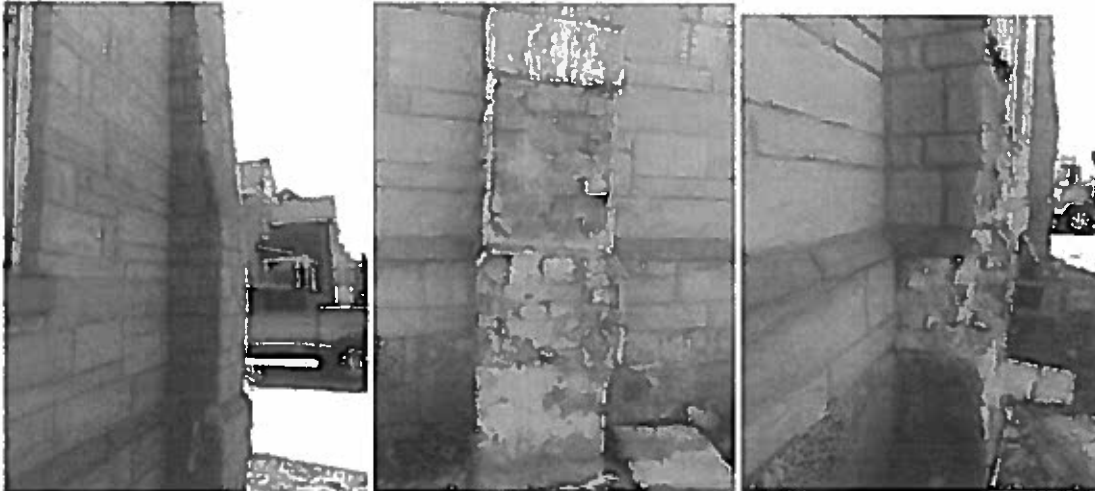
Buttress damaged (faux stone and brick damaged, water infiltration)

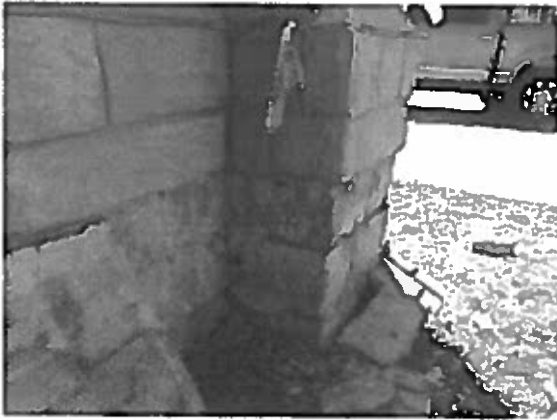
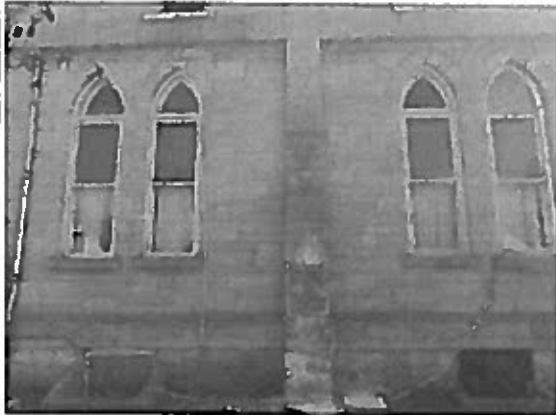
Buttress damaged (faux stone and brick damaged, water infiltration)

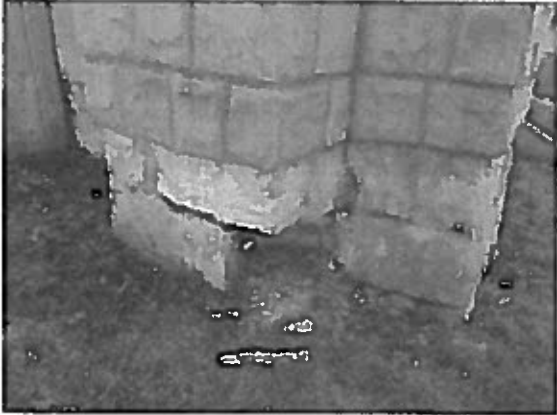
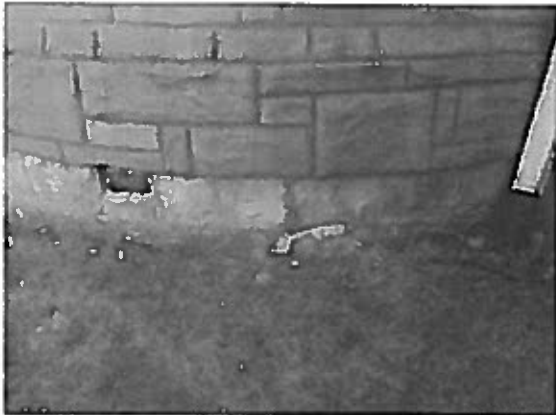
Foundation stone damages (water infiltration)

4. The existing foundations are deteriorated and crumbling in multiple locations. Foundation repairs will be required around the perimeter of the building and include for replacement of some sections of foundation walls, new water proofing and dimple board as well.

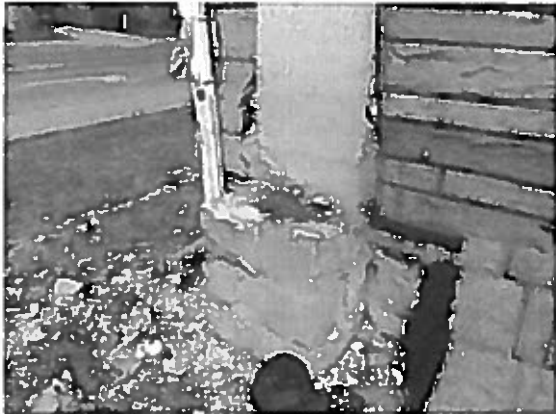
Foundation stone damages (water infiltration)

Buttress total collapse

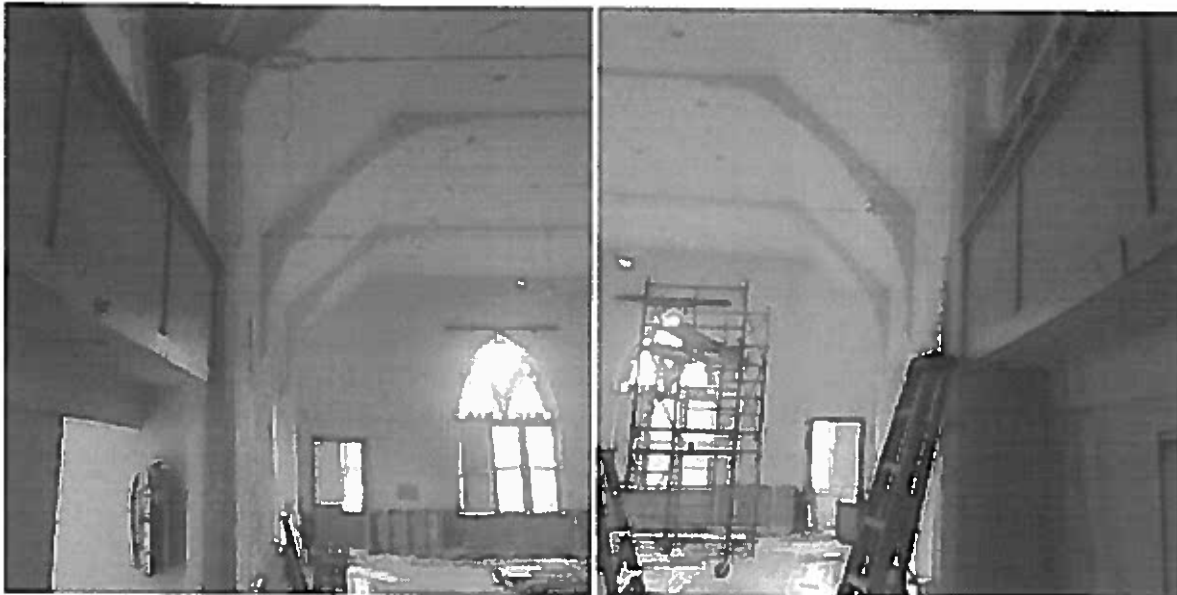
Interior pictures looking east

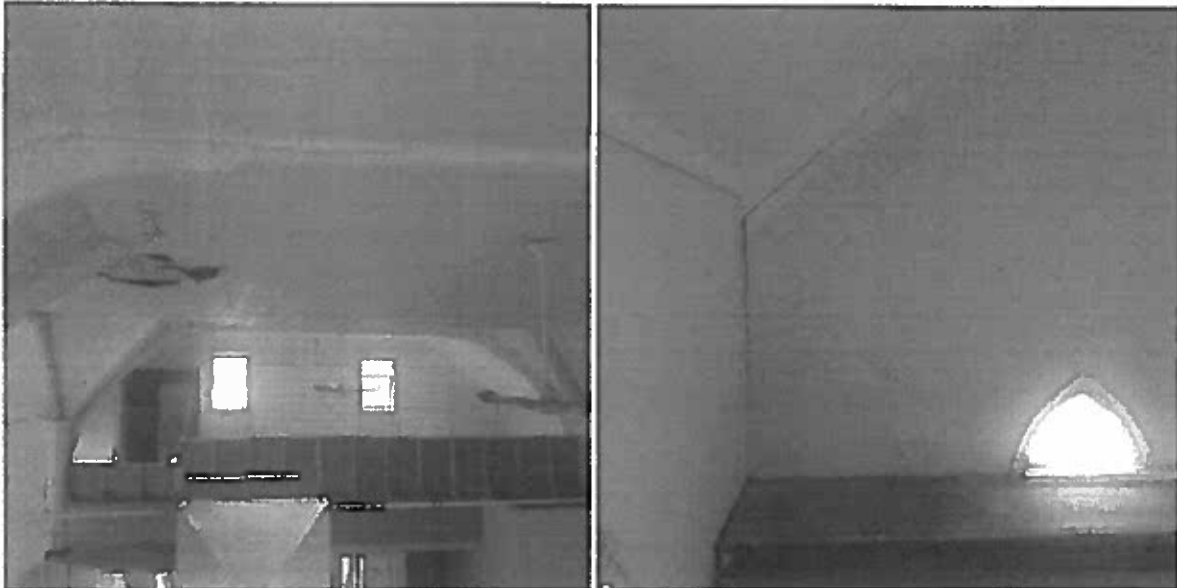
Interior pic looking south

Interior pic looking north

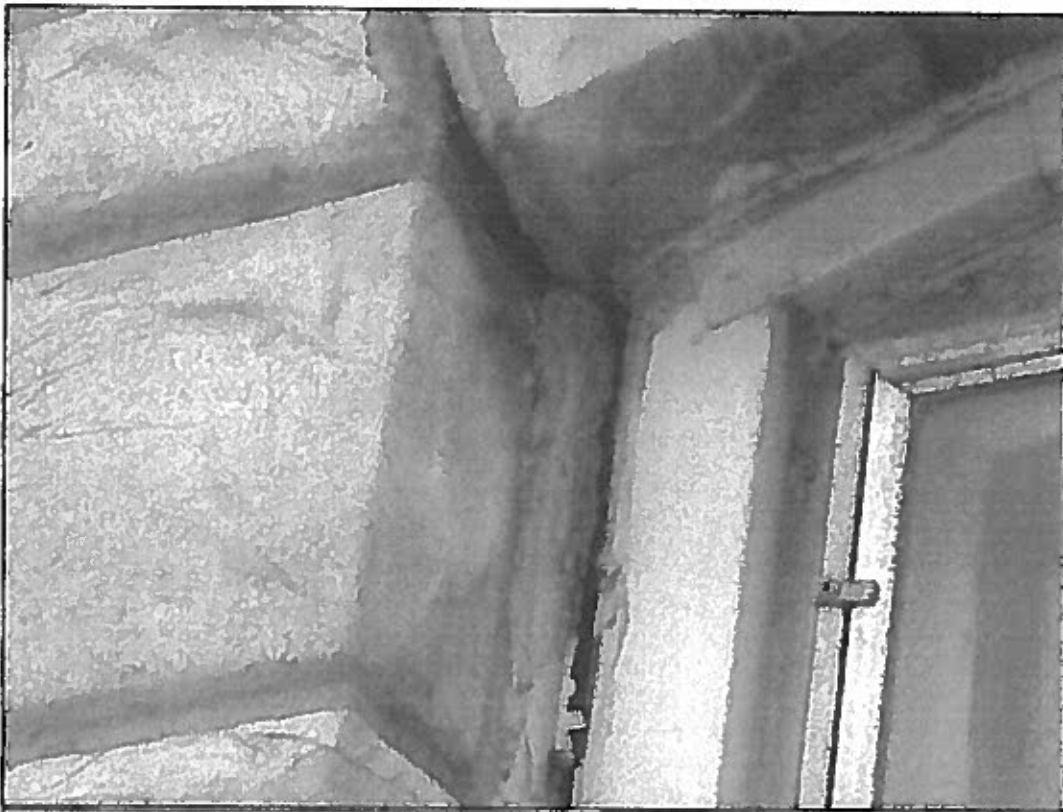
SHOWS EXTERIOR FACADE HAS CRACKED
FROM THE SOFFIT TO THE
FOUNDATION

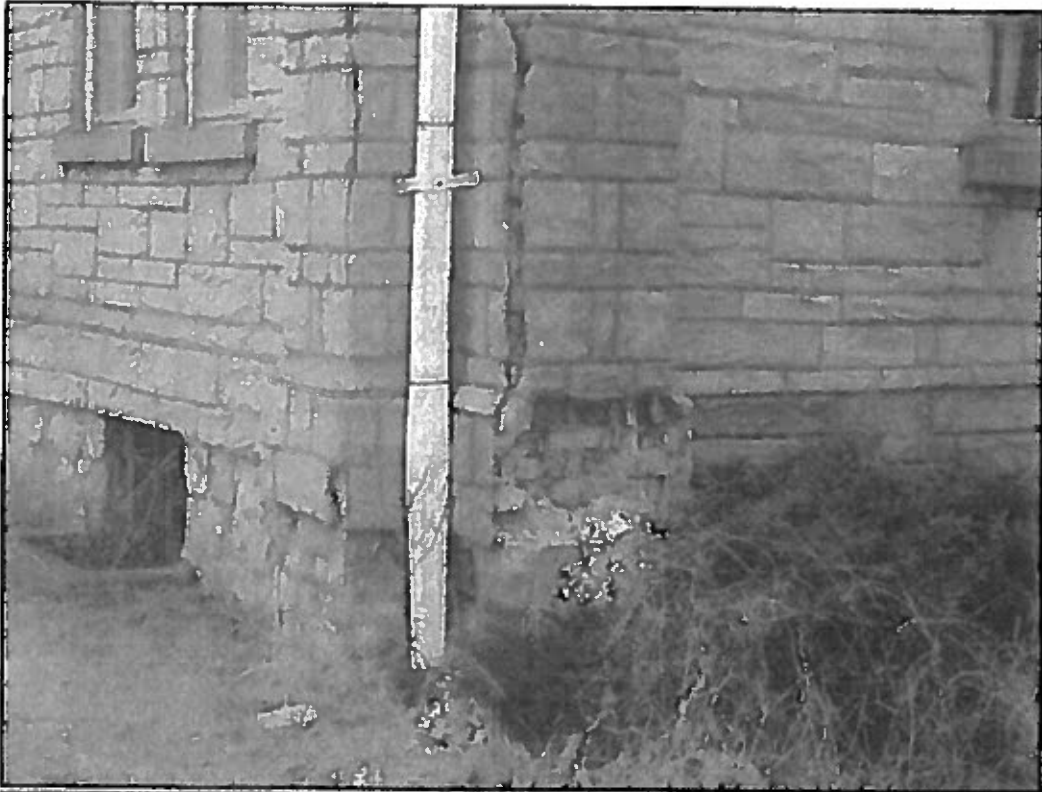
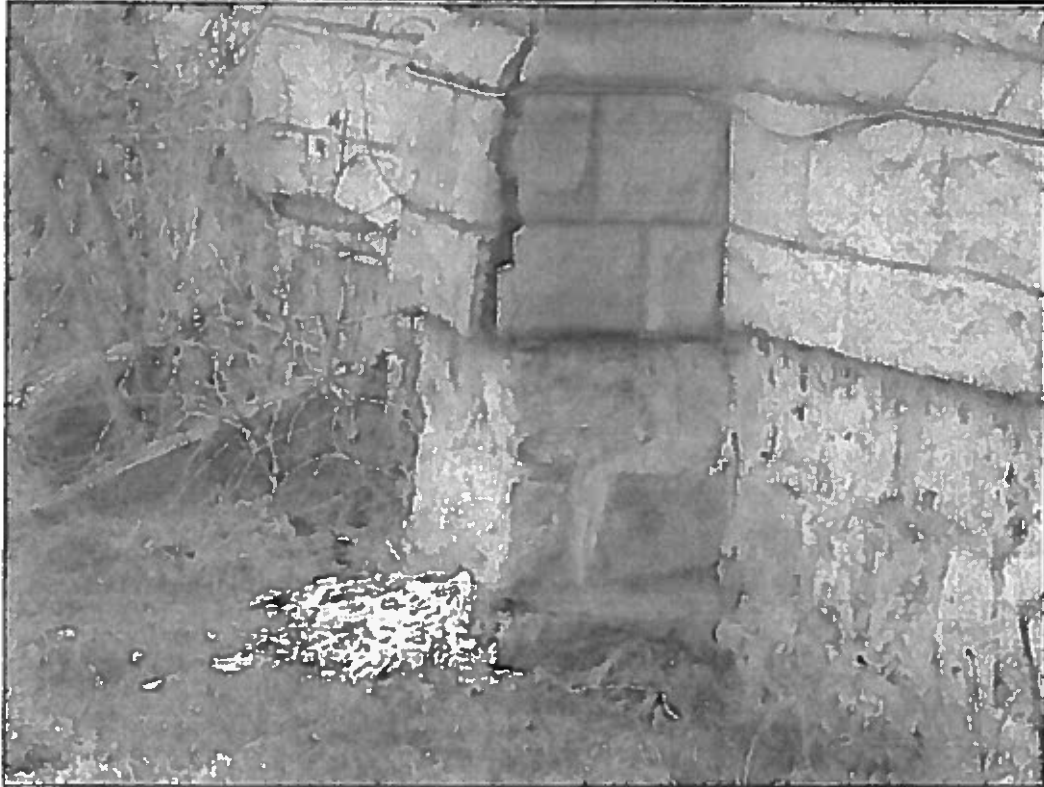
THERE APPEARS TO BE
A PLASTER FACADE
COVERING ORIGINAL
CLAY BRICKS.
