**THE CORPORATION OF THE CITY OF ST. THOMAS**  
**AGENDA**  
**THE SEVENTH MEETING OF THE MUNICIPAL HERITAGE**  
**COMMITTEE**

**Holy Angels Church - Alteration Request**

Re: FINAL DRAFT  
Limited Building Condition Assessment Report  
Holy Angels' and St. Anne's Parishes, St. Thomas

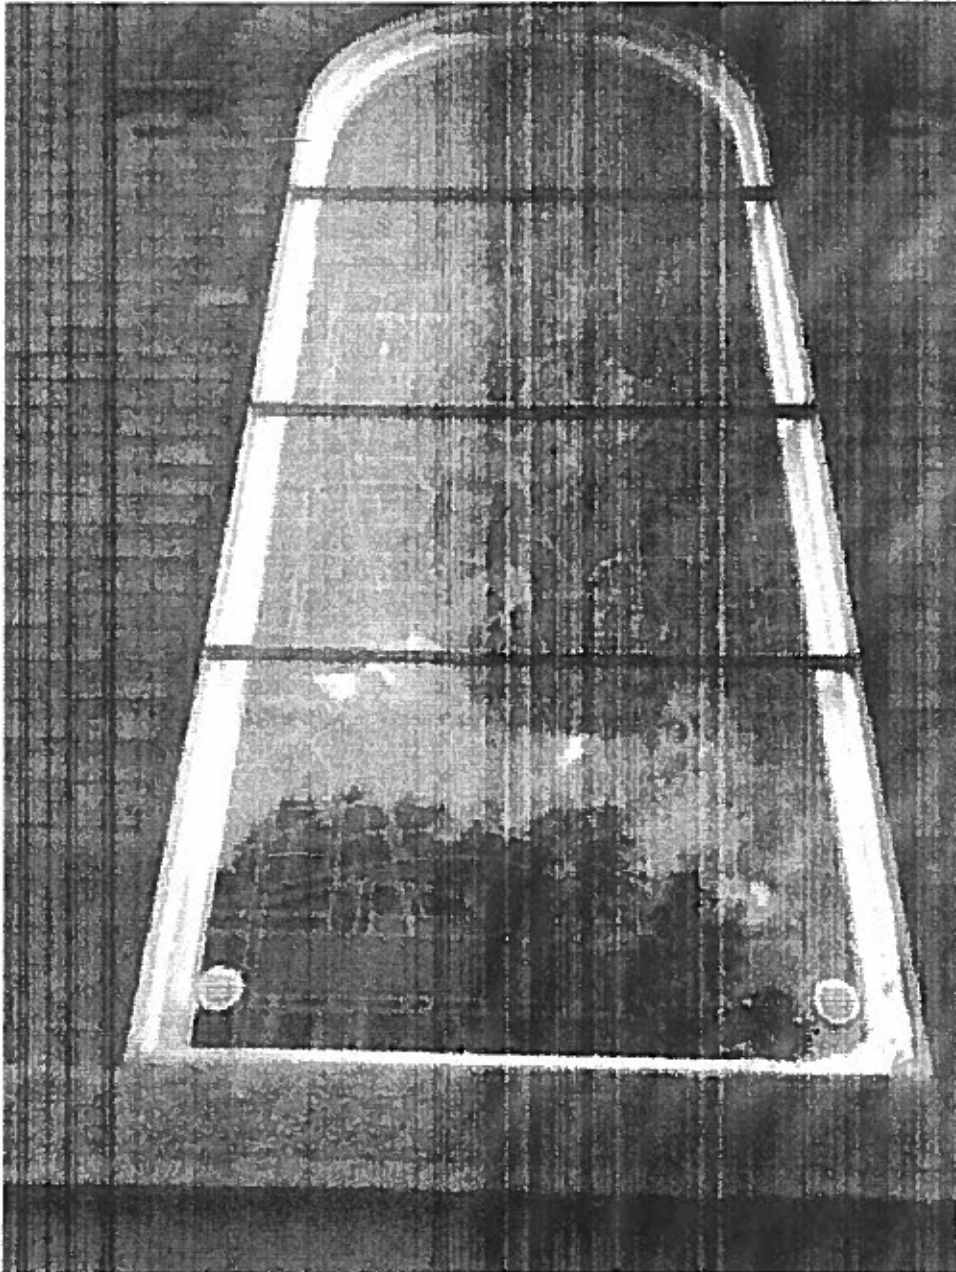
Below I have enclosed a picture of this style of stormglazing. More examples of our stormglazing can be seen at St. Peter's Basilica in London.

Our estimate for the stormglazing of the Apse windows would be \$2,470.00 per window, or a total of \$9,880.00 plus HST.

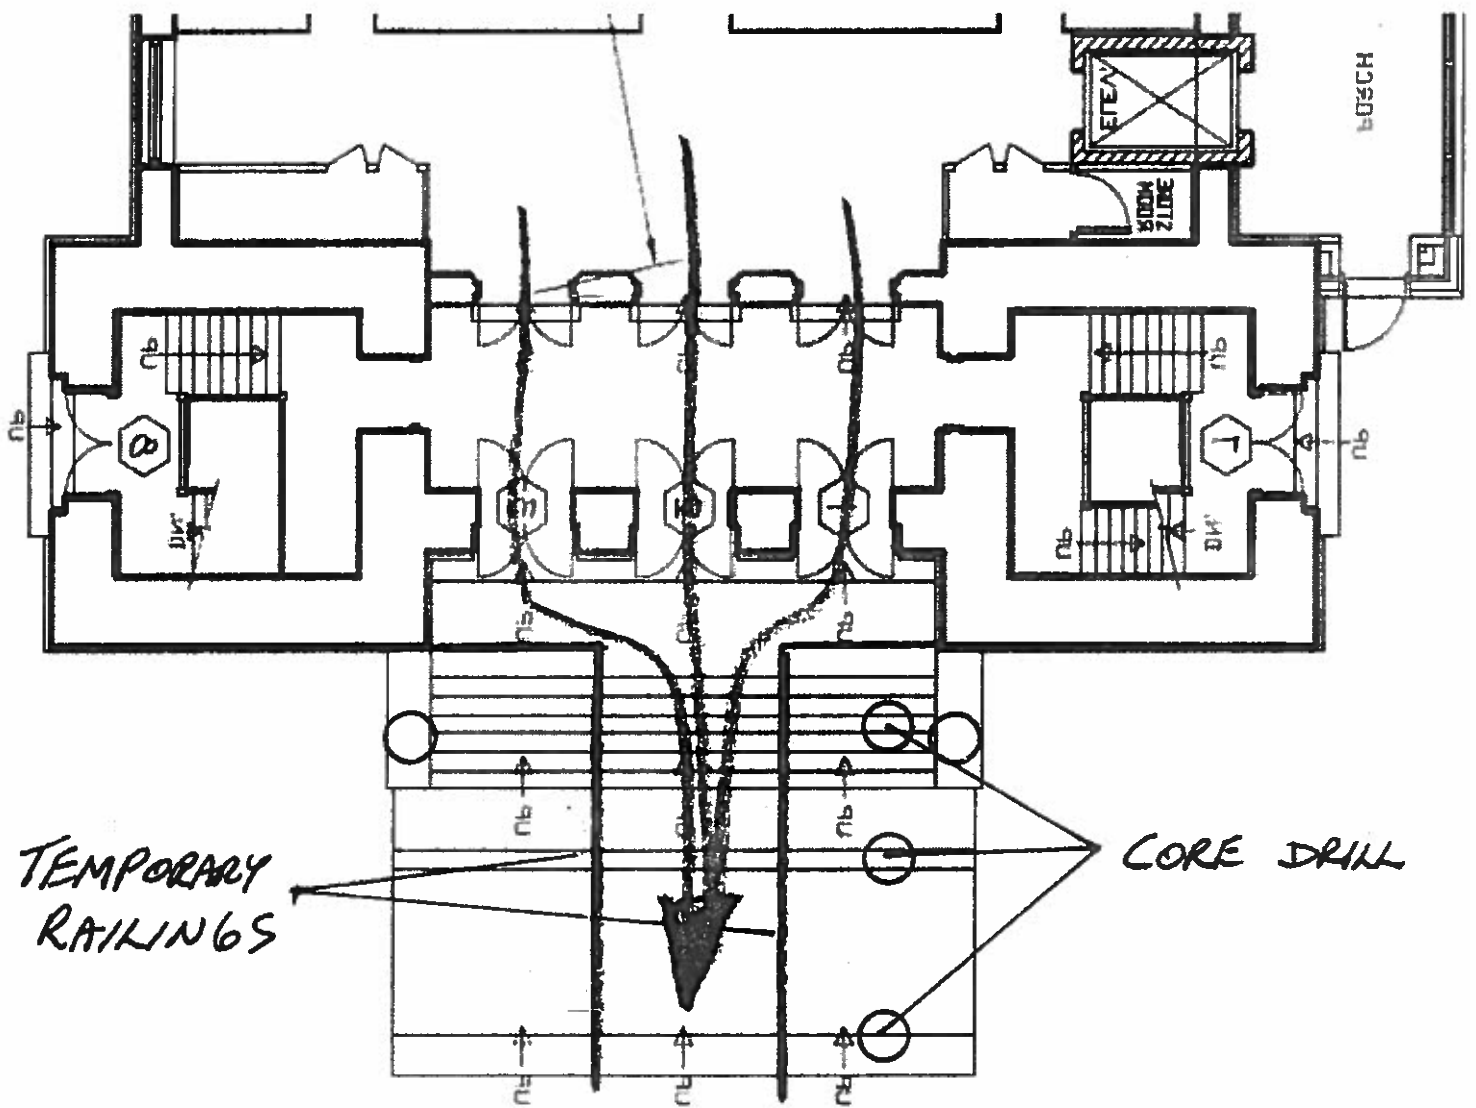
Location:		Holy Angels Church 502 Talbot St. St. Thoma	
Project:		Front Stair Repa AAA Recomm's	
Drawn By:	Scale:	Drawing#:	
J.L.	NTS	Front S	
Date:	8/9/2018	Short

It is reported that in 1992-93 the existing stairs have received a 2" covering of cementitious material over the original stone stairs and landing. This material has developed wide cracks and widespread delamination. Deterioration of the coating is creating uneven surfaces and loose material with wide gaps, resulting in potential trip hazards. The coating system is at the end of its service life. Removal and replacement is required.

- move the two centre railings closer together, to be placed approximately 10' apart and closer to the church, to place base-plates well behind riser face and re-anchor securely;
- for stair risers located between relocated railings, remove cement coating for height of risers, using grinders to create straight, clean cuts at top and bottom of removed materials;
- apply colour contrasting paint strip along edge of new nosing;
- install barricades at top of bottom of stairs to outside of this central modified stair area; conduct invasive testing and disassembly, in these side stair areas, as discussed above.

The above interim action will address immediate concerns for building egress and safe use of the stairs, and provide 2-3 years of time to develop and implement a longer-term solution.
