AGENDA
THE TENTH MEETING OF THE MUNICIPAL HERITAGE COMMITTEE

Request for Alterations - Old St. Thomas Church - 55 Walnut Street **Pages 45-76**

45
**Old St. Thomas Church
Restoration and Maintenance
Trust**

09-046-05
JULY 21, 2020

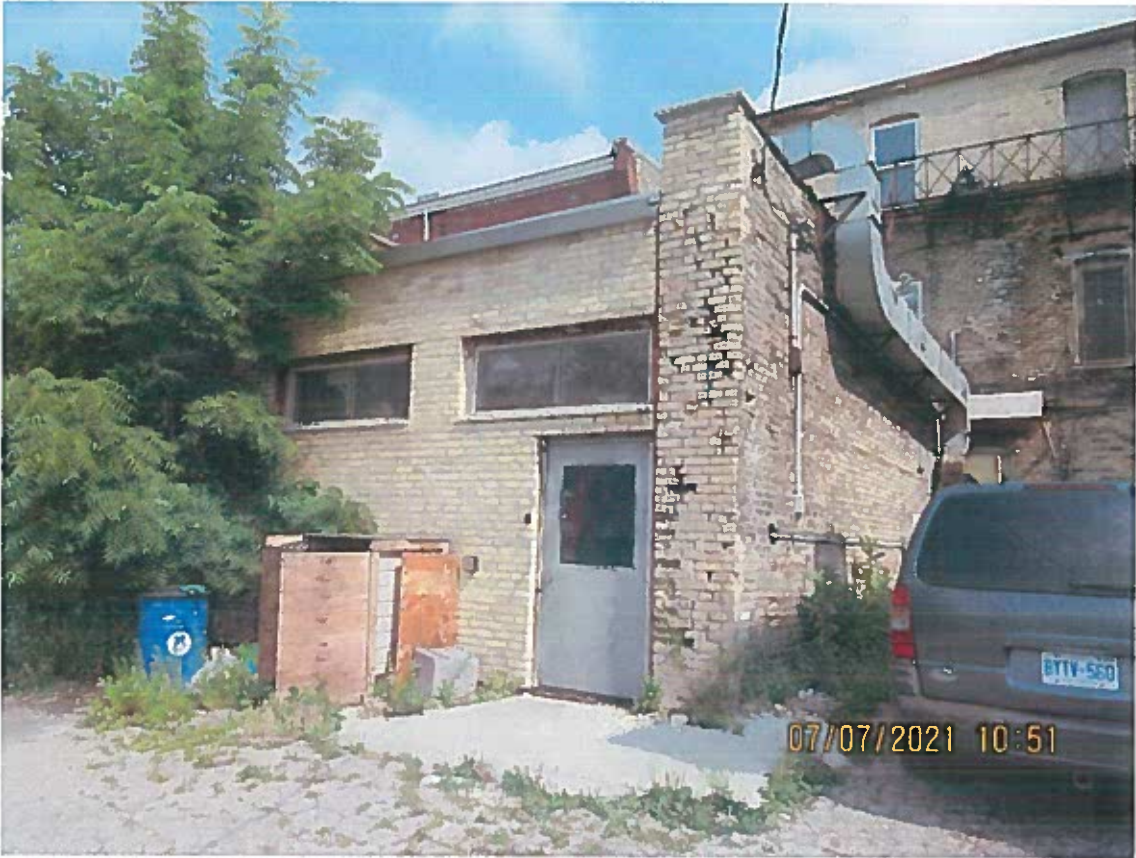
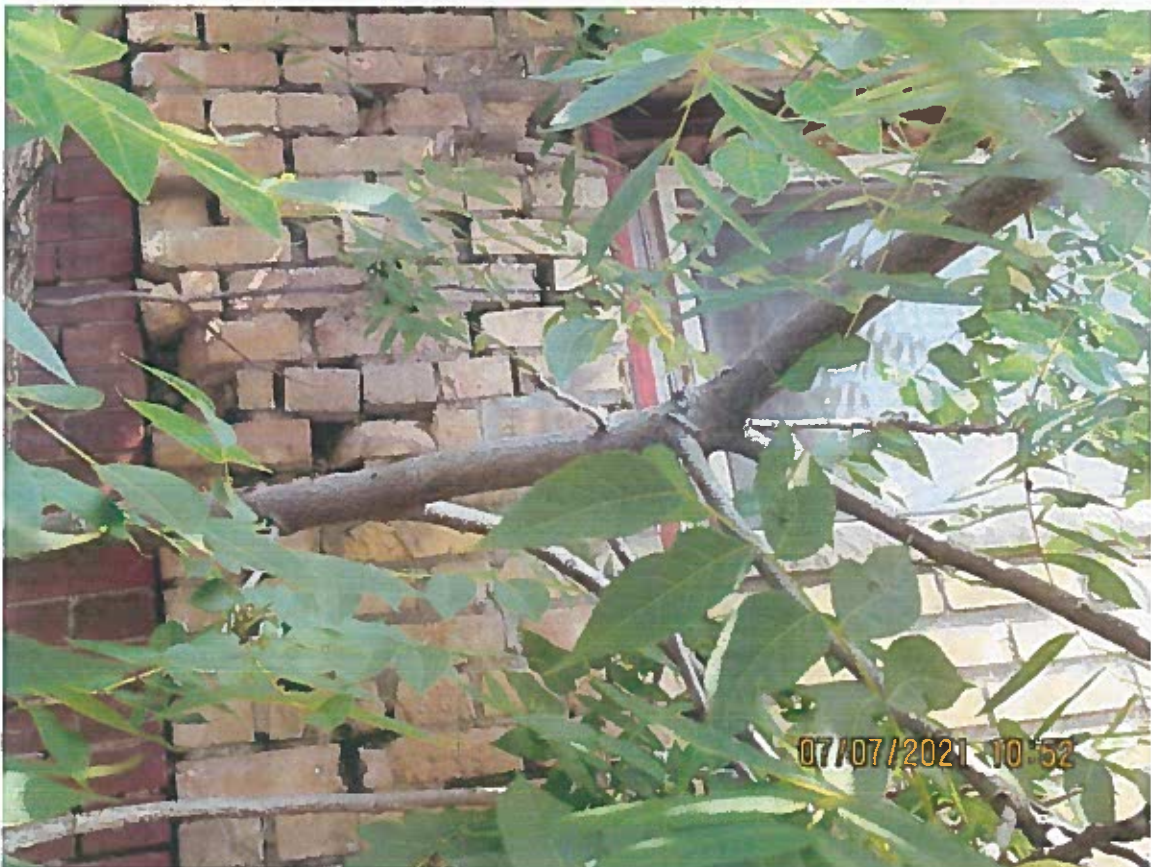
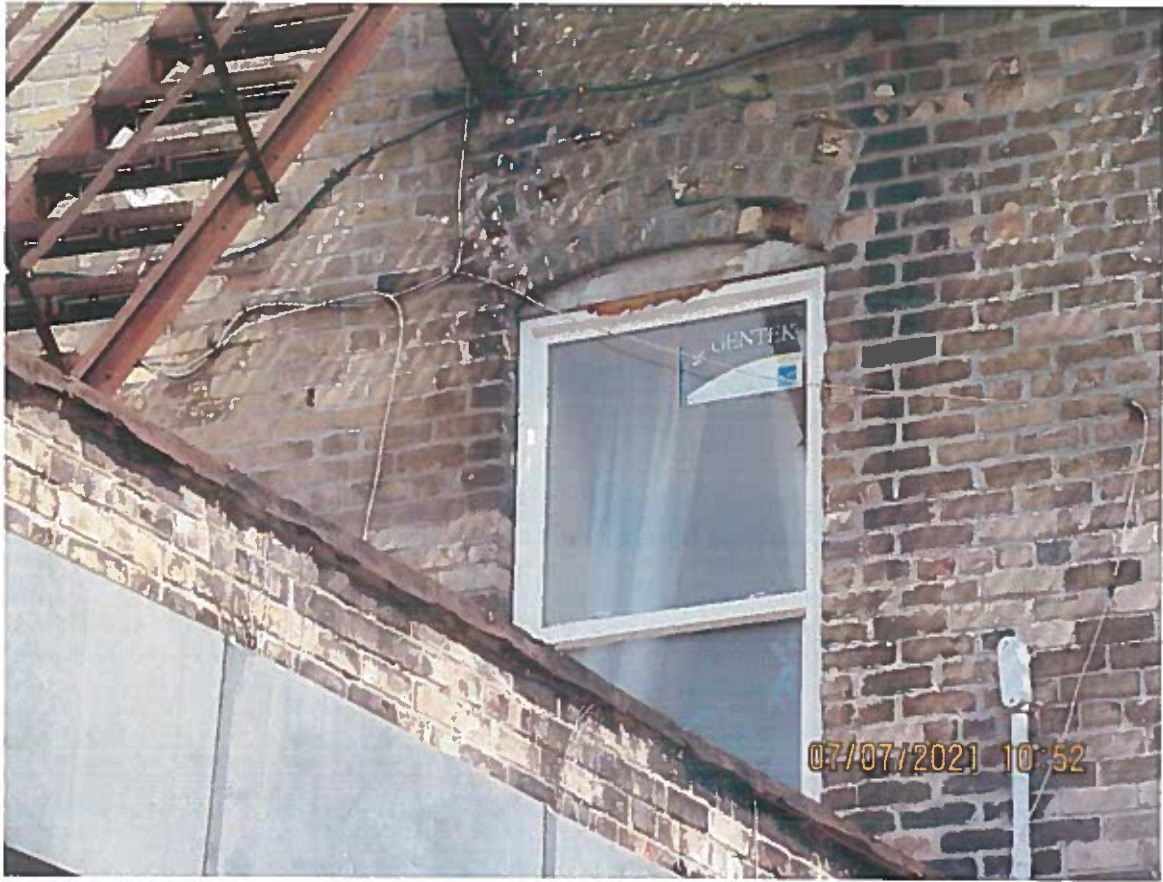
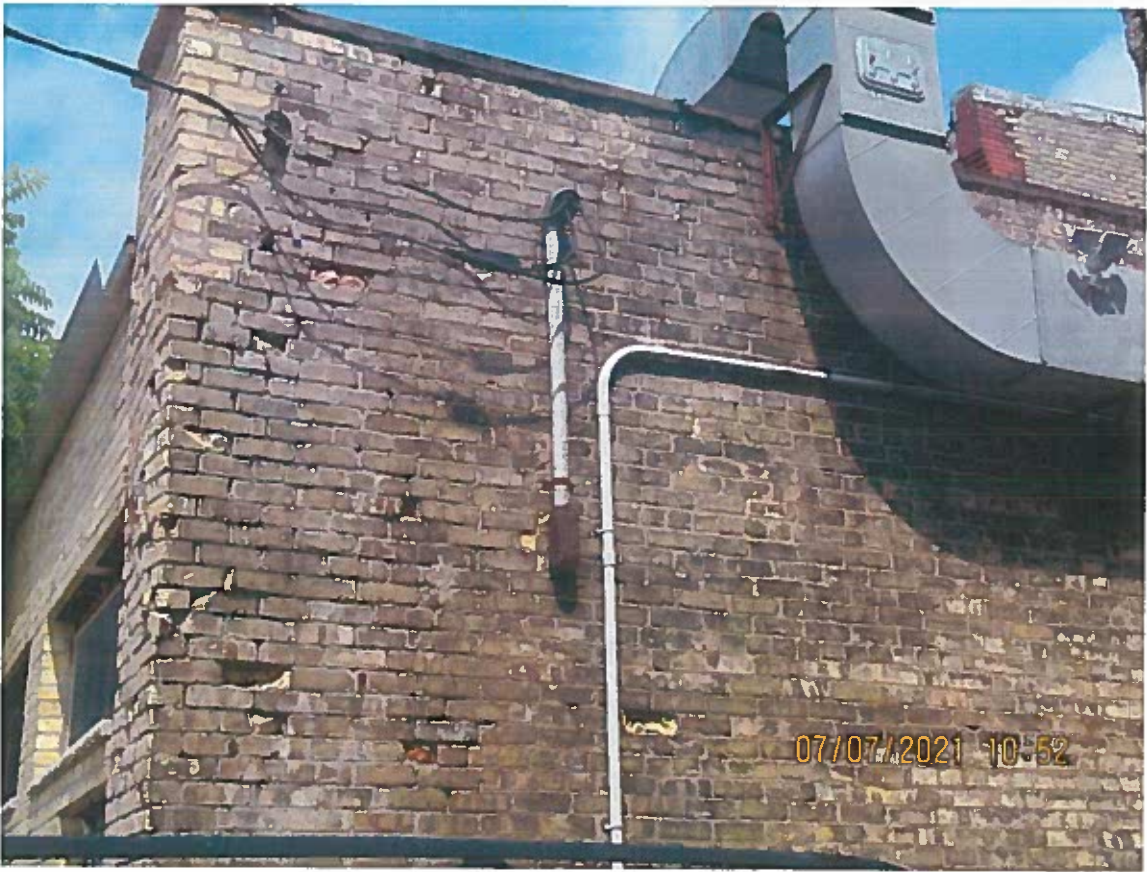
ITEM	DESCRIPTION and LOCATION	
1.	There is loose and spalling brick around the exterior of the building and many sections which mortar is missing, provide repairs or apply appropriate finish. (See photos)	
	REFERENCE	
	PSB 4.3.1	An Owner shall maintain all exterior walls, and other exposed surfaces, not inherently resistant to deterioration in good repair.
	PSB 4.3.2	Without restricting the generality of Subsection 4.3.1, good repair includes: a) treated with a protective coating of paint or preservative; b) maintained in good repair to prevent deterioration due to weather, insects, rodents or other elements; c) free from loose and unsecured or improperly secured objects and material which may create an unsafe condition; and d) insulation in accordance with the provisions of the Ontario Building Code.
	REQUIRED ACTION	
Repair the brick to be free of any conditions which may create a safety hazard and repair deteriorating portions.

ITEM	DESCRIPTION and LOCATION	
2.	Soffits and fascia at the front of the building contain openings, exposed untreated wood, and broken pieces.	
	REFERENCE	
	PSB 4.3.3	An Owner shall maintain all roofs, including valleys, fascia boards, soffits, eavestroughs, roof gutters, down pipes, guards, lightning arrestors, and cornices, in good repair.
	PSB 4.3.4	Without restricting the generality of Subsection 4.3.3, good repair includes: <ul style="list-style-type: none"> a) free from obstructions; b) free from hazardous accumulations of ice and snow; c) free from loose and unsecured or improperly secured objects and material which may create an unsafe condition; and d) maintained in a watertight condition so as to prevent leakage of water into the building.
	REQUIRED ACTION	
<p>There are openings in sections of the soffits and fascia overtop of the front entrance leading to the second story.</p> <p>All work shall be carried out in a manner accepted as good workmanship in the trades concerned and with materials suitable and sufficient for the purpose. <i>Please contact this office for inspection upon completion.</i></p>

ITEM	DESCRIPTION and LOCATION	
3.	There is a broken windows at the front of the building.	
	REFERENCE	
	PSB 4.4.1	An Owner shall maintain all exterior doors, windows, skylights, and shutters, including storm doors and storm windows, in good repair.
	PSB 4.4.2	Without restricting the generality of Subsection 4.4.1, good repair includes: <ul style="list-style-type: none"> a) constructed, erected and installed in accordance with the requirements of the Ontario Building Code; b) free of conditions which may create a health, fire or safety hazard; c) preventing the entrance of wind, rain or snow into the building; d) the refitting, replacing or renewing of damaged, decaying or defective doors, windows, frames, sashes, casings, shutters, hatchways or screens; e) re-glazing cracked, broken or missing glass; f) replacing or repairing defective hardware g) providing missing hardware; h) re-screening or weather stripping where such is defective or missing; and i) painting or applying an effective preservative.

REQUIRED ACTION	
Repair/replace window. All work shall be carried out in a manner accepted as good workmanship in the trades concerned and with materials suitable and sufficient for the purpose. <i>Please contact this office for inspection upon completion.</i>

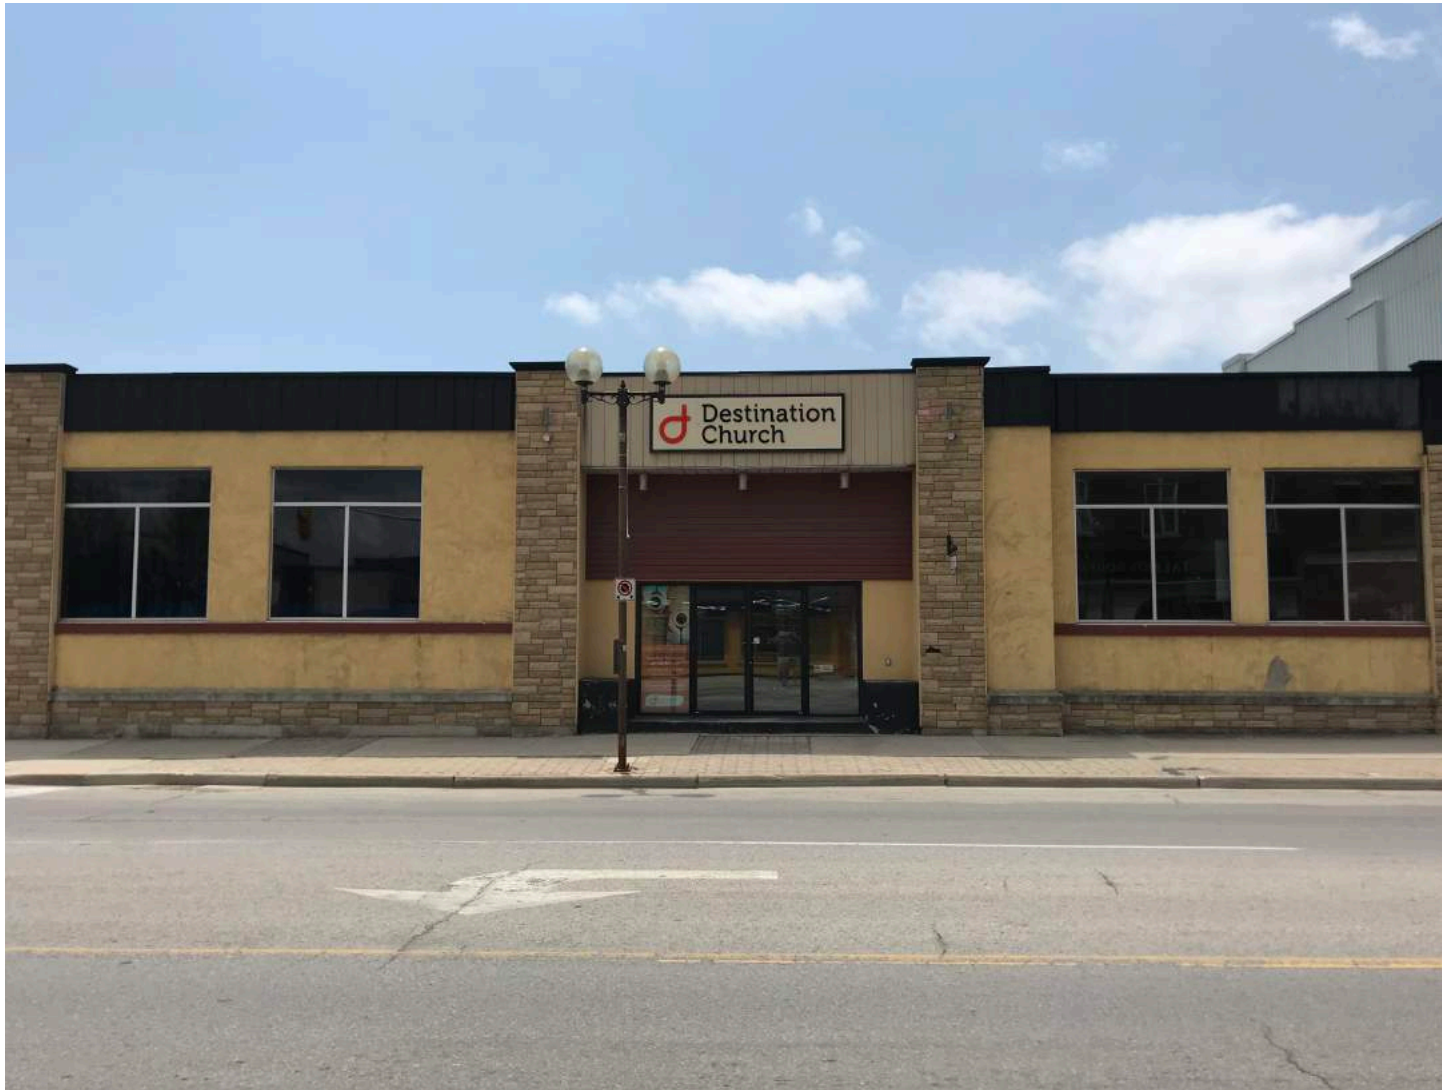
North Elevation (photo) of Destination Church Facade - Photo Taken June 29, 2021

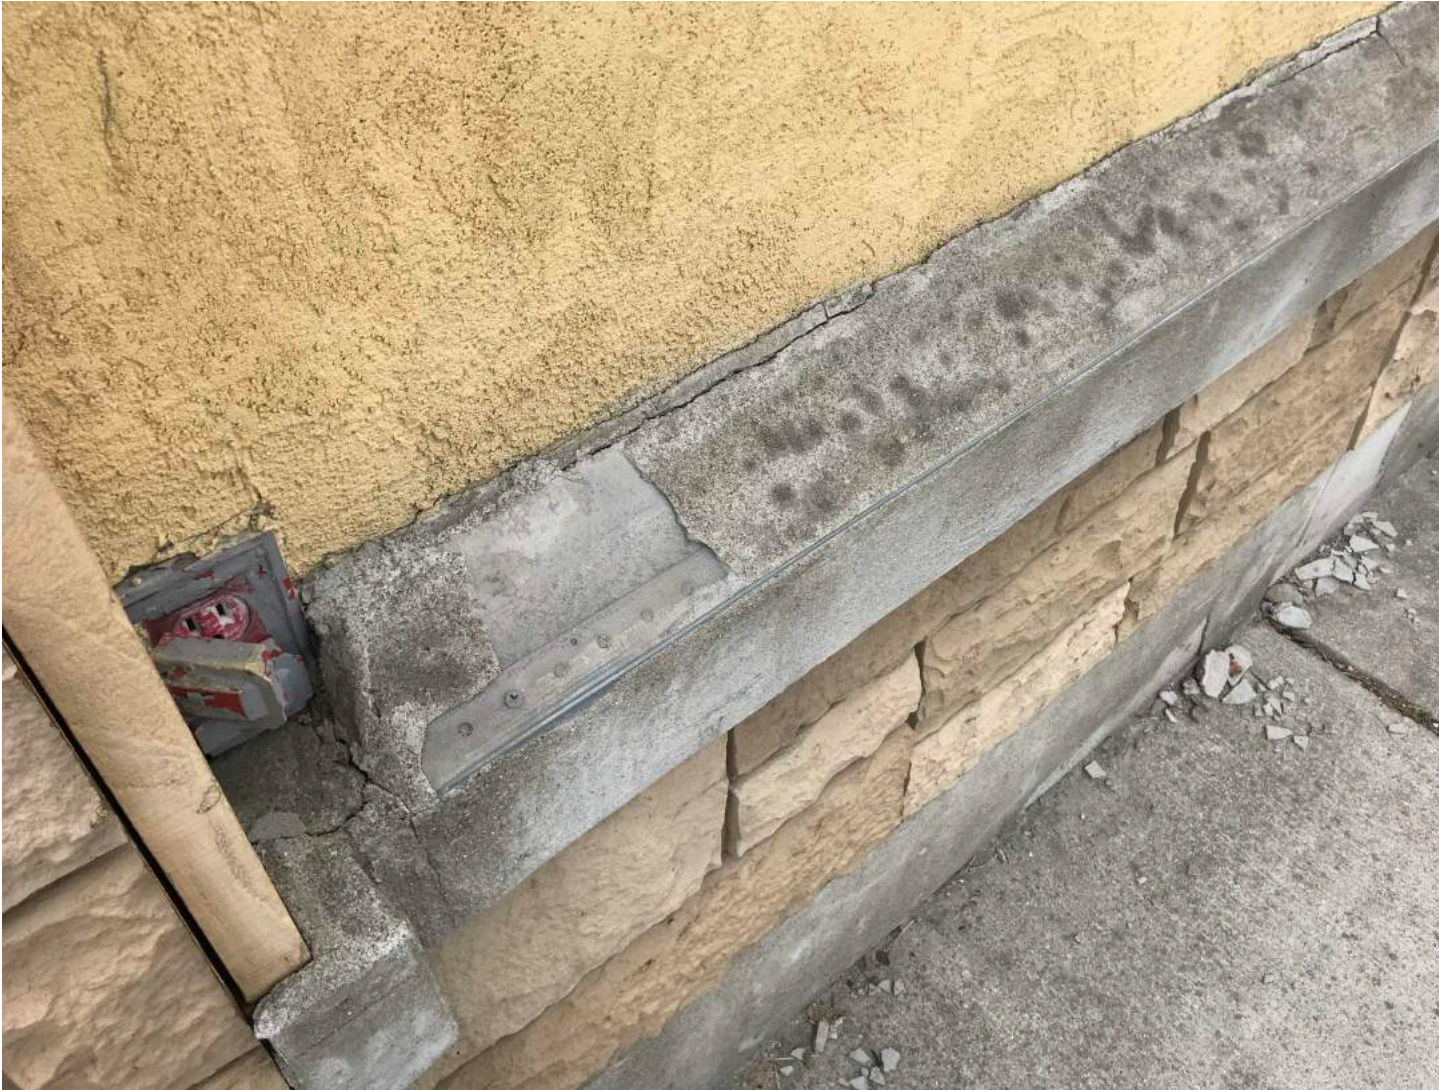
Example of missing parging along facade of Destination Church - Photo Taken June 29, 2021

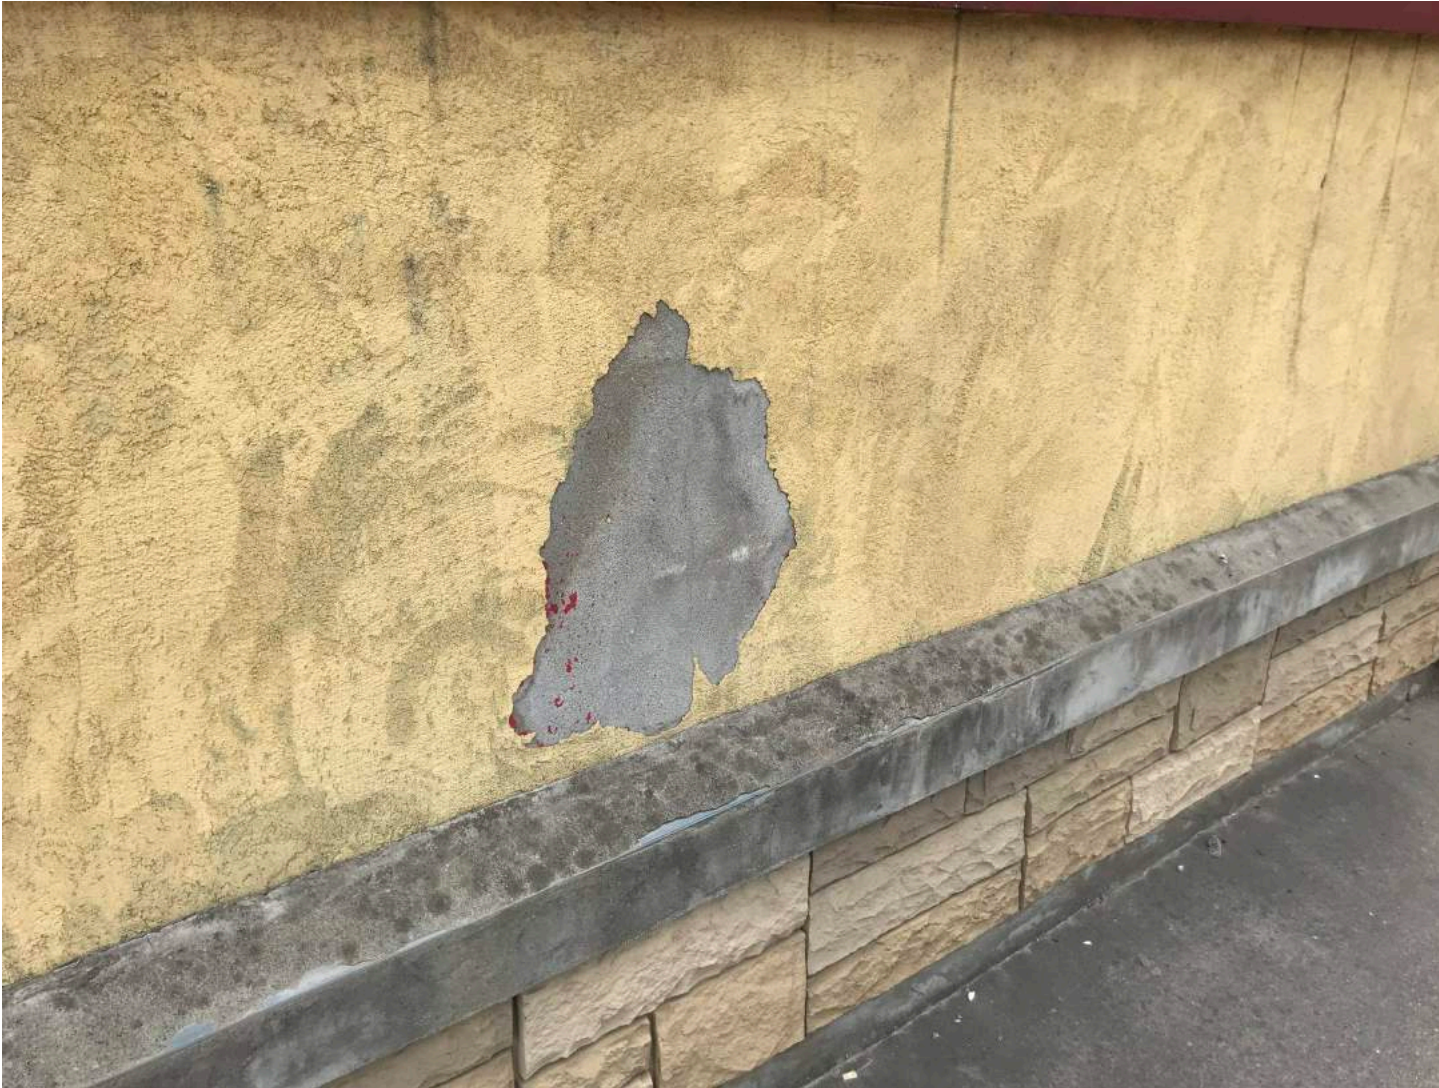
Further example of facade deterioration at Destination Church - Photo Taken June 29, 2021

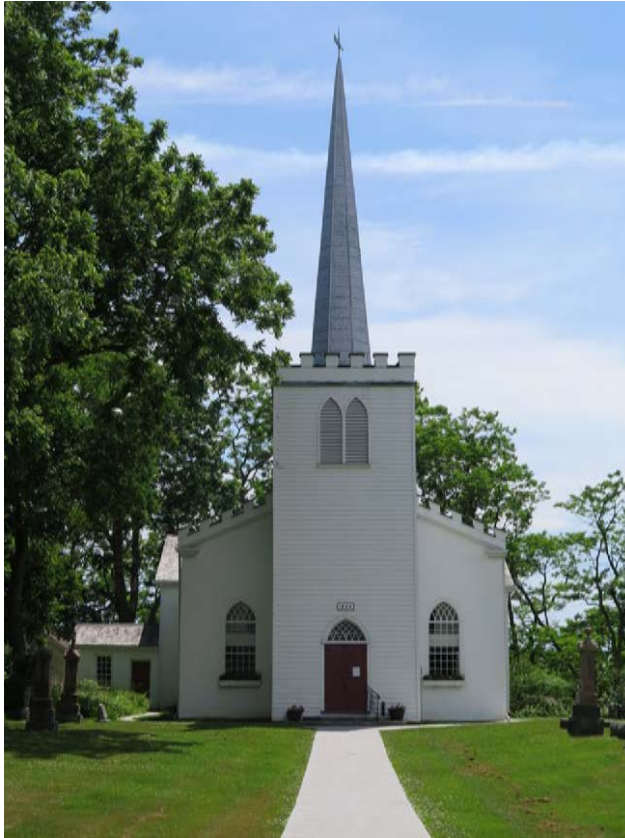
1. VIEW OF OLD ST. THOMAS CHURCH

The church continues to be in good condition and has been well maintained by the Restoration Committee. A number of major projects were completed since the last report. The window sashes on the east and west wall of the nave have been repaired, repainted, and reinstalled.

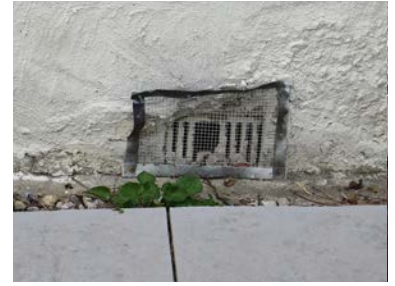
- 2 . 1 The vents located at the building's foundation have been replaced in accordance with the recommendations outlined in the 2011 report and remain in good condition. One screen on the west side has been pulled away and needs to be reattached. See drawing in Appendix 1.C for location.

2.1 VENT SCREEN TO BE REATTACHED

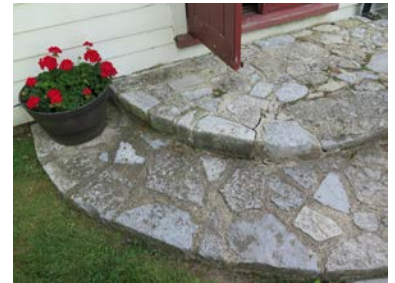
- 2 . 2 The stone steps at the main entrance to the church appear to have some loose stones and also appear to be sloping towards the building which may be contributing to moisture build-up at the base of the tower. It is recommended that the stone steps be rebuilt to slope away from the building in order to facilitate water drainage away from the base of the tower.

2.2 LOOSE STONES AT THE MAIN ENTRANCE STEPS

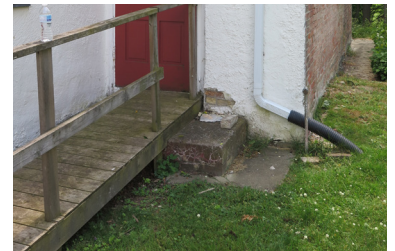
- 2 . 3 As noted in the 2018 report prepared by the Ontario Heritage Trust, the wood accessibility ramp on the west elevation continues to show heavy algal staining and should be monitored.

2.3 ACCESSIBILITY RAMP SHOWING ALGAL STAINING

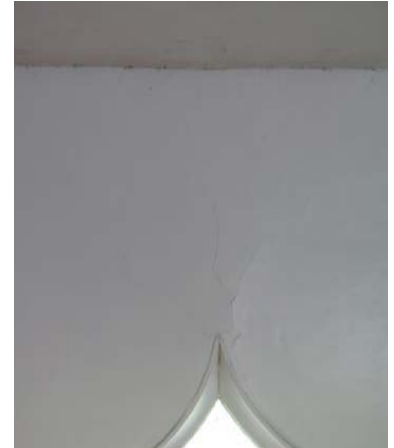
3.1 CRACK ABOVE WINDOW HAS PROGRESSED SINCE THE 2016 REPORT

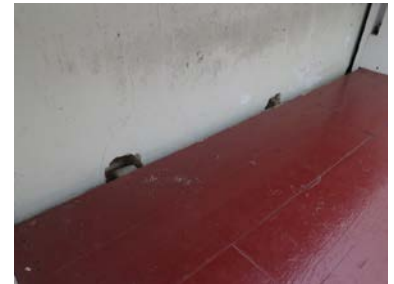
- 3.2 A gap was observed between the choir balcony and the south wall. The gap was measured in two locations and should be monitored as part of the ongoing maintenance program. Location and measurements can be found on the drawing in Appendix 1.B.

3.2 GAP BETWEEN CHOIR BALCONY AND SOUTH WALL

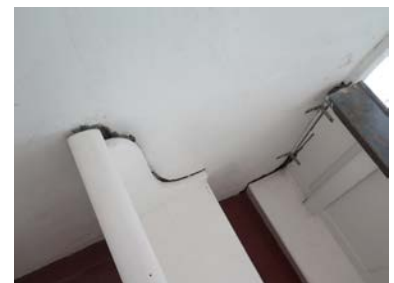
- 3.4 A 1" gap was observed between the west wall and the pews on the north balcony. A similar 1" gap was also observed between the east wall and the pews of the north balcony. Metal ties were observed connecting the balcony to the east wall and are indicative of a previous solution. These gaps should be monitored as part of the ongoing maintenance program.

3.4 GAP AND METAL TIES AT NORTH BALCONY AND EAST WALL

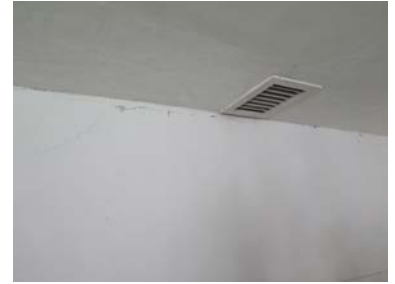
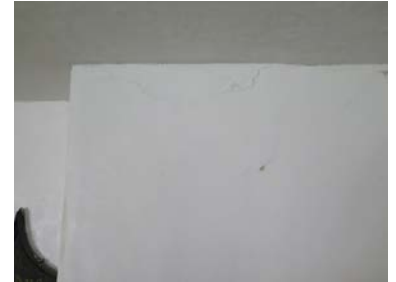
- 4 . 1 Cracks along the south wall of the choir balcony at the ceiling appear to be progressing from what was observed in 2016. As well, new cracks have appeared in the south wall of the transept. This is likely as a result of movement and moisture penetration caused by open mortar joints on the exterior brick wall. It is recommended that the brick wall be repointed and existing cracks continue to be monitored as part of the ongoing maintenance program. A comparison of known cracks can be found in Appendix 2.

4.1 CRACKS ALONG SOUTH WALL OF CHOIR BALCONY AT THE CEILING

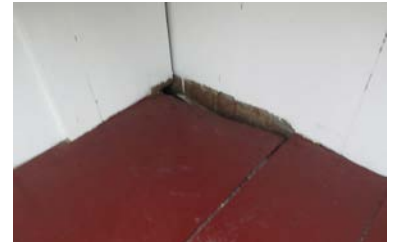
- 4 . 2 A paint line is visible on the west wall of the choir balcony beneath a pew indicating that something has been removed since the 2016 assessment.

4.2 PAINT LINE VISIBLE ON SOUTHWEST CORNER BELOW PEW ON CHOIR BALCONY

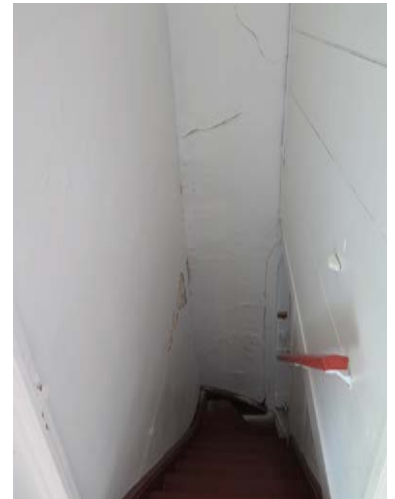
- 4 . 3 Paint bubbling and peeling in the choir balcony stair area appears to have progressed since the 2016 report. This is likely caused by a combination of open mortar joints on the exterior brick wall allowing moisture penetration and the use of a non-breathable paint on the interior. It is recommended that the exterior wall be repointed and the interior area be monitored as part of the ongoing maintenance program to ensure moisture penetration is eliminated.

4.3 PEELING AND BUBBLING PAINT IN CHOIR BALCONY STAIR AREA

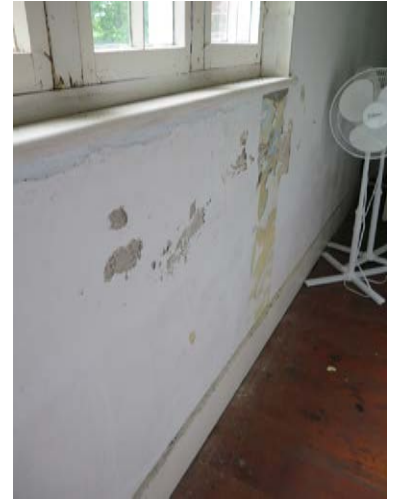
- 4 . 4 Peeling paint and wallpaper on the east wall of the transept appears to have progressed since the 2016 report. This is likely a result of movement and moisture penetration caused by open mortar joints on the exterior brick wall. It is recommended that the exterior brick wall be repointed.

4.4 PEELING PAINT AND WALLPAPER ON EAST WALL IN TRANSEPT

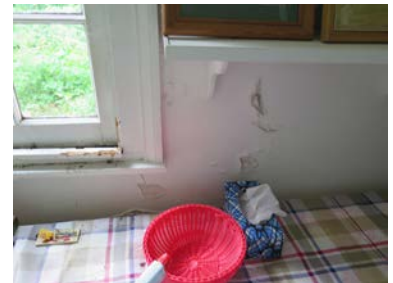
- 4 . 5 Paint bubbling and peeling was observed on the south wall of the vestry and is likely a result of water penetration and movement caused by open mortar joints on the exterior brick wall. It is recommended that the exterior brick wall be repointed.

4.5 PEELING PAINT ON SOUTH WALL OF VESTRY

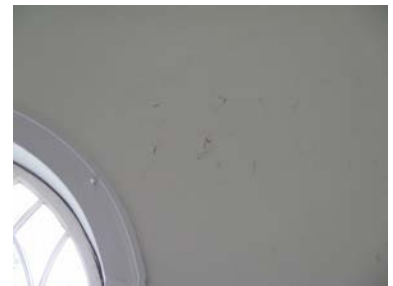
- 4 . 6 Cracked and bubbling paint was observed on the east wall of the nave between the arched portions of the windows.

4.6 CRACKED PAINT BETWEEN WINDOWS

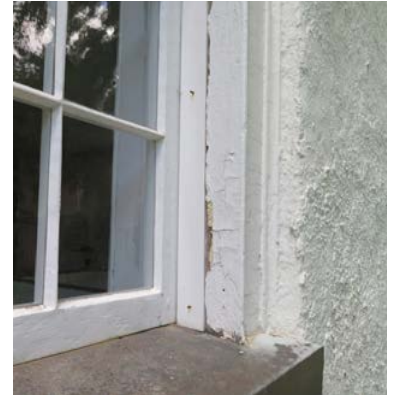
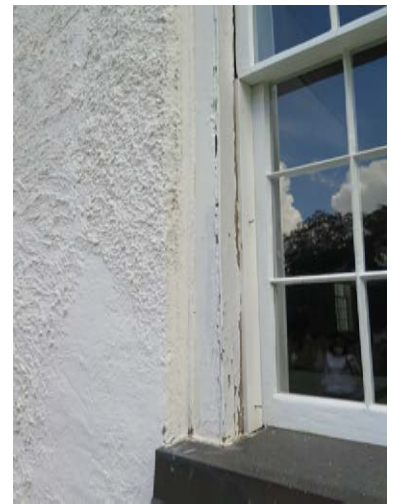
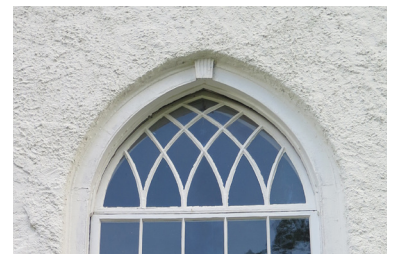
It was also observed that many of the sashes do not fit tightly within the frames, leaving gaps and potential for moisture penetration and further damage to the windows. After the frames are repaired, great care should be taken to ensure the sashes fit tightly within the frames to reduce the potential for damage to the newly repaired sashes.

5.1 NAVE WINDOW FRAMES IN NEED OF REPAIR

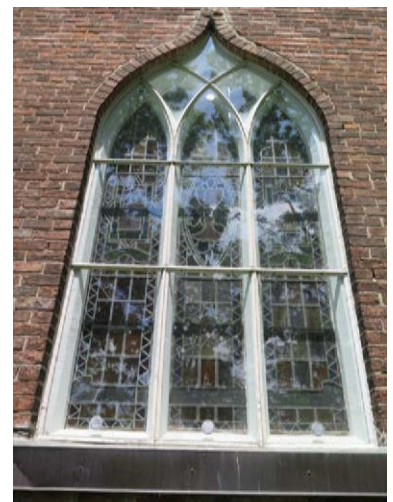
- 5 . 2 The south window was repaired and repainted as per the recommendations in the 2016 report. New lexan panels with metal vents at the top and bottom were also installed per the recommendations of the 2016 report and appear to be functioning well. A brick repair was done above the arch of the window and it does not appear to have moved indicating that the interior crack is likely old damage.

5.2 NEW LEXAN PANELS AND VENTS INSTALLED ON SOUTH WINDOW

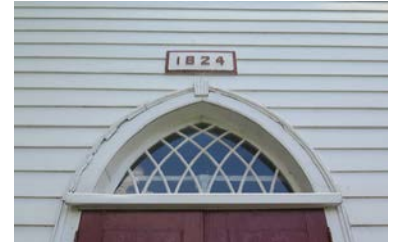
- 5 . 3 As noted in the 2018 report prepared by the Ontario Heritage Trust, the wood frame of the transom above the main entrance is showing signs of deterioration and should continue to be monitored.

5.3 TRANSOM ABOVE MAIN ENTRANCE

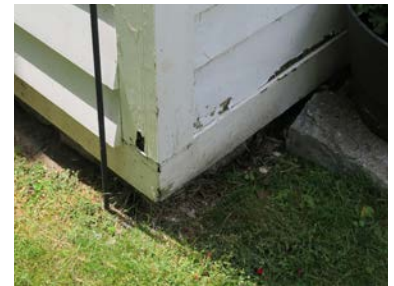
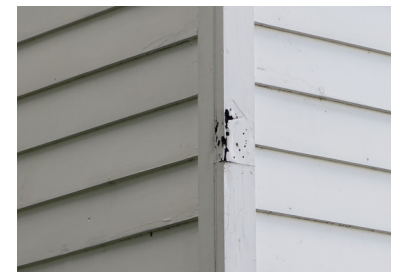
- 6 . 1 The siding on the east and west sides of the tower are showing signs of rot at the bottom corners and half way up the tower. This material was previously replaced in the 1980's and there is evidence of patchwork repairs of panelling on the west elevation, so replacement in kind with new material is acceptable. The lowest board of the tower should be removed and replaced, as well a water board may be installed along the foundation to allow drainage. The north side and adjacent boards should be checked as well. If rot of the original structure behind is observed in the process of these repairs, treat with wood preservative (zinc or copper naphthanate) where decayed or damaged wood is cut out, consolidate and fill with epoxy resins and fillers before replacing damaged siding with new to match existing.

6.1 WOOD SIDING DAMAGED AT BOTTOM CORNERS AND HALF WAY UP TOWER

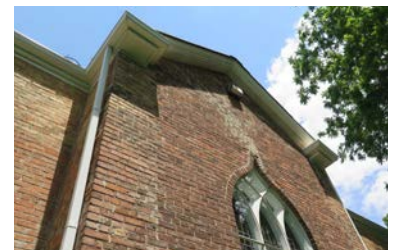
- 6 . 2 Mortar joints on the brick walls of the transept and vestry are showing signs of deterioration and many joints are in poor condition with significant gaps, particularly on the upper portion of the south-facing wall. This is likely resulting in movement and moisture penetration causing damage to interior finishes. It is recommended that south wall be 75-100% repointed and that the east and walls of the transept and the south wall of the vestry be 100% repointed. The repair above the south window appears stable, no evidence of movement since previous review.

6.2 REPOINTING AT SOUTH WALL

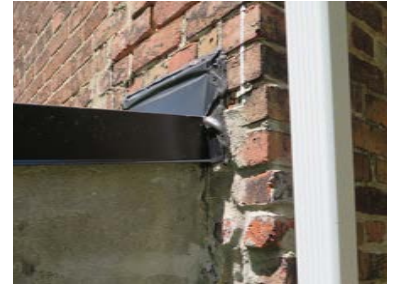
- 6 . 3 Buttresses appear to be intact with one instance of a small gap at the wall connection. This gap should continue to be monitored as part of the ongoing maintenance program. The buttress flashing is in good condition however the brick needs to be repointed at the reglet connections.

6.3 REPOINT BRICK AT REGLET CONNECTIONS

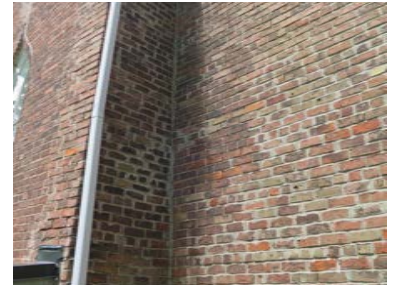
- 6 . 4 Buckling was observed at the exterior corner on the south wall, resulting in significant gaps in the mortar joints. This appears to be the result of old movement. It is recommended that this area be monitored as part of the ongoing maintenance program.

6.4 BRICK BUCKLING AT EXTERIOR CORNER ON SOUTH WALL

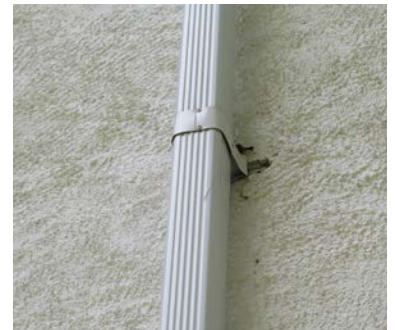
- 6 . 5 The repaired exterior stucco is holding up well. Evidence of previous downspout connections are visible in the stucco on the east elevation of the nave.

6.5 PREVIOUS DOWNSPOUT CONNECTION EMBEDDED IN STUCCO

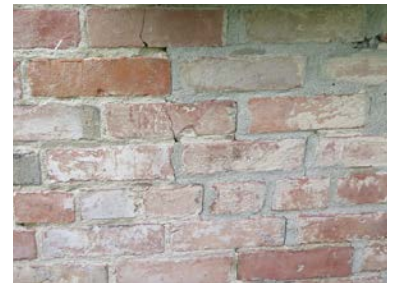
- 6 . 6 Stepped cracking of brickwork was observed beneath the west transept window, allow for the replacement of a minimum of four bricks with matching heritage brick.

6.6 STEPPED CRACKING AT WEST TRANSEPT WINDOW

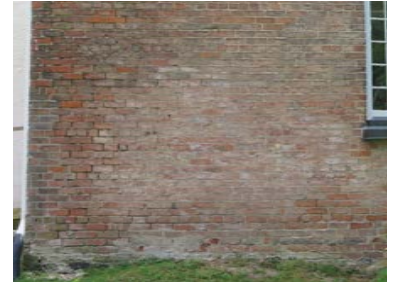
- 6 . 7 There is spalled brick at the northwest corner of the transept at the base and significant gaps in the mortar joints likely resulting in moisture penetration. It is recommended that the brick wall be repointed and the interior area be monitored as part of the ongoing maintenance program. Allow for the replacement of a minimum of fifteen bricks with matching heritage bricks.

6.7 SPALLED BRICK AT NORTHWEST TRANSEPT CORNER

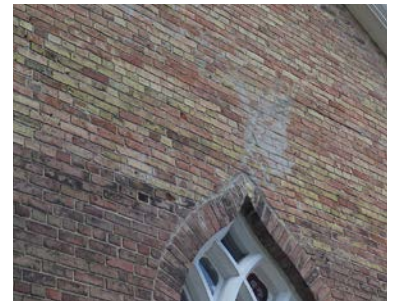
- 6 . 8 Cement parging is visible above the window on the exterior of the east transept.

6.8 CEMENT PARGING ABOVE EAST TRANSEPT WINDOW

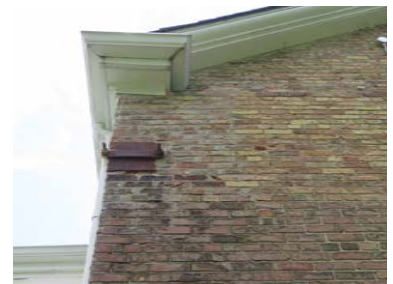
- 6 . 9 The brick on both the east and west walls of the transept appear to be buckling at the line of the eaves. This buckling was noted in the 2003 report and should continue to be monitored as part of the ongoing maintenance program.

6.9 BUCKLING BRICKWORK AT WEST TRANSEPT GABLE

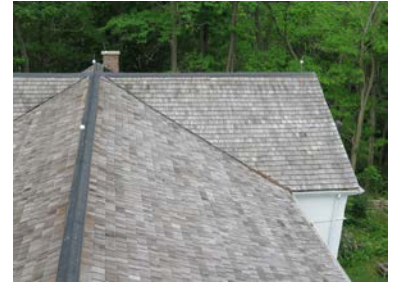
- 7 . 1 A new cedar shingle roof was installed in 2015 to specifications of the Ontario Heritage Trust. The repaired roof is performing well.

7.1 CEDAR SHINGLE ROOF

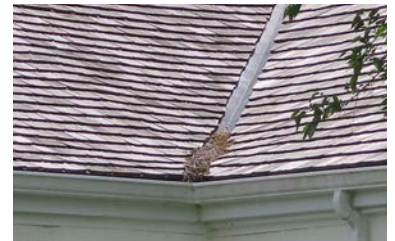
- 7 . 2 Accumulation of debris has been observed in the roof valleys and eavestroughs. It is recommended that quarterly cleaning be undertaken and that the gutters be monitored, particularly during rainy weather, to help identify any areas of overflow which may be contributing to the moisture penetration evident on the interior.

7.2 DEBRIS ACCUMULATING IN ROOF VALLEYS

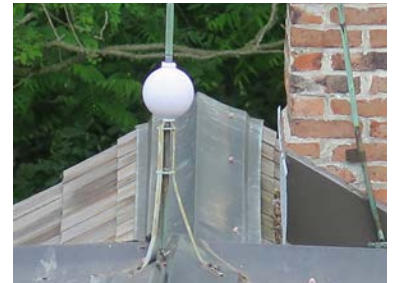
- 7 . 3 The lightning balls on the main roof are in good condition, and show no signs of being struck. They should however be tested to ensure they are still operating properly.

7.3 LIGHTNING BALLS TO BE TESTED

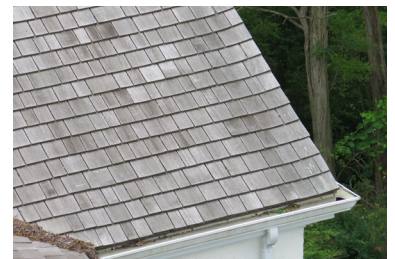
- 7 . 5 Cedar shingles were observed to be curling upwards at the roof edge of the west transept gable. Upon closer inspection, this appears to be intentional in order to help divert water away from the west facade.

7.5 MONITOR EAVESTROUGHS & DOWNPIPES

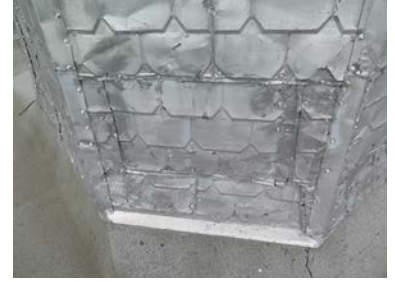
- 8 . 1 Rust continues to appear at the base of the spire. Immediate attention is not required as it appears to be performing well and ideally the historic material should be retained. One panel is missing but it is not visible from below.

8.1 RUST ON SPIRE SHINGLES AND MISSING PANEL

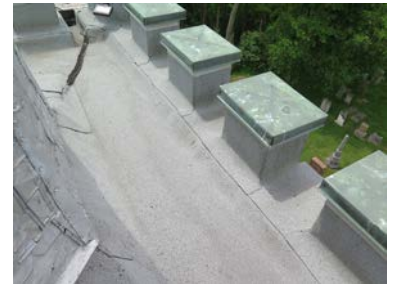
- 8 . 2 The 2 ply bituminous roofing membrane installed as per 2003 recommendations is performing well and needs no maintenance at this time. No signs of moisture penetration or water accumulation were observed.

8.2 2-PLY BITUMINOUS ROOF MEMBRANE

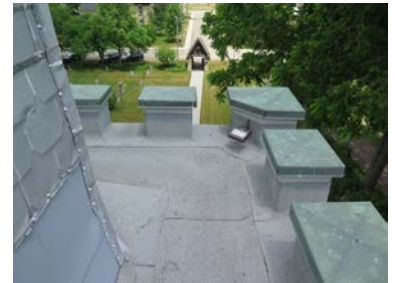
- 8 . 3 Copper caps of the tower merlons are performing well and are not in need of any maintenance at this time.

8.3 COPPER CAPS IN GOOD REPAIR

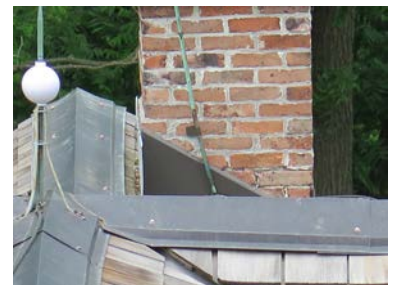
8.4 UNSYMPATHETIC FLASHING AT CHIMNEY

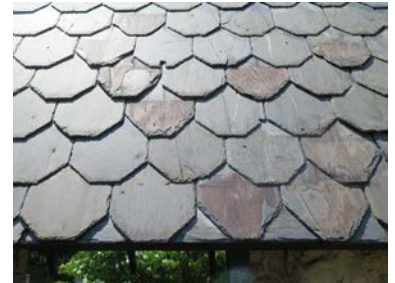
9.3 SPLIT AND FLAKING SLATE SHINGLES ON THE LYCH GATE ROOF

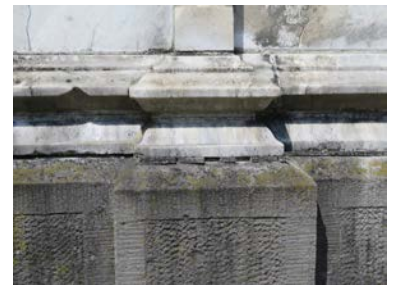
9.4 OPEN JOINTS ON CHISHOLM MONUMENT

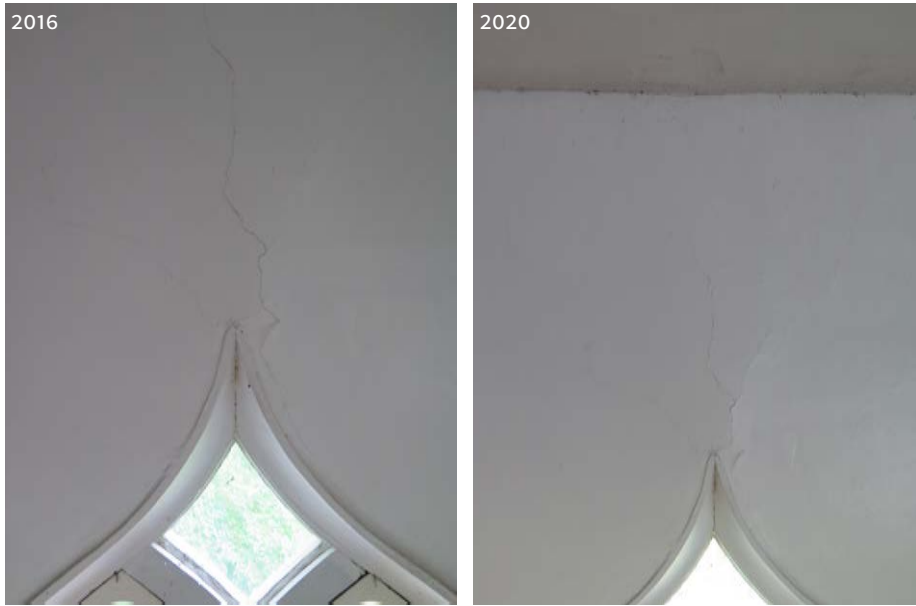
- A 2 . 1 Cracks above the west transept window appear to be progressing from what was observed in 2016, and should continue to be monitored.

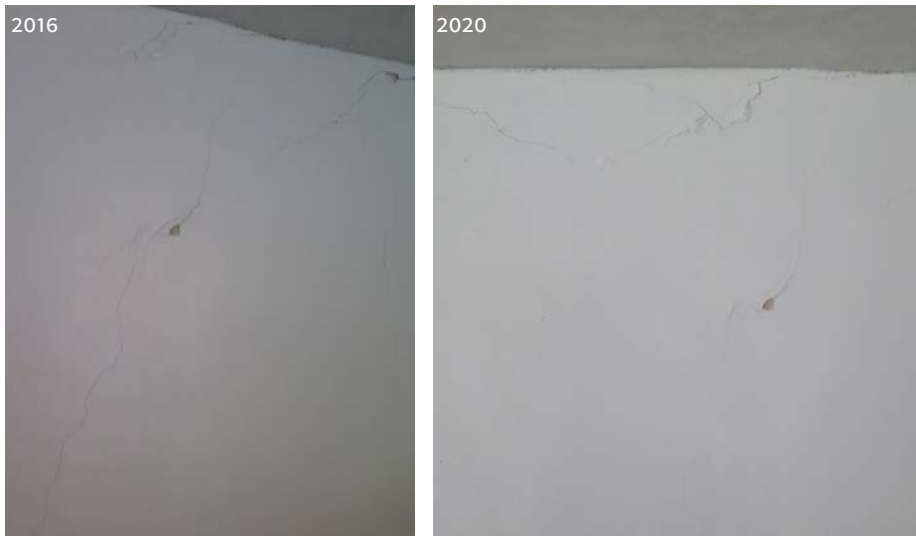
APPENDIX 2 - CRACK COMPARISON

- A 2 . 2 Cracks along the south wall at the ceiling appear to be progressing from what was observed in 2016, and should continue to be monitored.

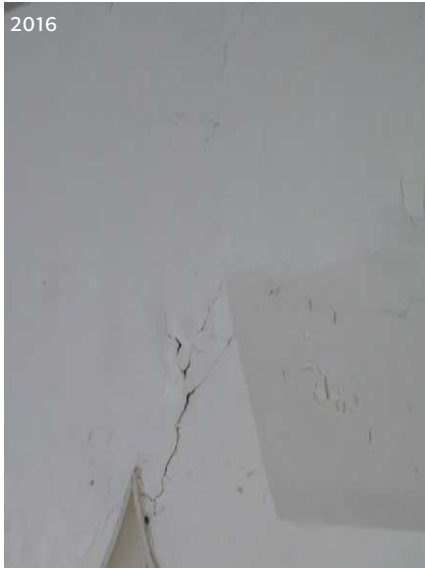
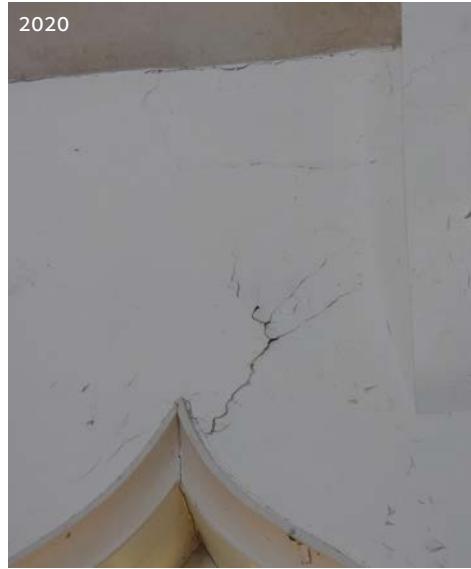
- A 2 . 3 Cracks above the south window are in a similar condition as those observed in 2016, and should continue to be monitored.

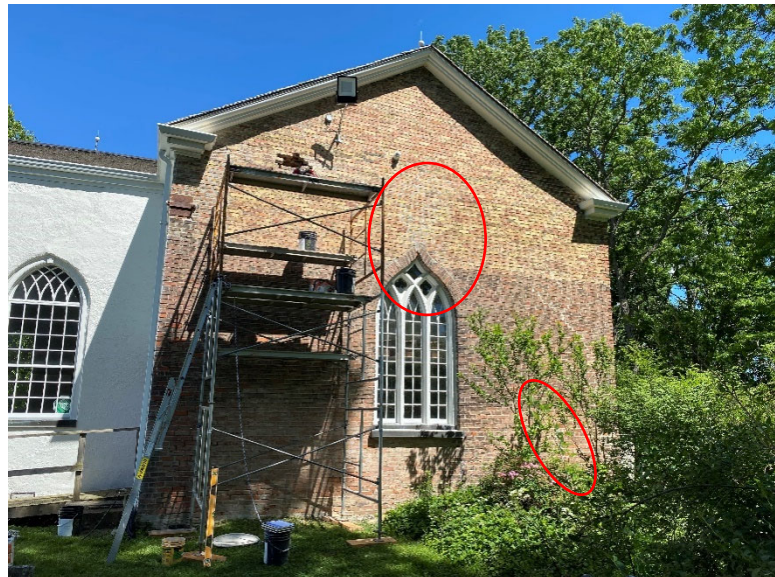
West Elevation
Harder denser mortar locations

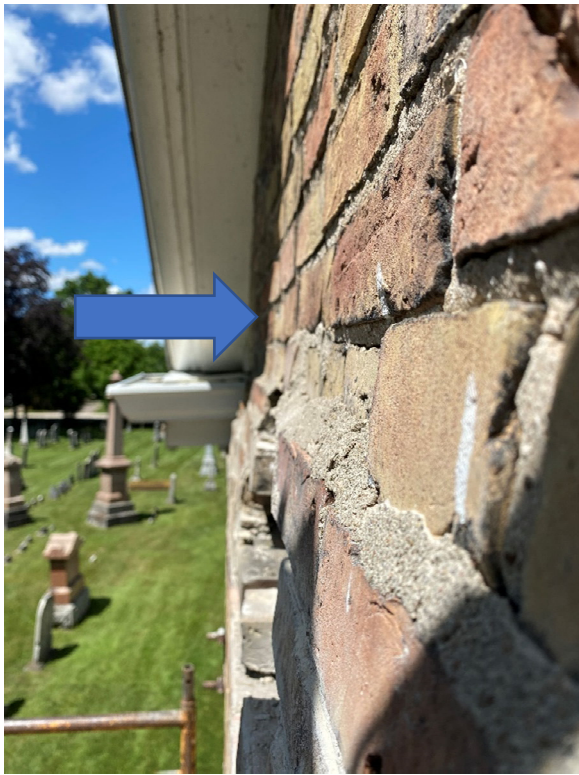
Existing Wall Condition Looking North
Wall steps outward from 24" below eave and sweeps inward towards soffit panel. Slope inward ranges from 2" to 3"

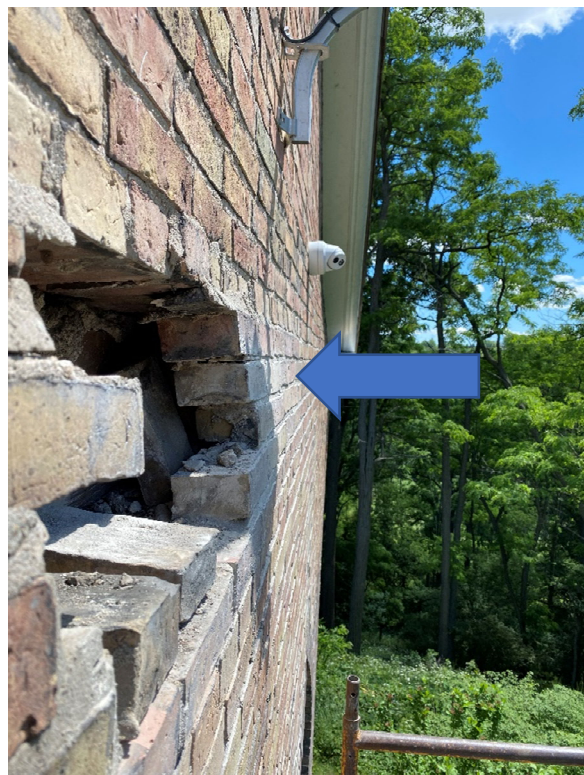
Existing Wall Condition Looking South
South line has a more subtle sweep

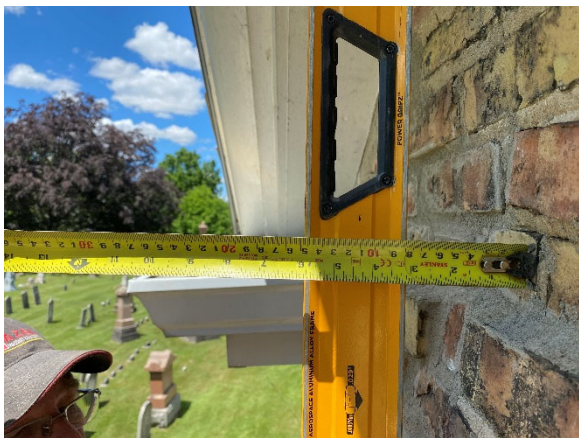
Out of Plumb Measurement
Displacement ranges from 2" – 3"

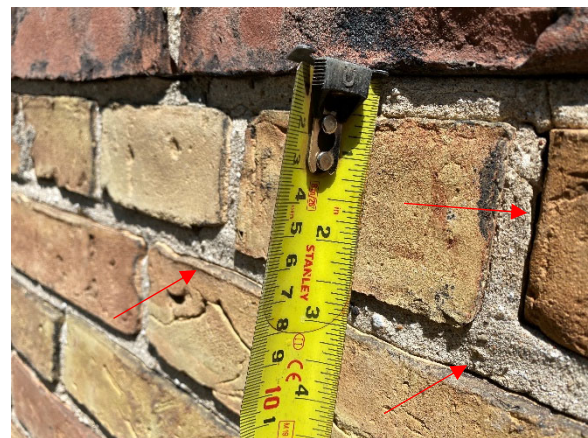
Open Mortar Joints
Open joints allow water ingress

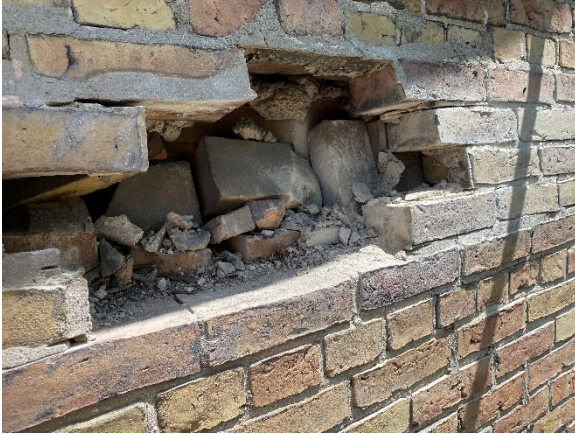
Masonry Opening
Random brick loose laid in inner core

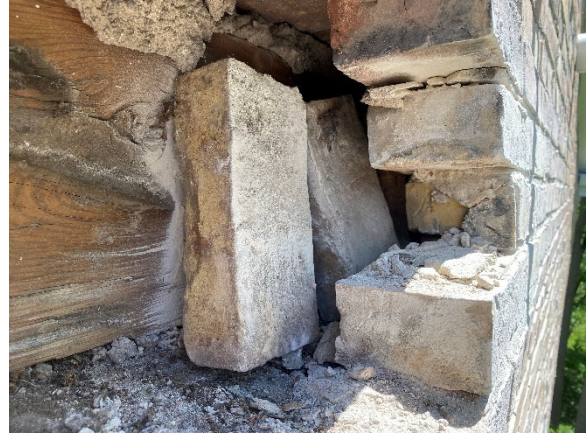
Opening Detail
Loose masonry removed

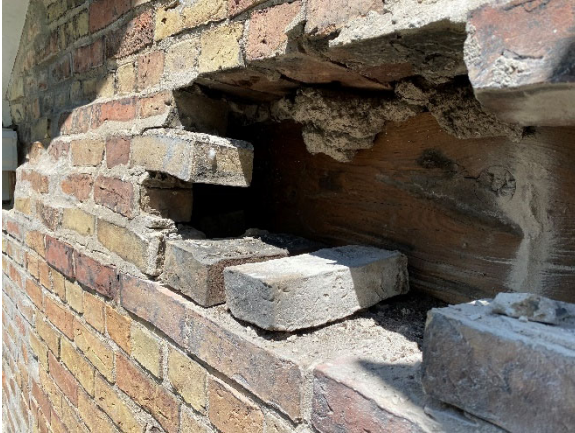
Masonry Inspection Opening
Header course

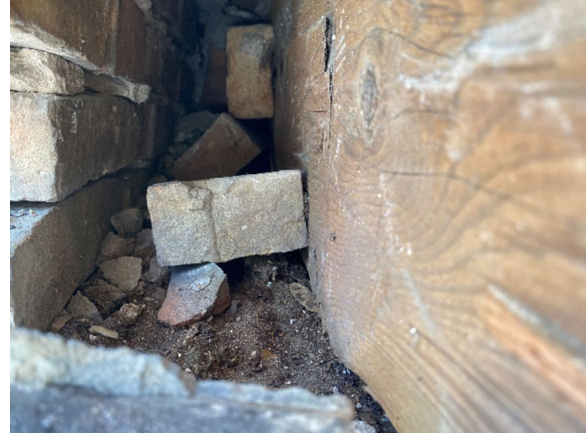
Void Space
Loose laid brick infill and mortar debris.
