**Heritage Impact Assessment—
244-248 Talbot Street, St. Thomas,
Ontario**

DRAFT REPORT

November 8, 2021

Project Number: 160940802

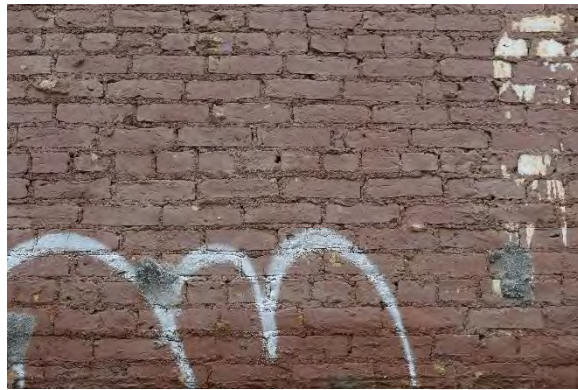
Plate 18: Brick bond of 244 Talbot Street, looking east

- Decorative brickwork including pilasters, quoins, corbelling, drip moulds, voussoirs, and window and door surrounds
- Fenestration pattern of front façade windows with eight on each upper storey
- Segmental and semi-circular window openings
- Semi-circular stone surrounds with keystones and label stops
- Brick foundation

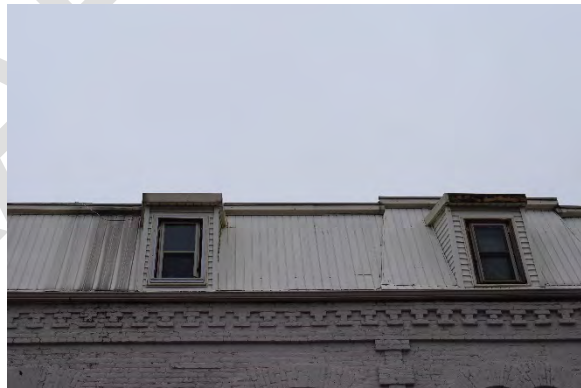
Plate 23: Details of mansard roof, dormers, and corbel on 248 Talbot Street, looking west

When it was initially constructed, the 246-248 Talbot portion of the building was two and one half storeys in height and included a mansard roof with semi-circular dormers and an oculus dormer (Plate 1). The adjacent 244 Talbot was three storeys in height with a flat roof and parapet.

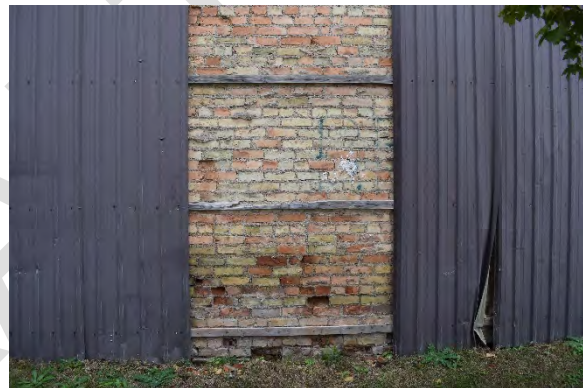
Plate 27: Missing corrugated metal revealing buff brick, looking east

The addition on 244 and 246 Talbot Street is an irregular shaped structure with a shed roof and gable roof (Plate 26). The south, east, and north elevations have concrete block exteriors, and the west elevation is buff brick clad in corrugated metal. Sections of the corrugated metal are missing and reveal the buff brick (Plate 27). The east elevation contains a storefront that formerly contained a laundromat. The storefront consists of hand painted signage affixed to modern siding, two fixed windows, and a

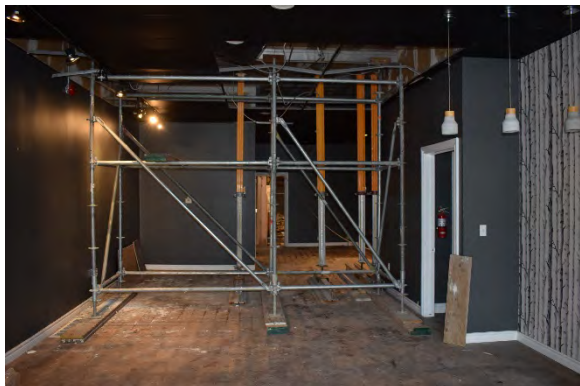
Plate 30: First storey of 244 Talbot Street, looking south

The first storey of 244 Talbot Street contains an unoccupied commercial space. The space has a drop-tile ceiling and hardwood floor. The walls are drywall and contain sections of wallpaper (Plate 30). The commercial space also contains two bathrooms. The basement contains machine cut timber beams and shows the buff brick foundation of the structure (Plate 31).

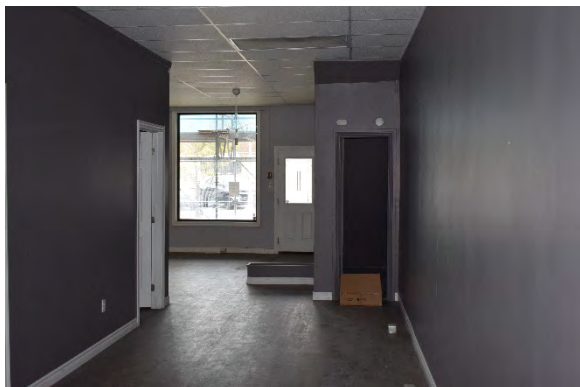
Plate 32: First storey of 246 Talbot Street, looking north

The first storey of 246 Talbot Street contains an unoccupied modern commercial space. The space has a drop-tile ceiling and laminate floor. The walls are drywall and contain sections of modern wallpaper (Plate 32). The commercial space is divided into offices and contains a bathroom. The basement contains machine cut timber beams and shows the buff brick foundation of the structure (Plate 33).

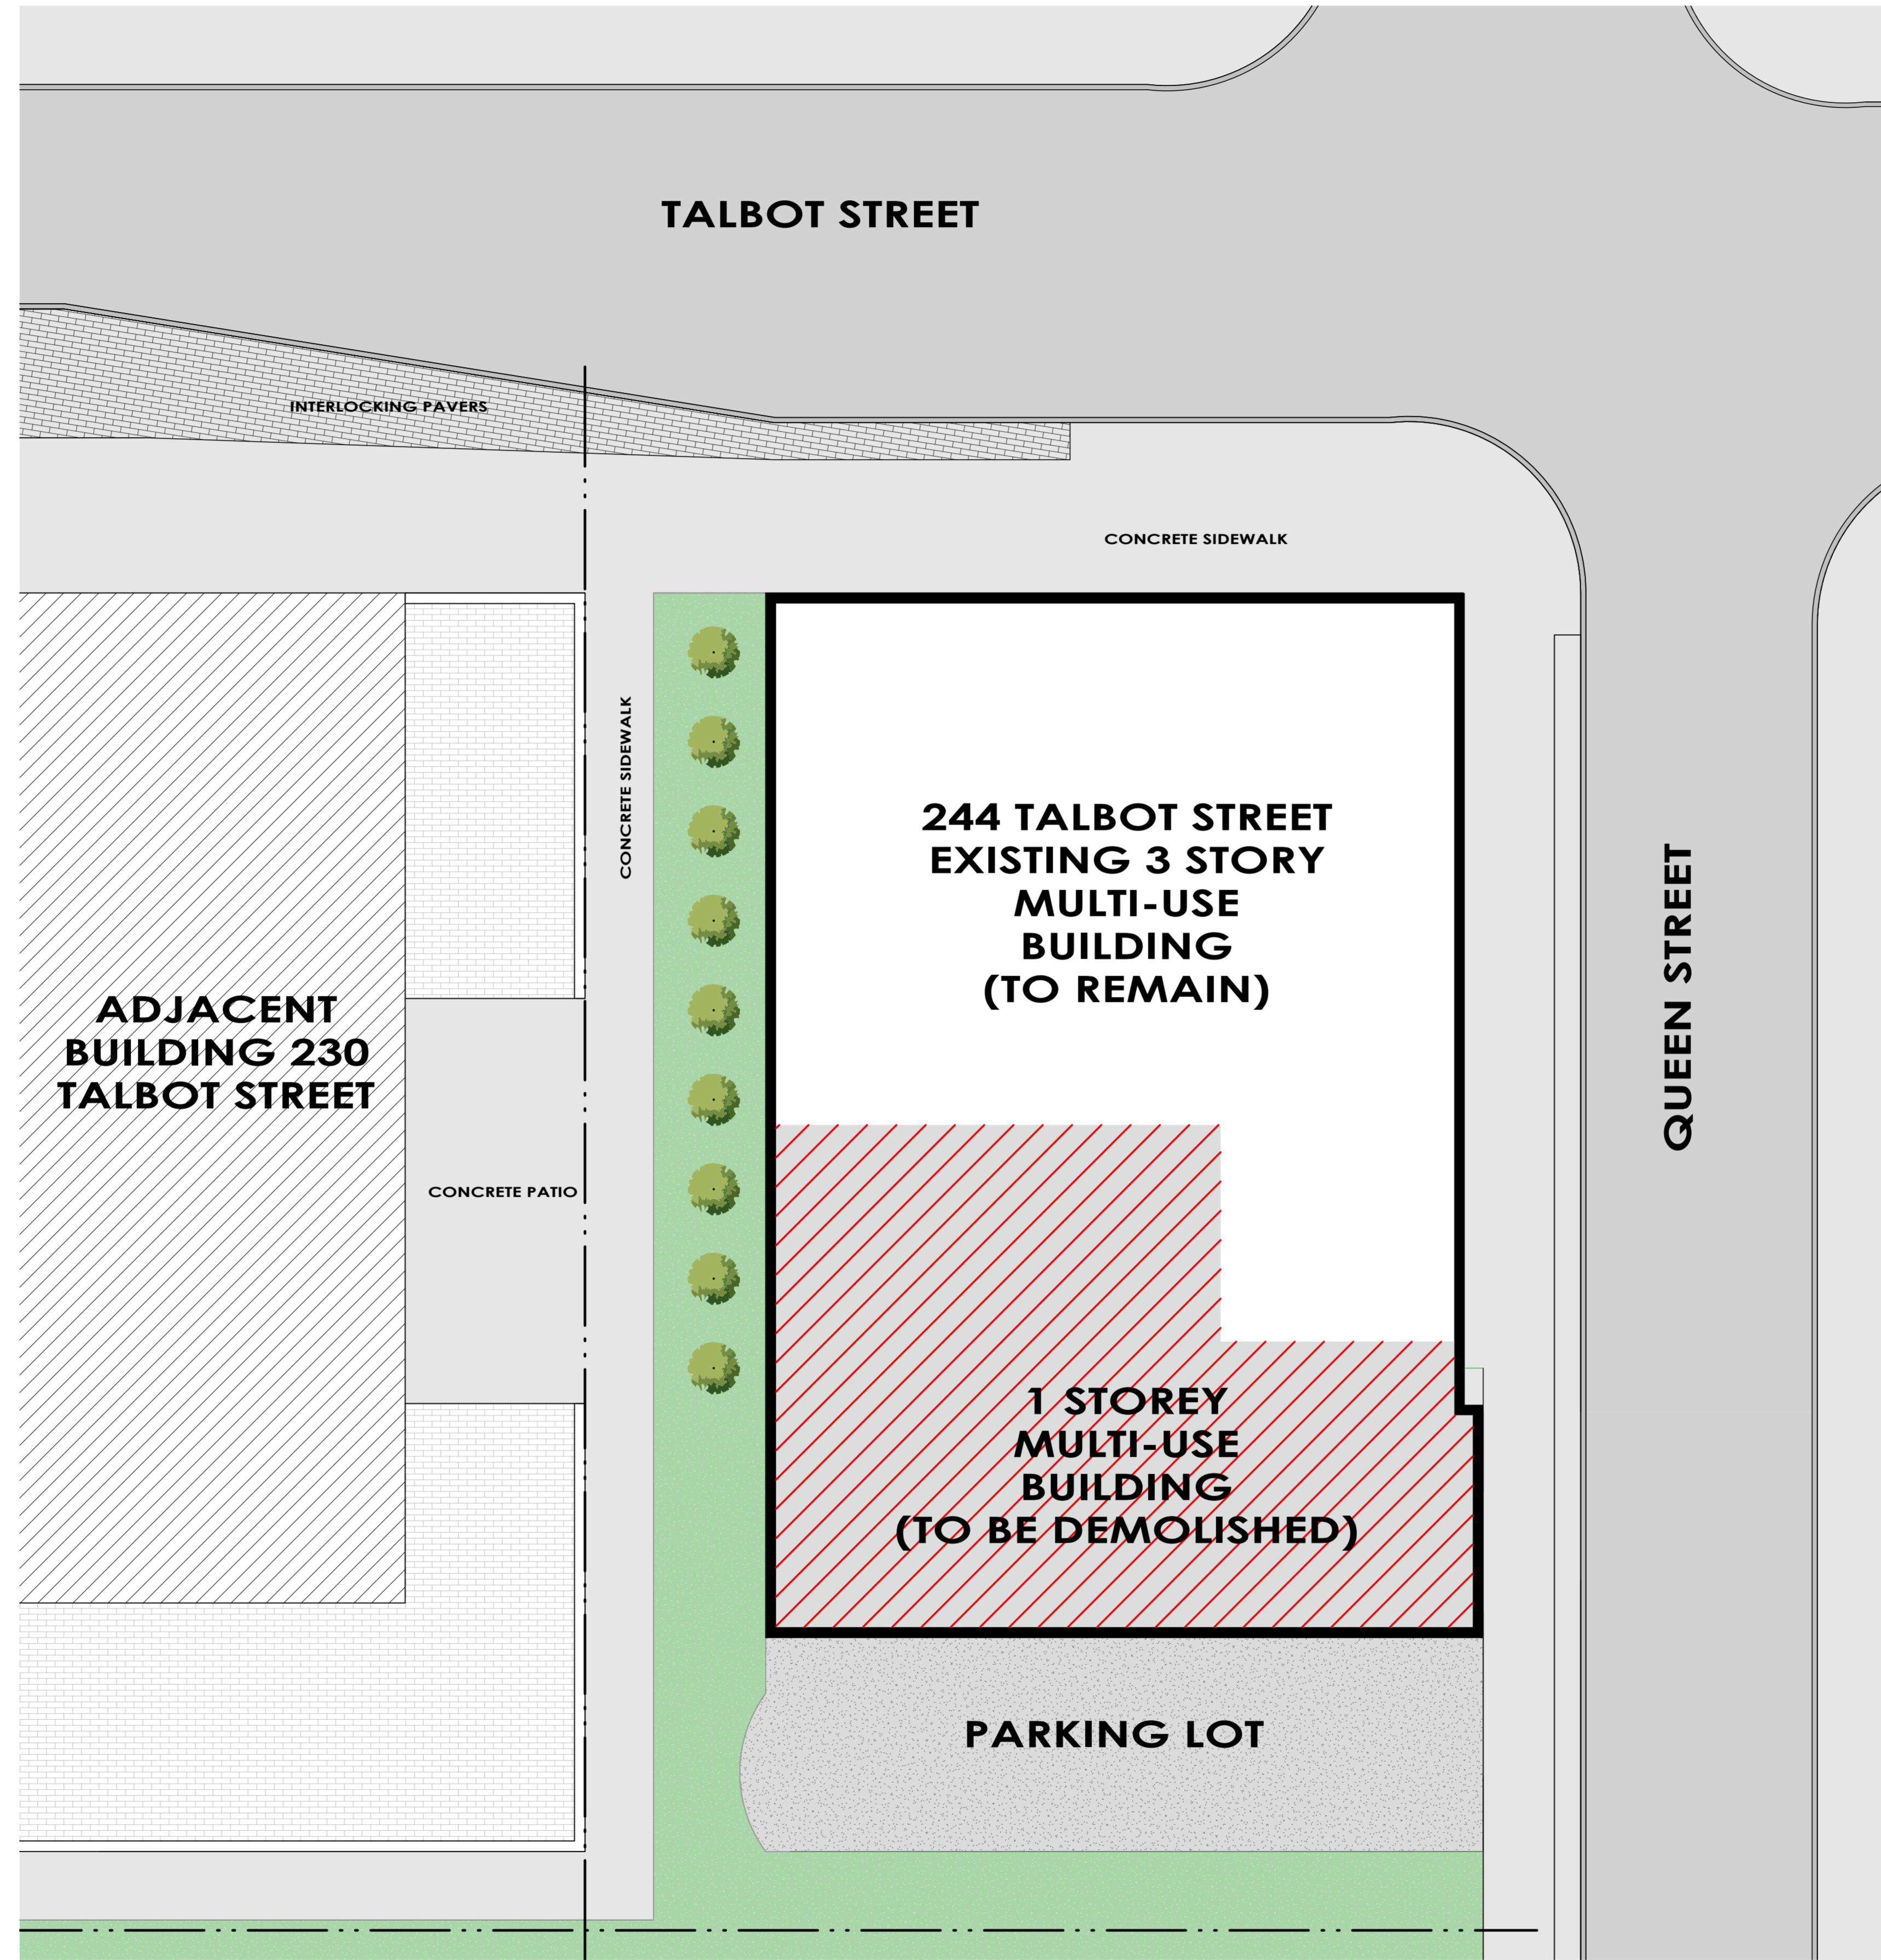
.SP1

SITE PLAN

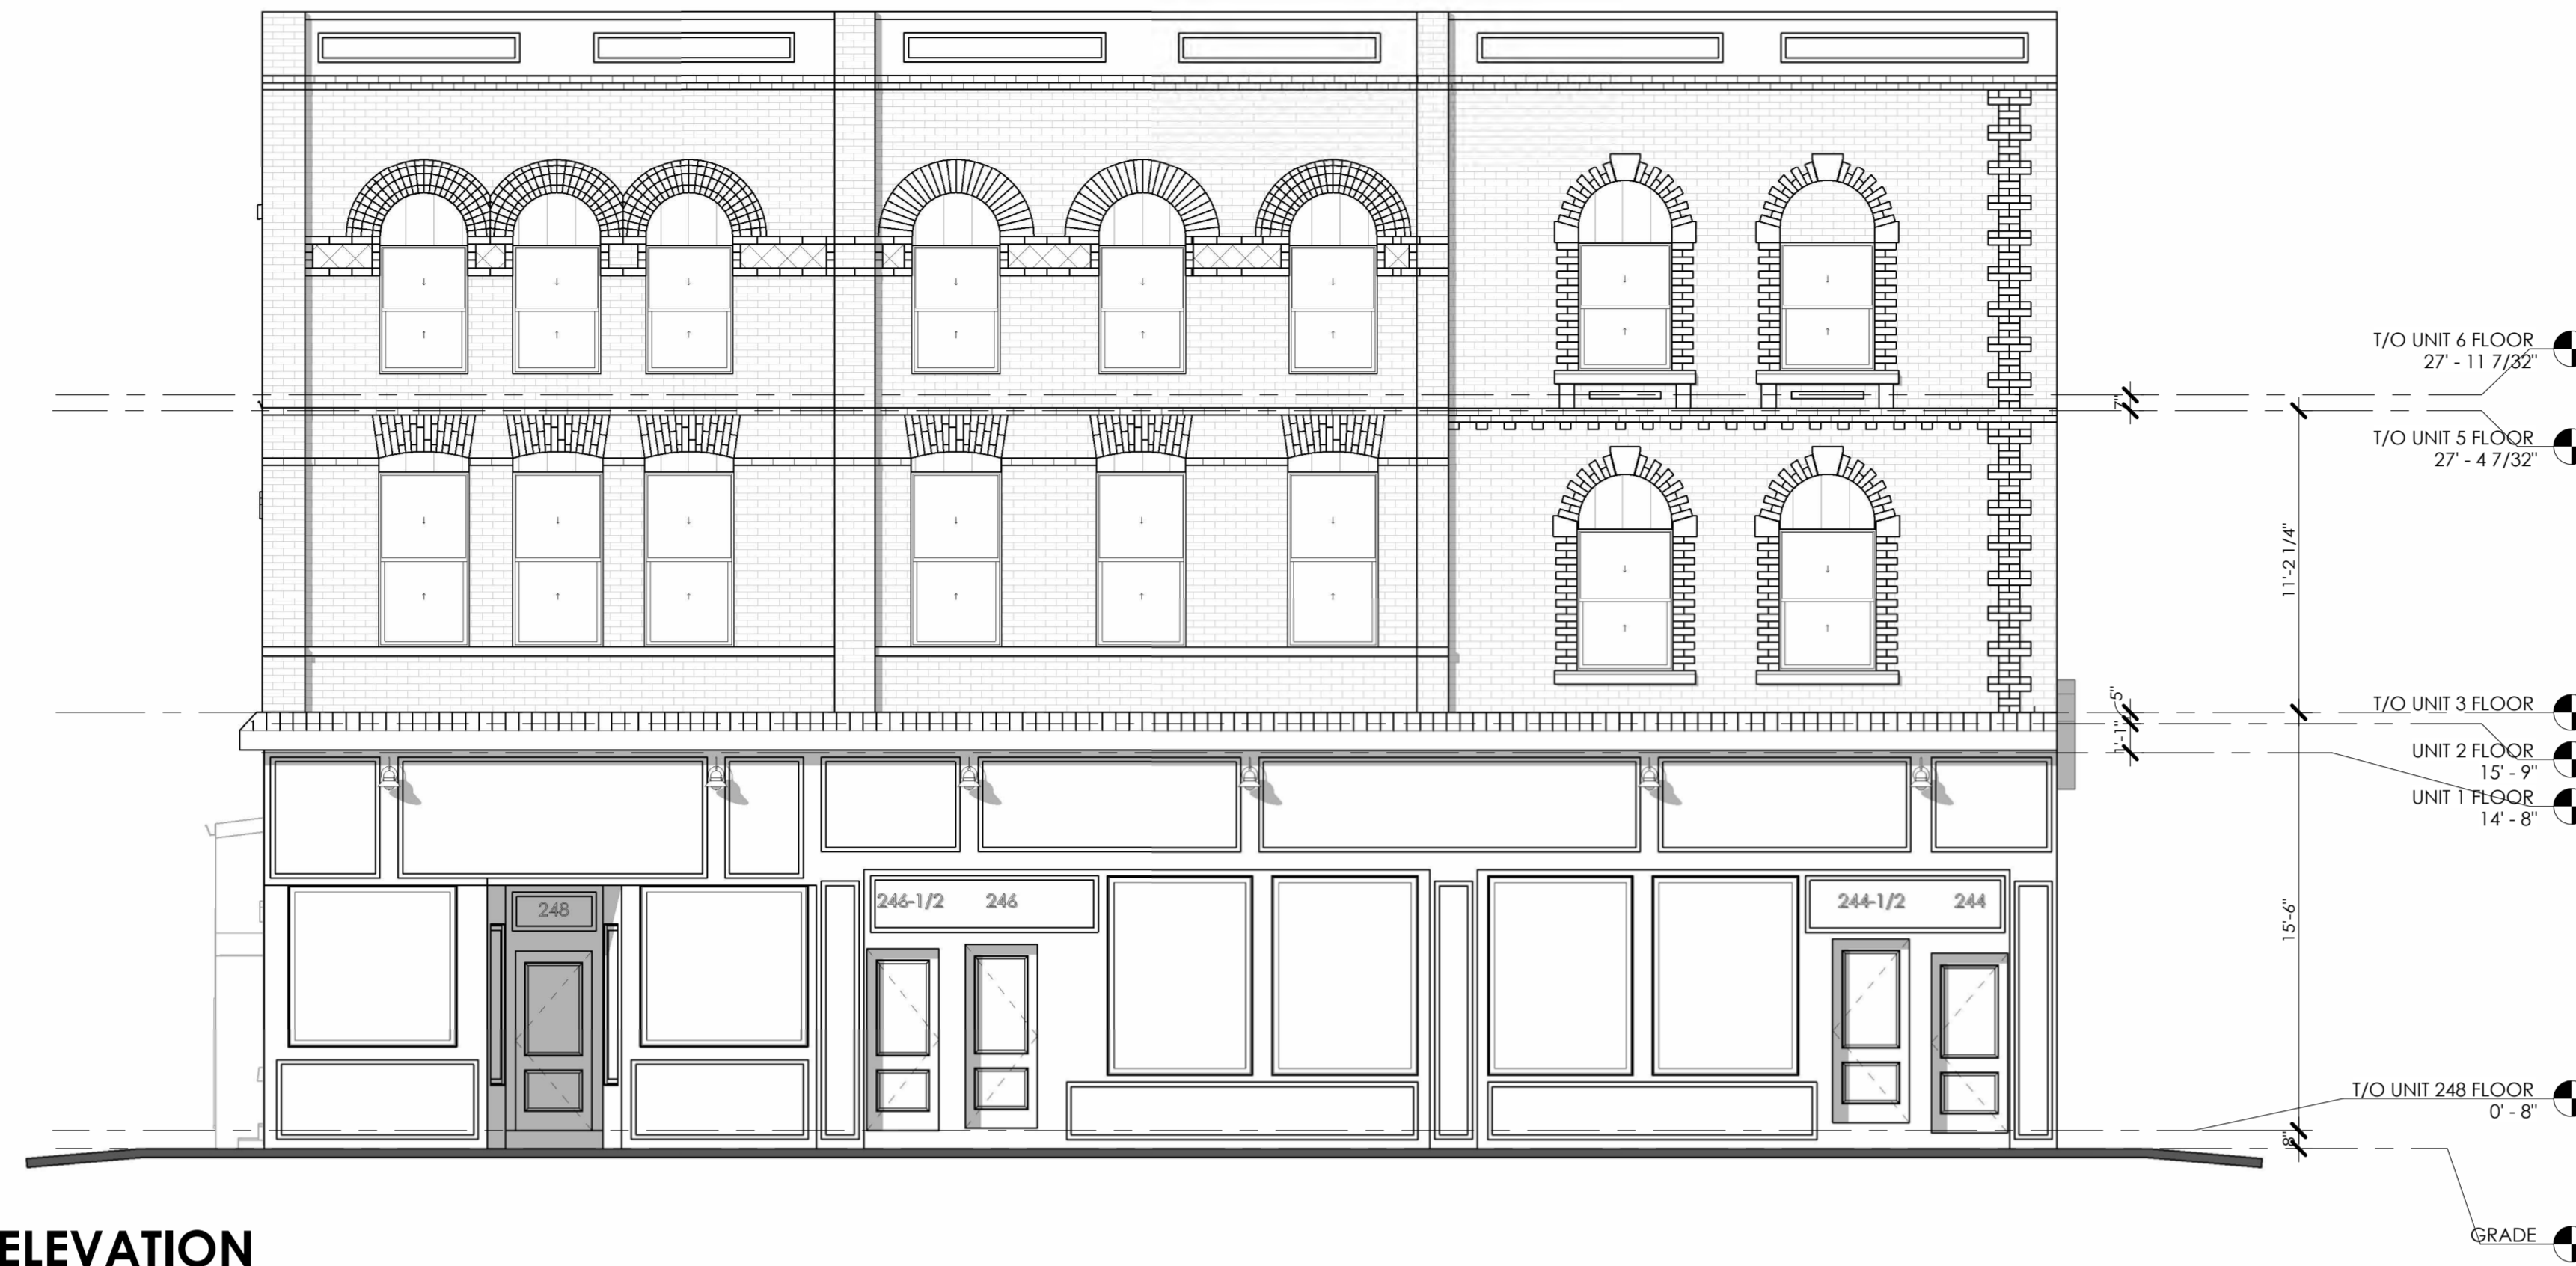
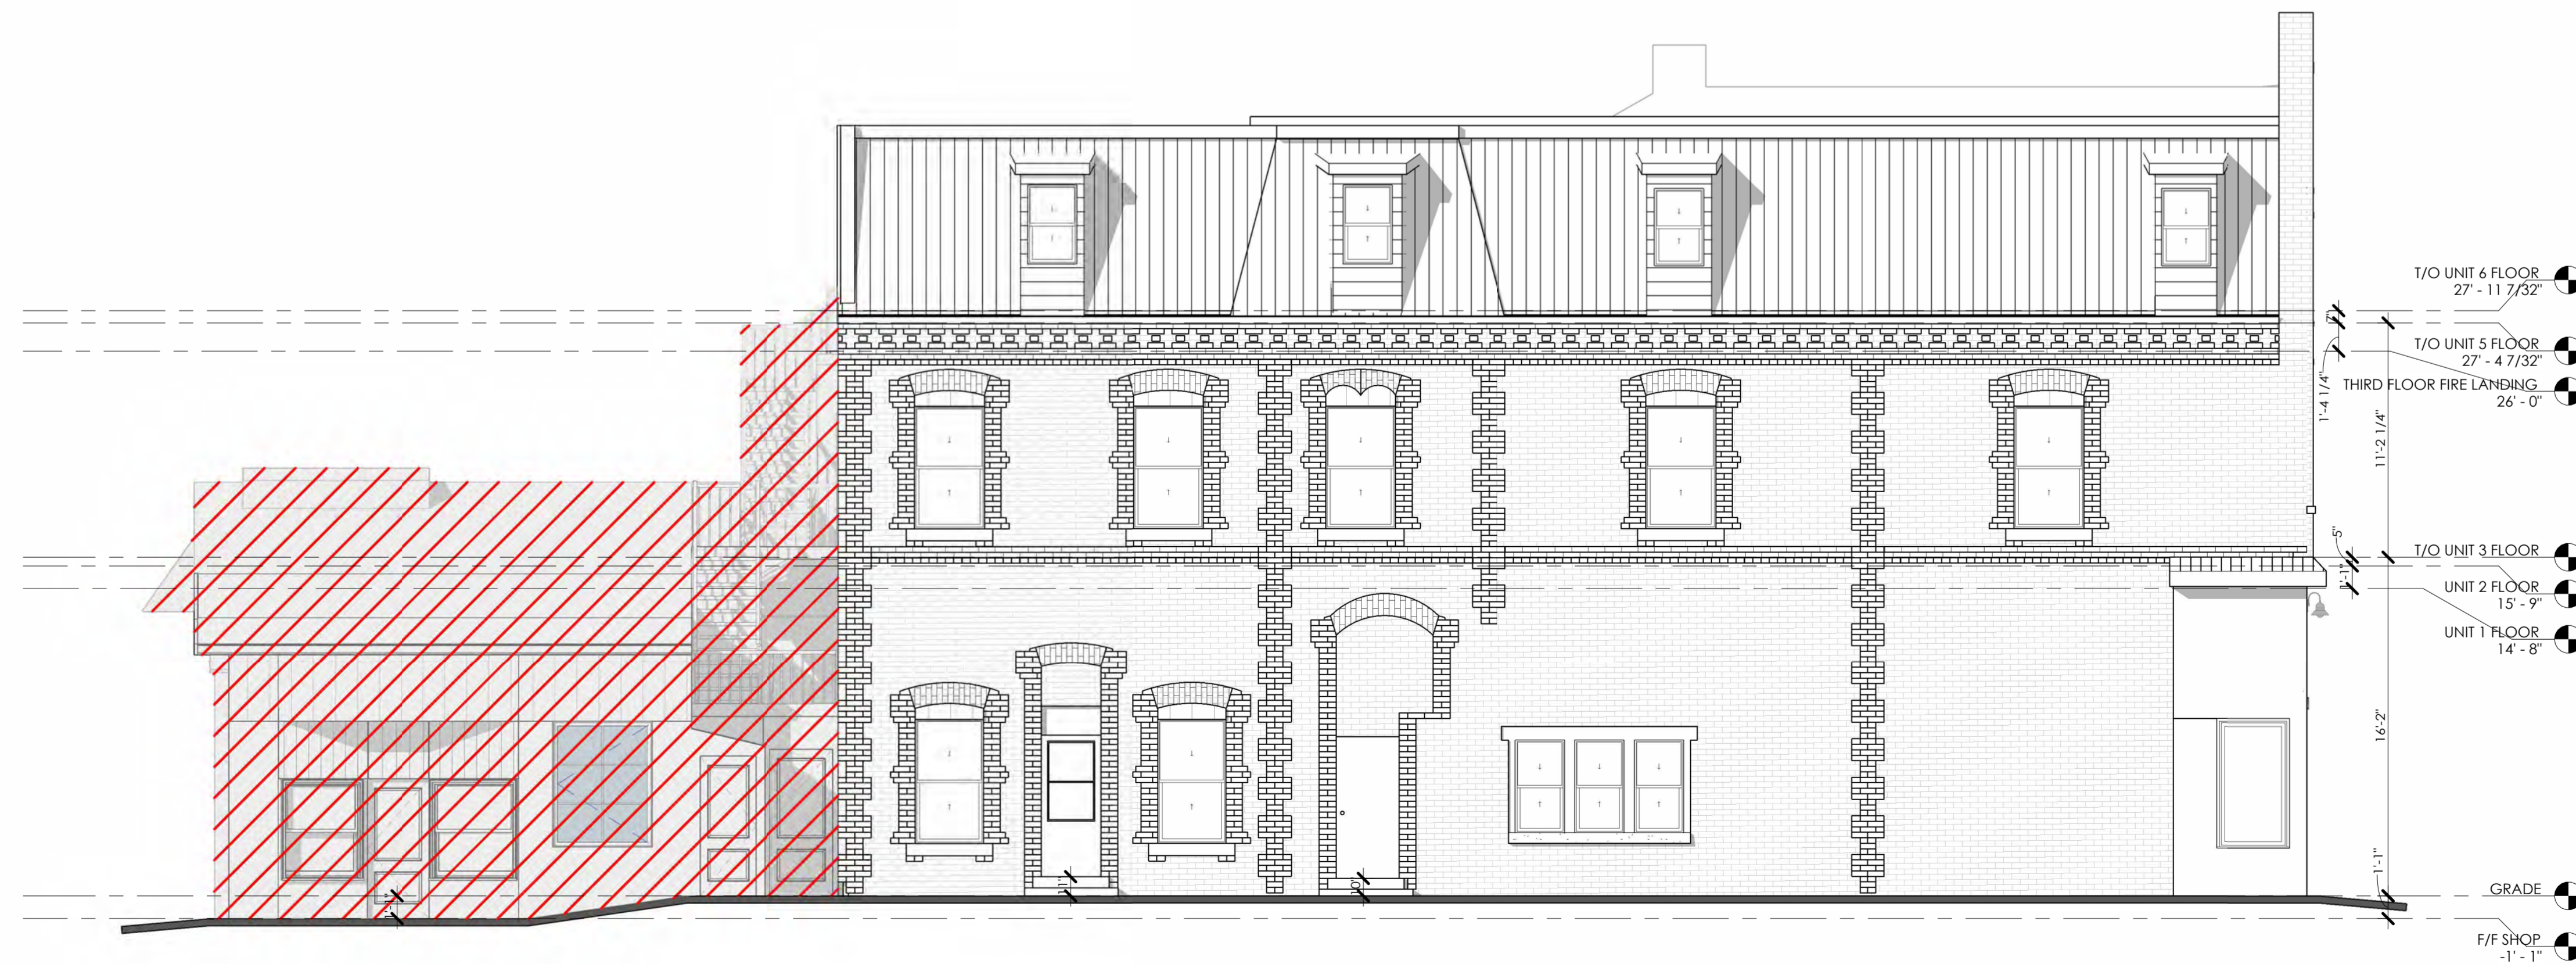
SHEET TITLE:
**NORTH AND EAST
ELEVATIONS**

NORTH ELEVATION
3/16" = 1'-0"

EAST ELEVATION
3/16" = 1'-0"

AREA TO BE DEMOLISHED

The *Demolition Outline Letter* prepared by Remy Consulting Engineers Limited (RCEL) in November 2021, noted that the concrete block addition at the rear of the original 1870s building is an independent structure. The addition has an independent foundation system and its concrete block walls do not integrate with the adjacent brick masonry of the original building. RCEL concluded that the demolition of the rear concrete block addition will not have a detrimental impact on the brick masonry of the original building. RCEL has been retained by the Proponent to complete a detailed survey of the rear concrete block building and to develop a comprehensive demolition plan that will address the following: Temporary Facilities and Controls, Selective Demolition; Hazardous Materials Abatement, Underground Services, Electrical and Mechanical Services, Telephone and Communication Services Lines, Cleaning and Material Recovery, and Coordination with Utility Owner(s) (RCEL 2021).

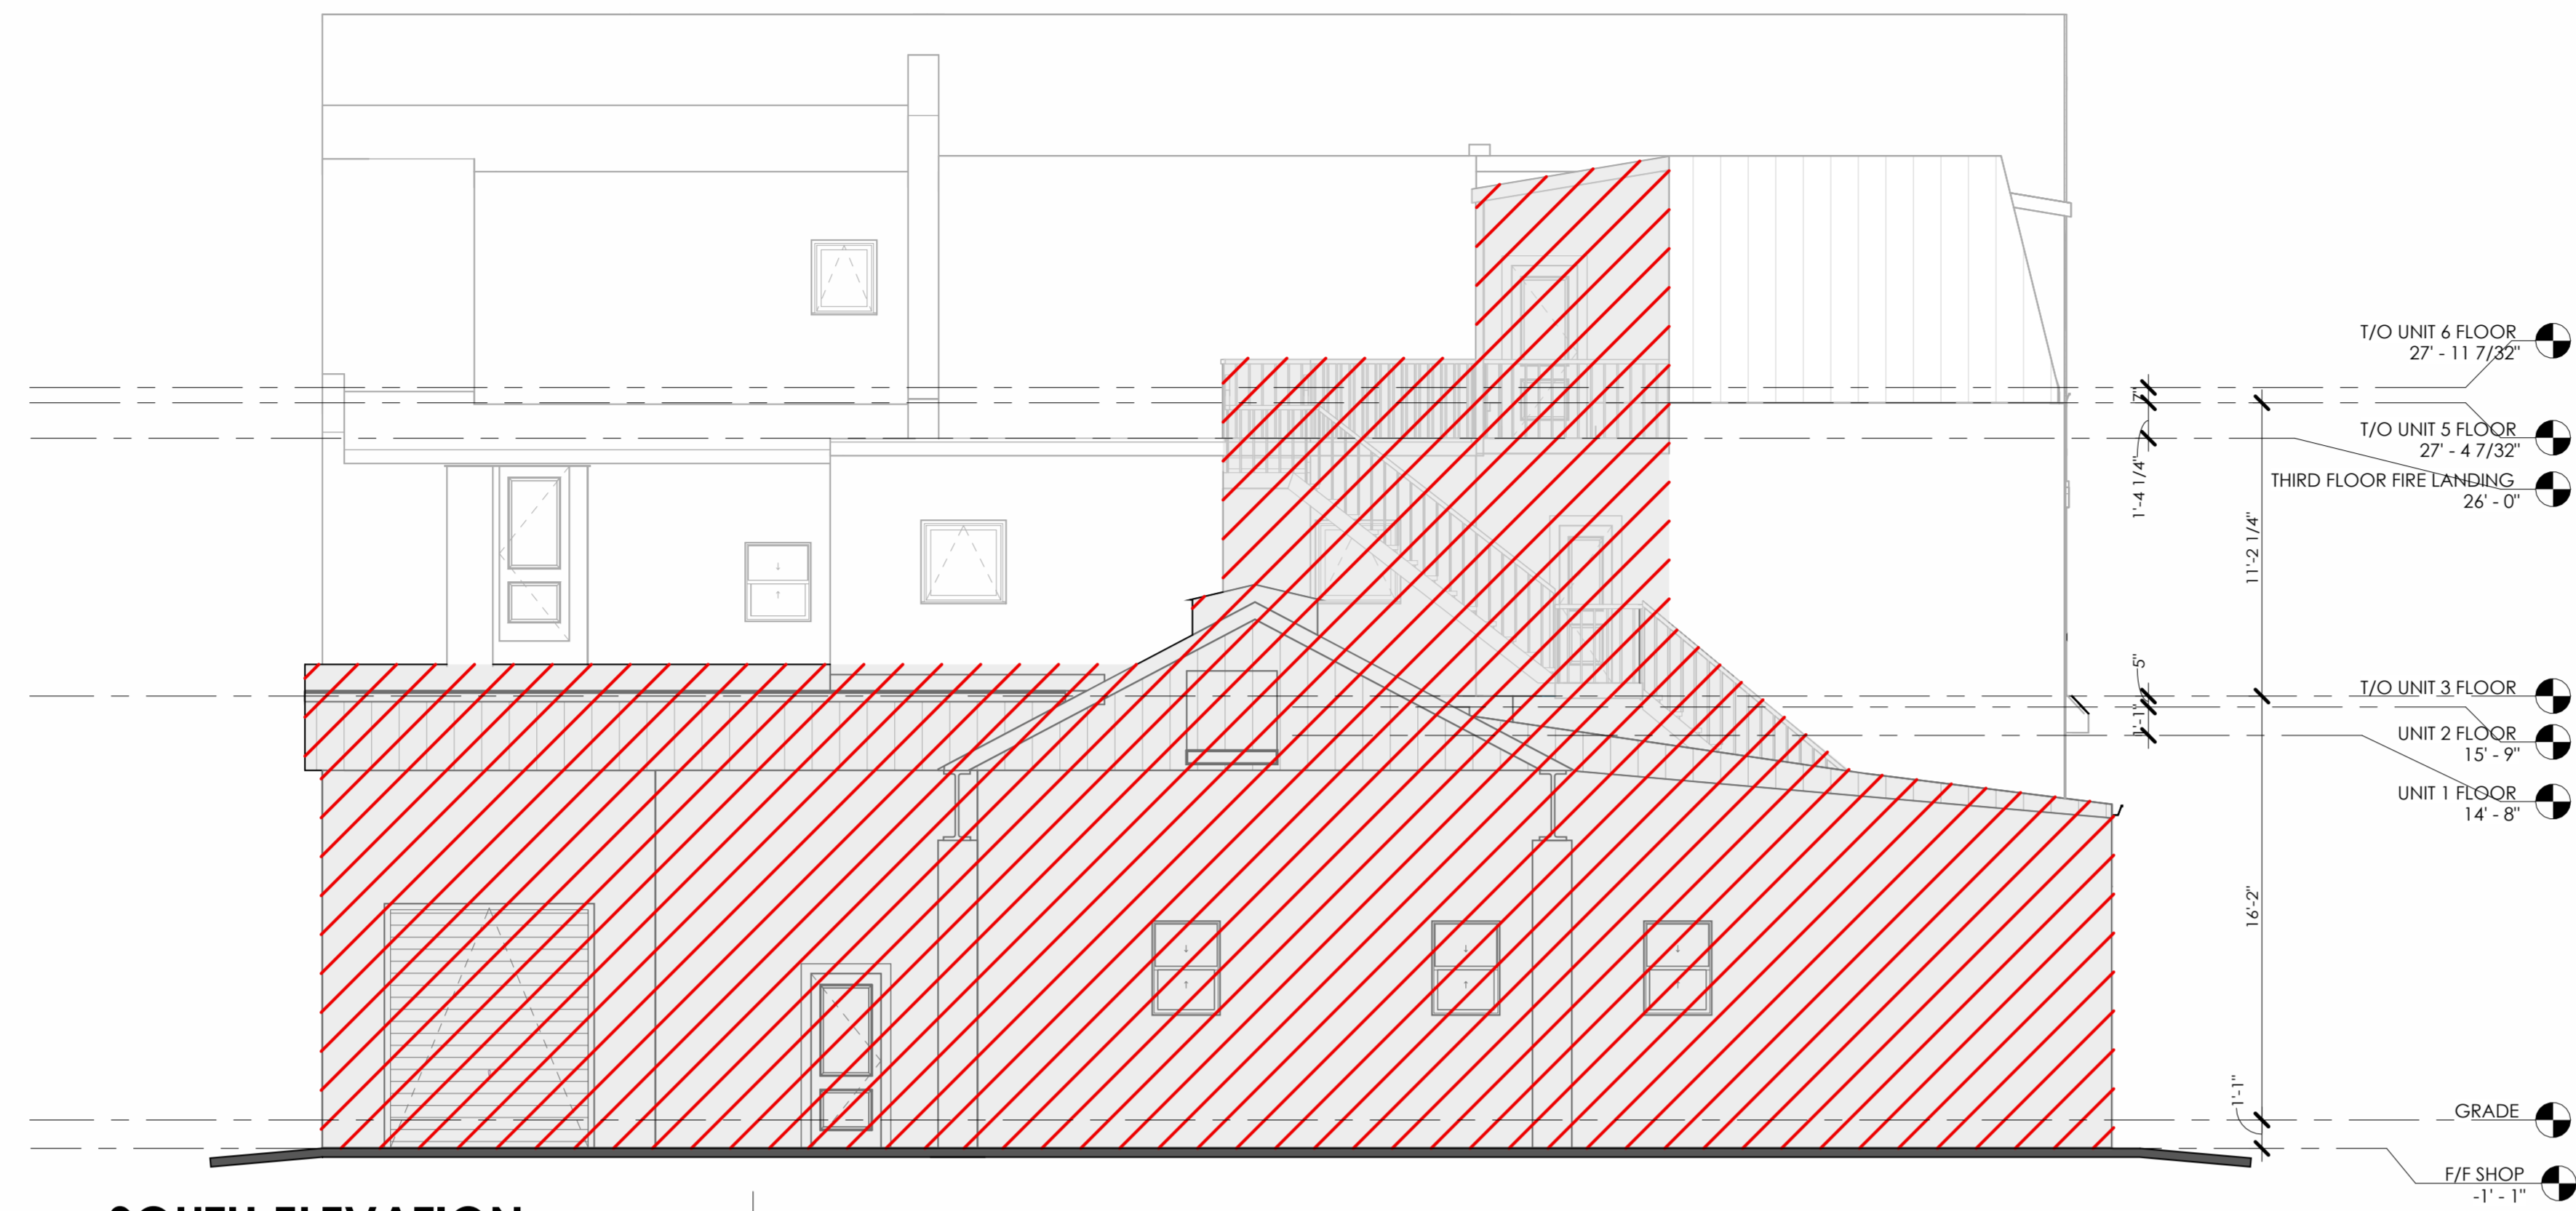
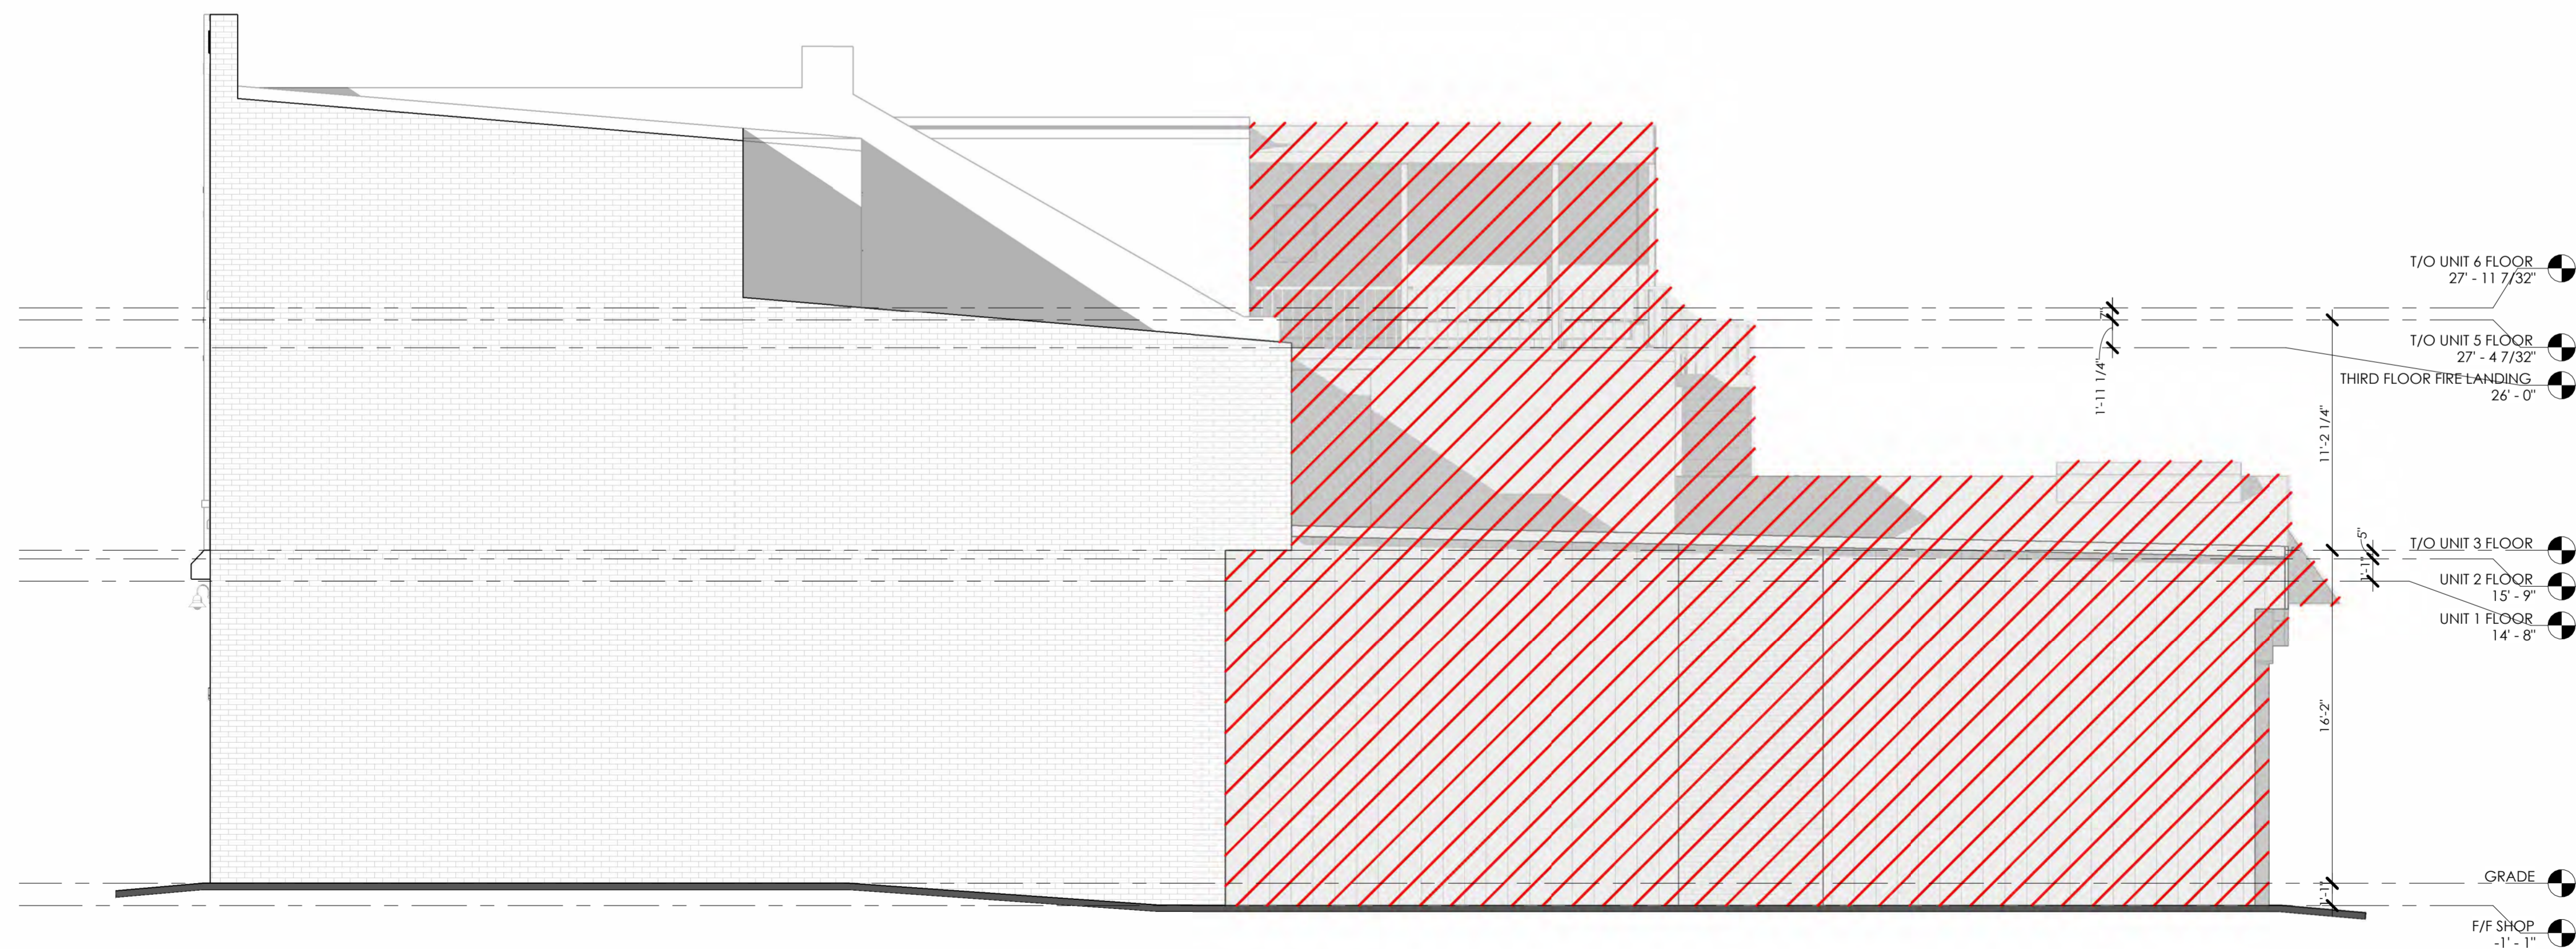
SOUTH ELEVATION

WEST ELEVATION

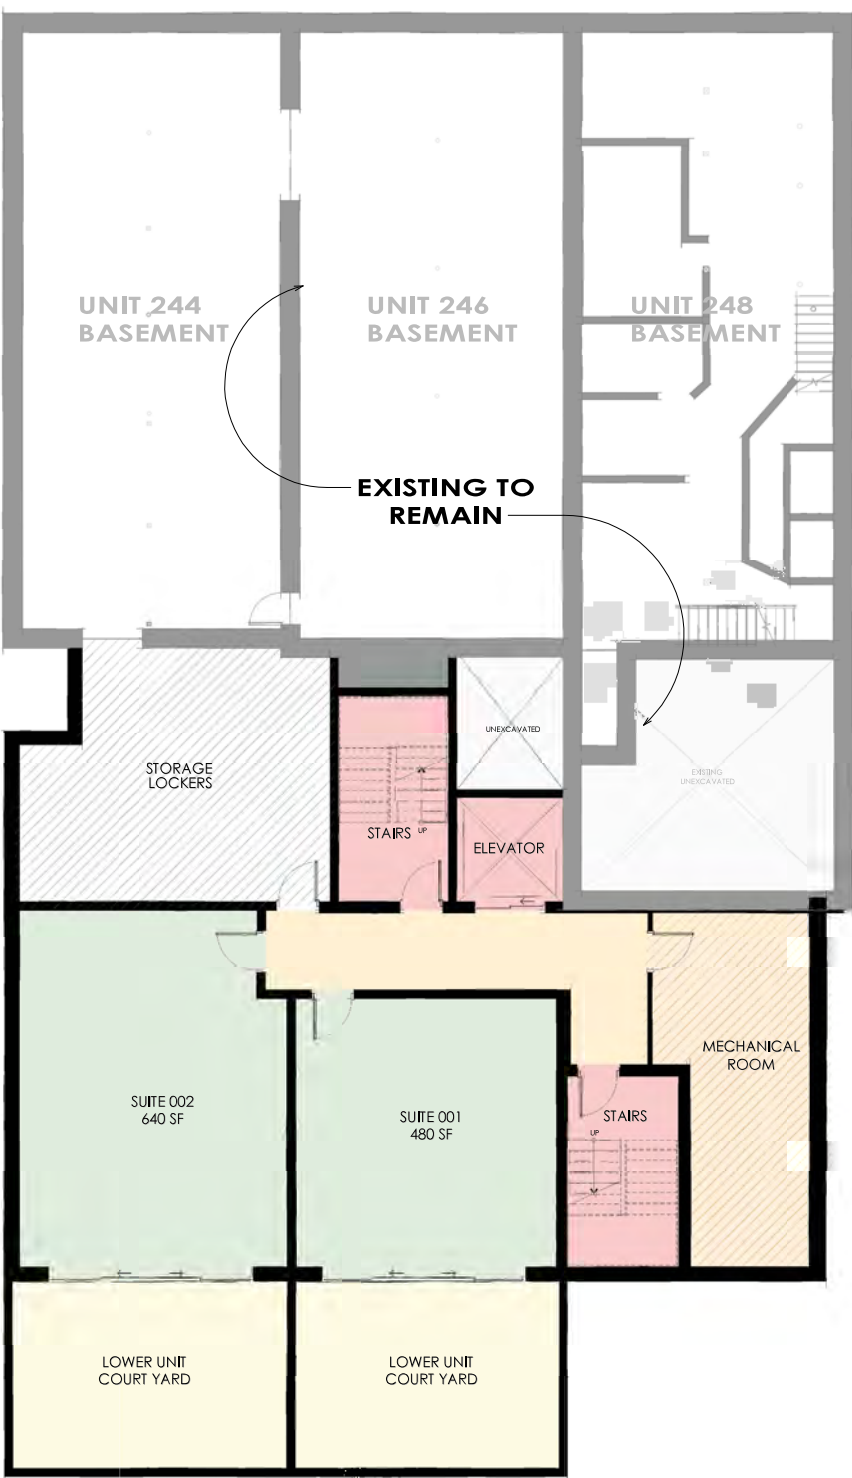
LOWER LEVEL (2950 SF)

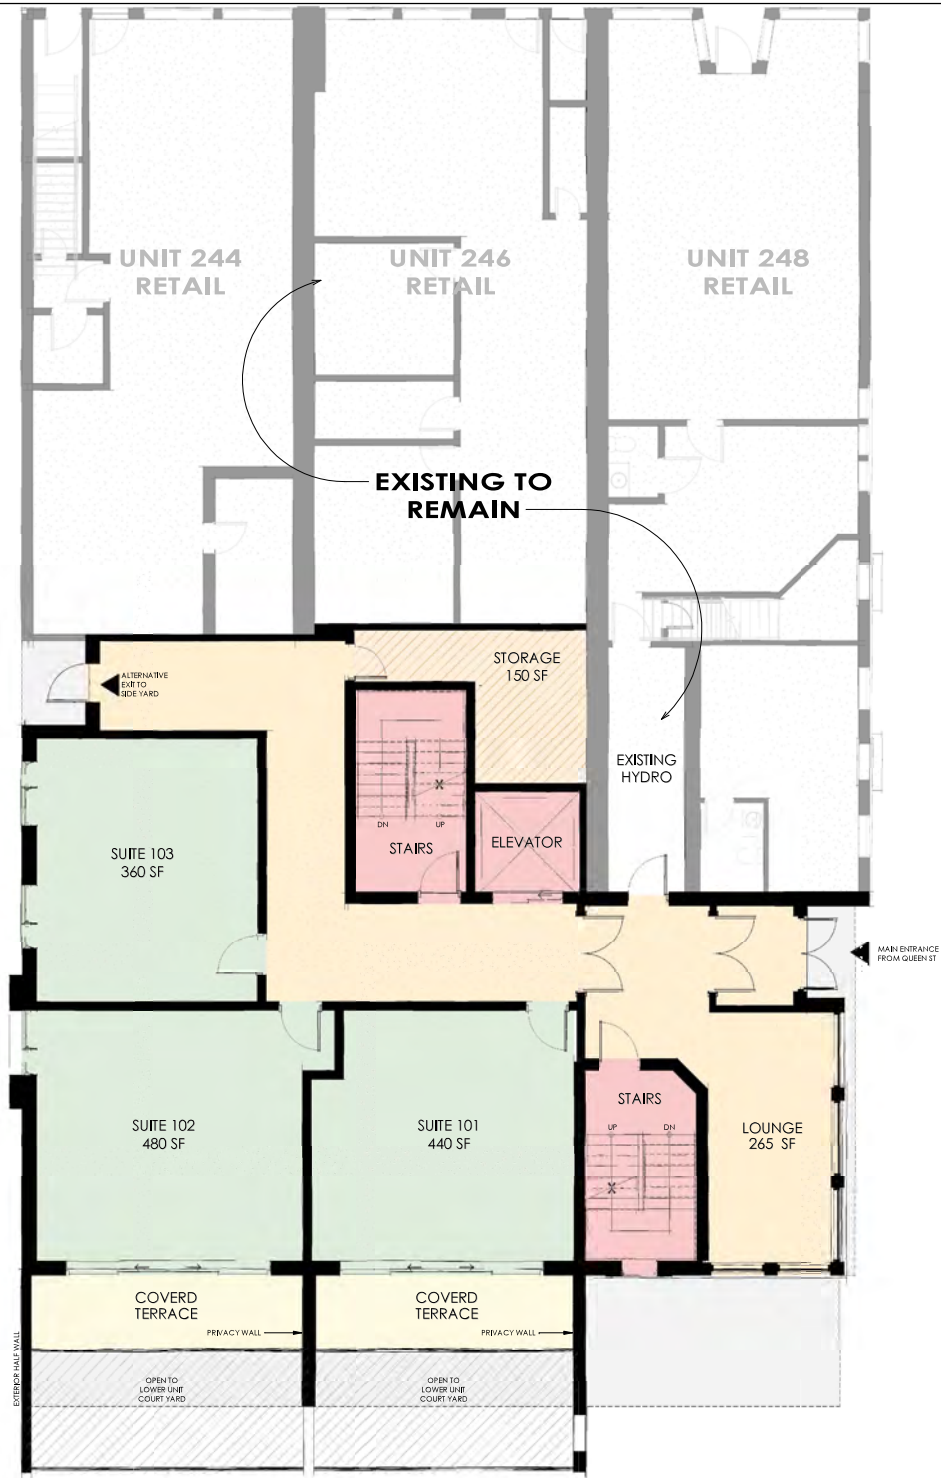
FIRST FLOOR

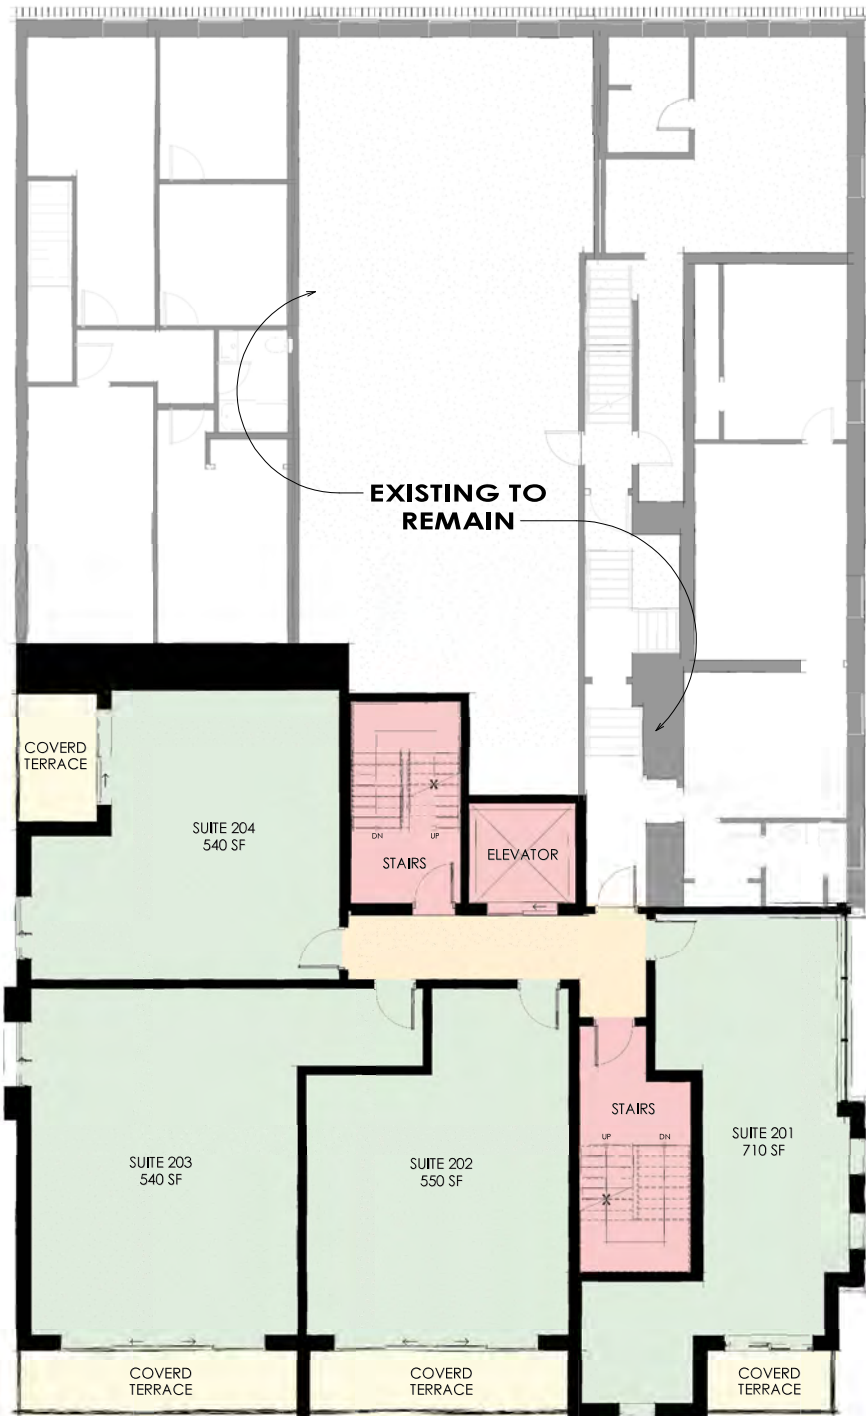
SECOND FLOOR (3184 SF)

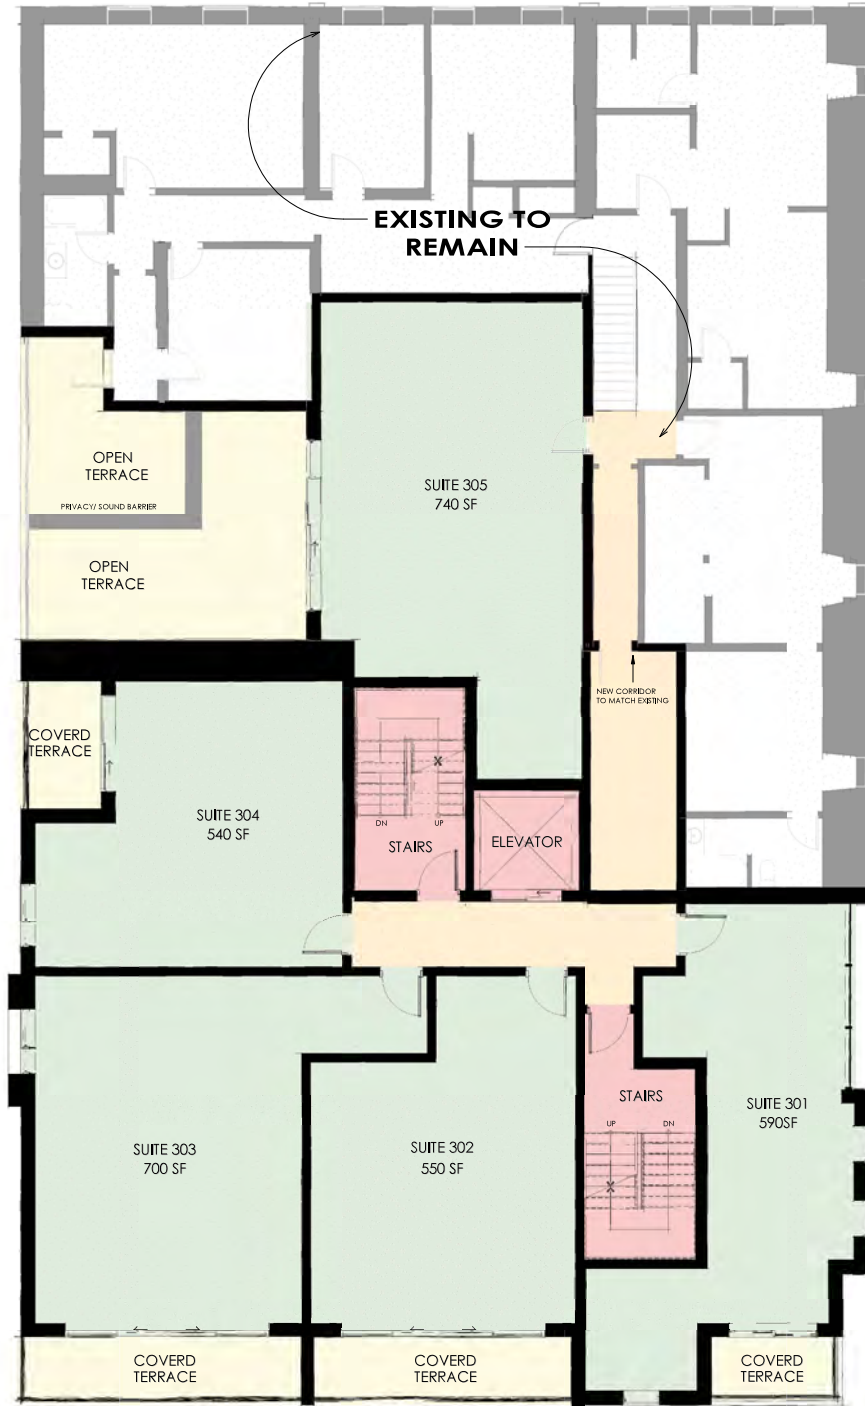
THIRD FLOOR (4075 SF)
