**Heritage Impact Assessment—
244-248 Talbot Street, St. Thomas,
Ontario**

DRAFT REPORT

November 8, 2021

Project Number: 160940802

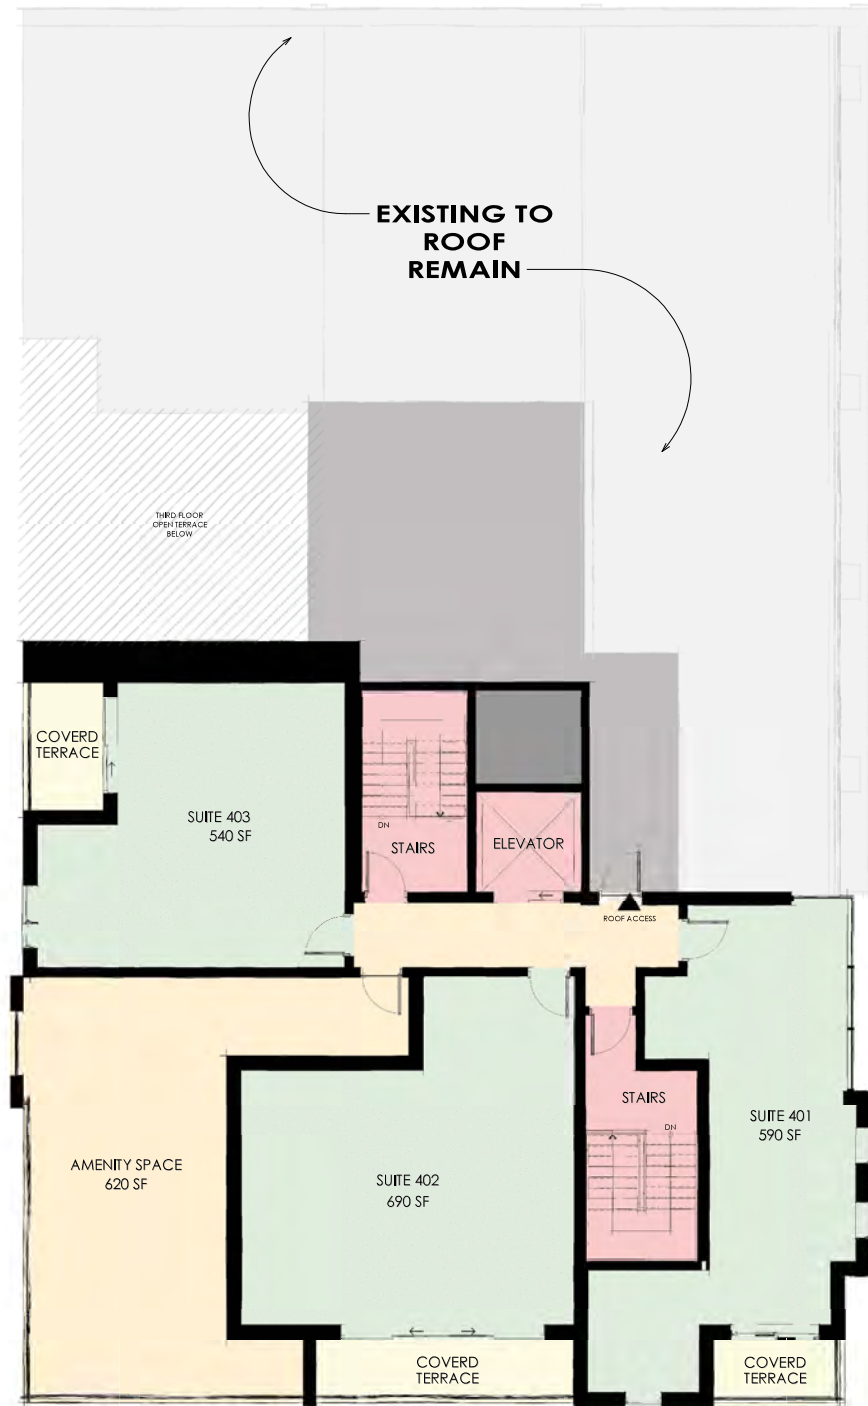
FOURTH FLOOR

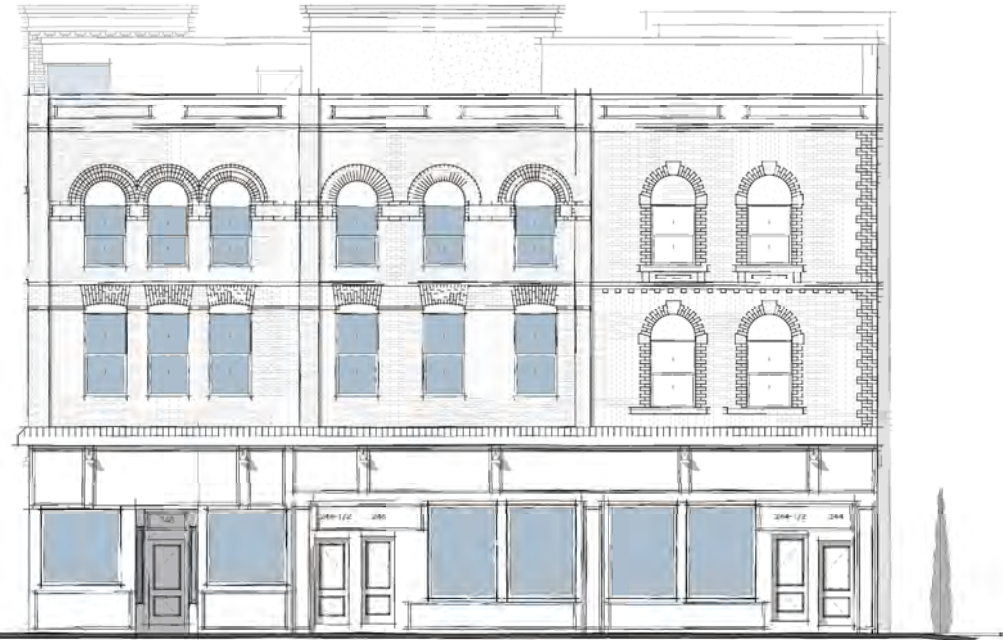
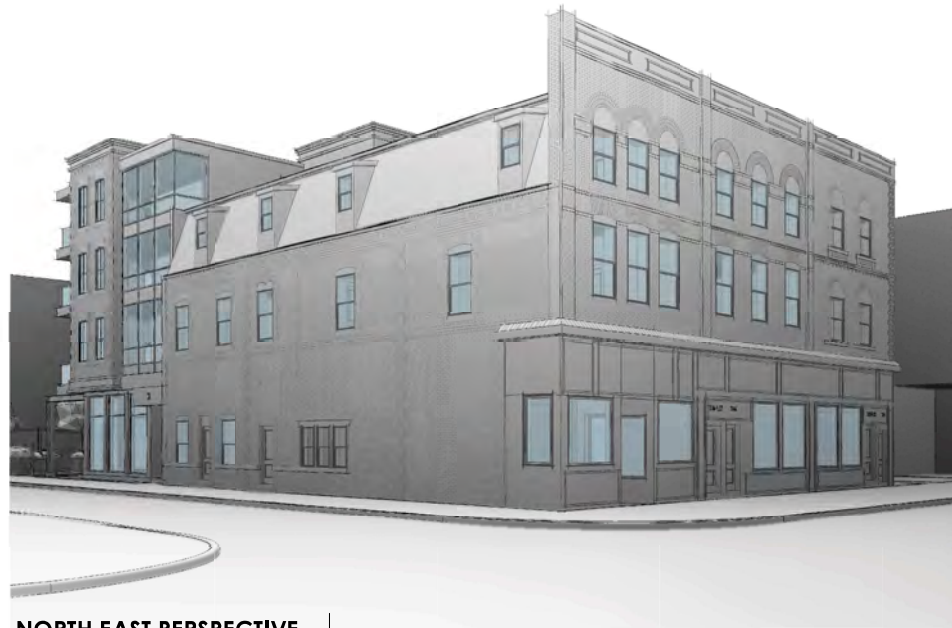
A7

NORTH ELEVATION (TALBOT ST)

MATERIALS LEGEND	
BRICK	BRICK VENEER TO MATCH EXISTING BRICK ON EXISTING FACADE OF STRUCTURE
STUCCO-1	BARGE EPS / STUCCO RAINSCREEN BY STO OR APPROVED EQUAL COLOUR: TO MATCH EXISTING BARGE STUCCO ON EXISTING FACADE OF BUILDING.
STUCCO-2	EPS / STUCCO RAINSCREEN BY STO OR APPROVED EQUAL COLOUR: WHITE
ALUM-1	REVEAL @ PANEL SYSTEM BY JAMESHARDIE COLOUR: BLACK
ALUM-2	REVEAL @ PANEL SYSTEM BY JAMESHARDIE COLOUR: MATCH EXISTING TEAL ON FACADE OF EXISTING BUILDING.
GL	WINDOW GLAZING BY ANDERSEN WINDOWS AND DOORS OR APPROVED EQUAL COLOUR: TBD (COORDINATE W/ OWNER & ARCHITECT) -CLEAR INSULATED VEION GLASS -LOWE GLAZING

<p>Predominant use of brick as an exterior cladding material.</p>	<p>As noted above, the proposed undertaking includes retention in situ of the historic building along with previously approved restoration work. This allows for the existing brick used as the exterior cladding to be maintained and enhanced.</p>

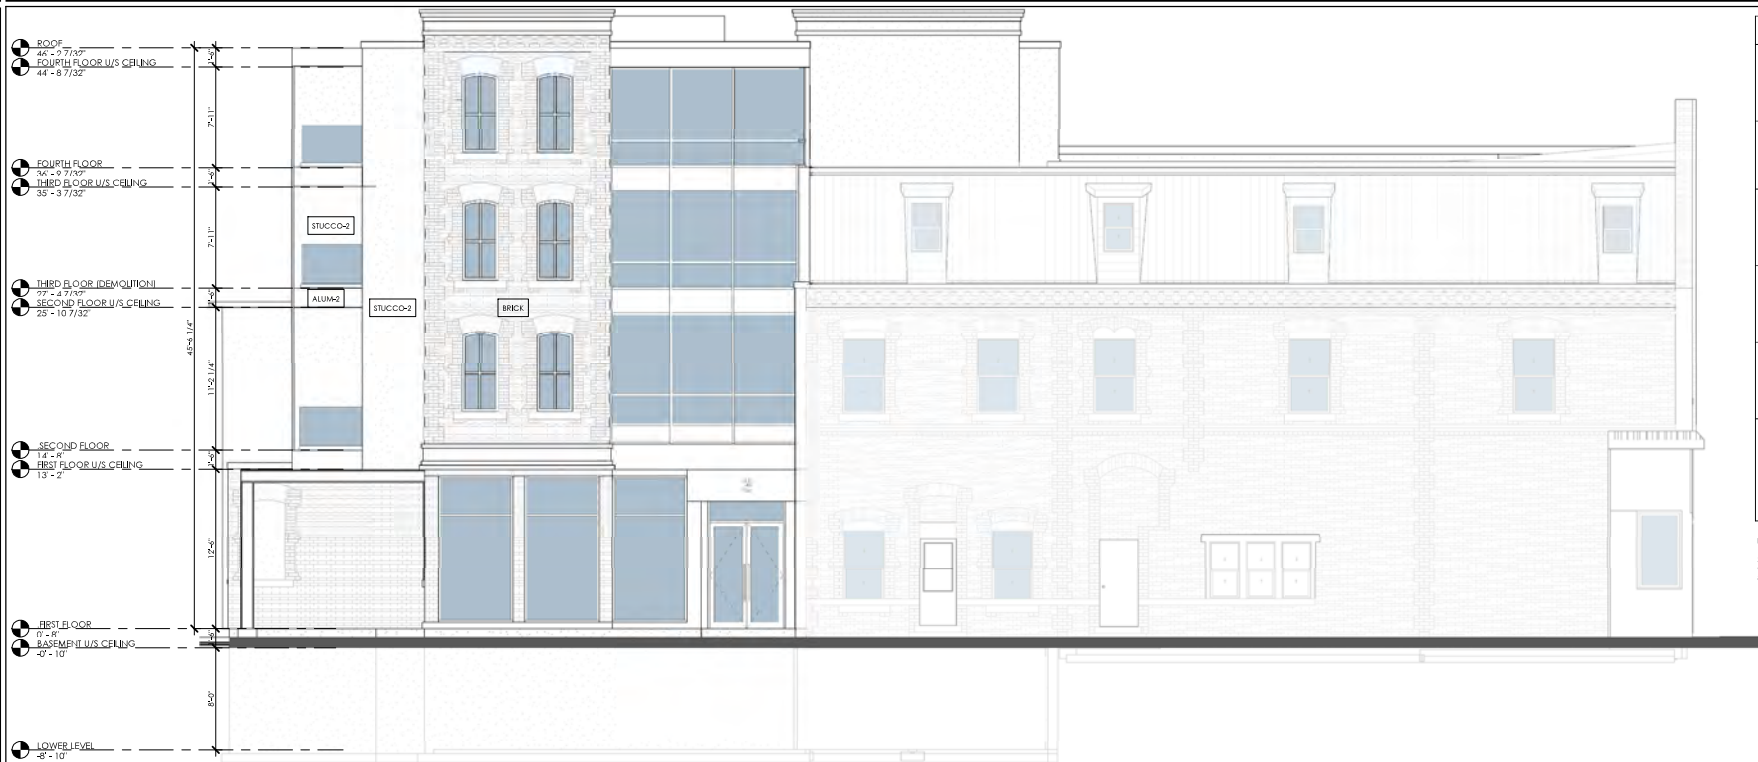
EAST ELEVATION

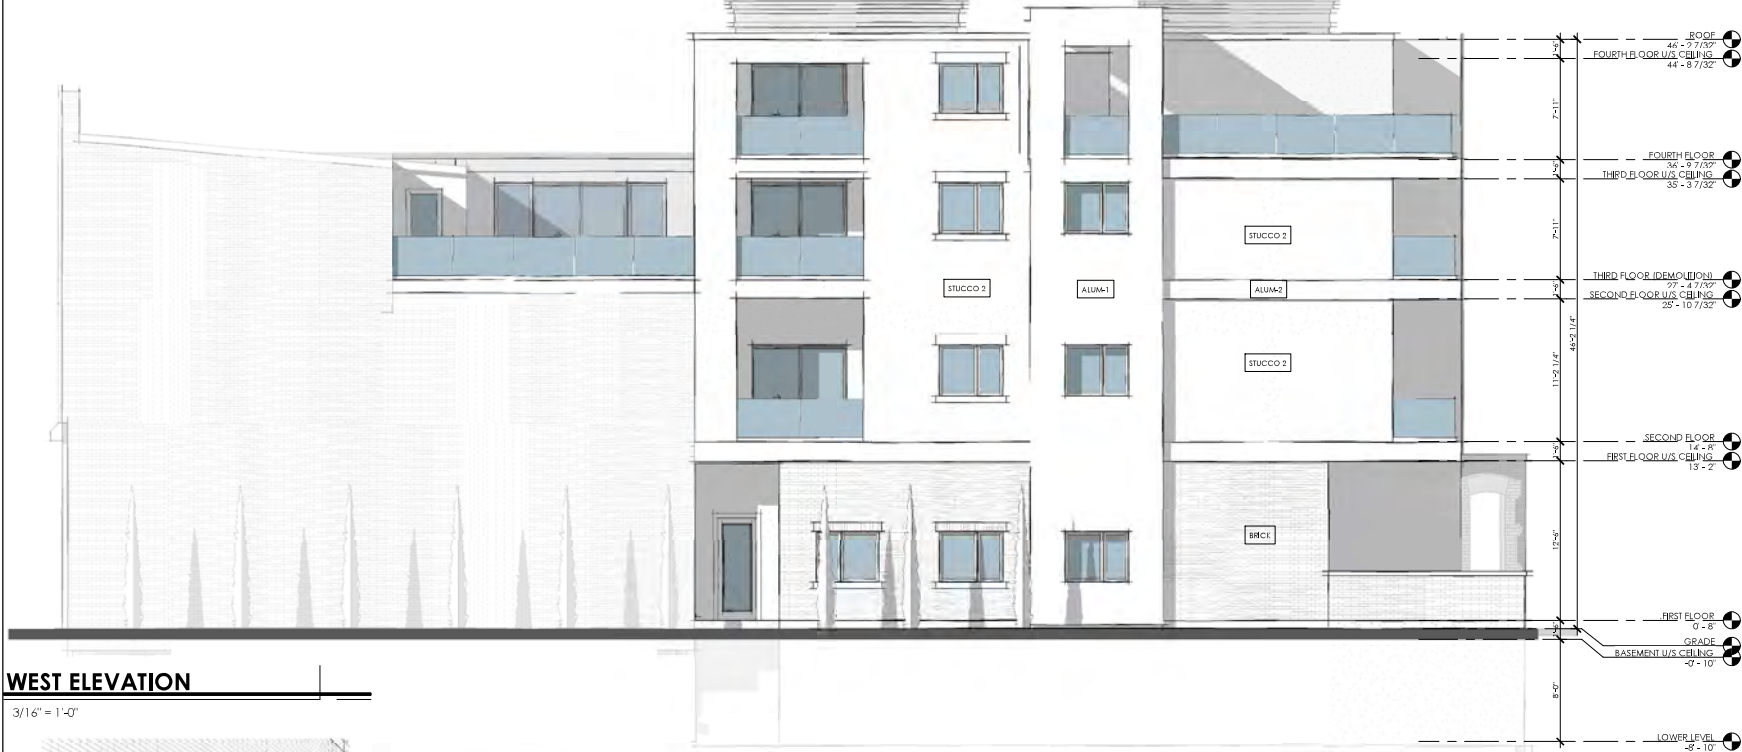
WEST ELEVATION
