**Phase One Environmental Site Assessment**

Warehouse Street  
St. Thomas, Ontario

LON-21016021-A0

**EXP Services Inc.**

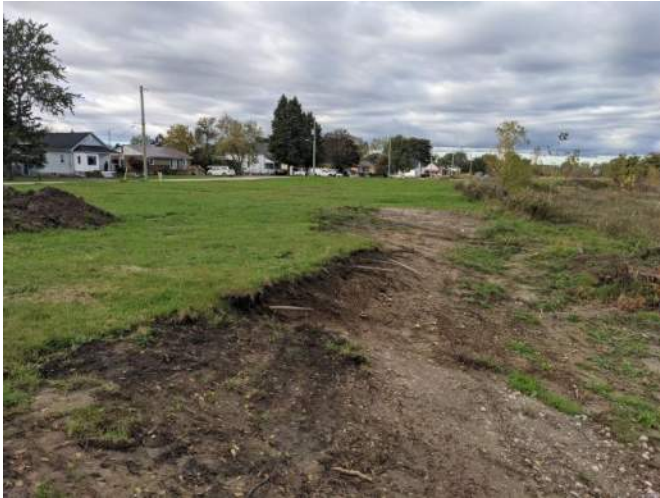
**Photo 1: View of Site from northeast corner facing southwest featuring slop along northern Site boundary.**

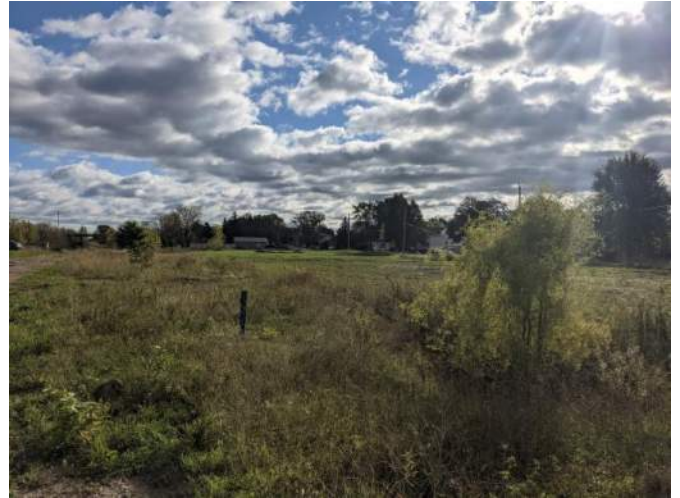
**Photo 2: View of Site from northwest corner facing southeast.**

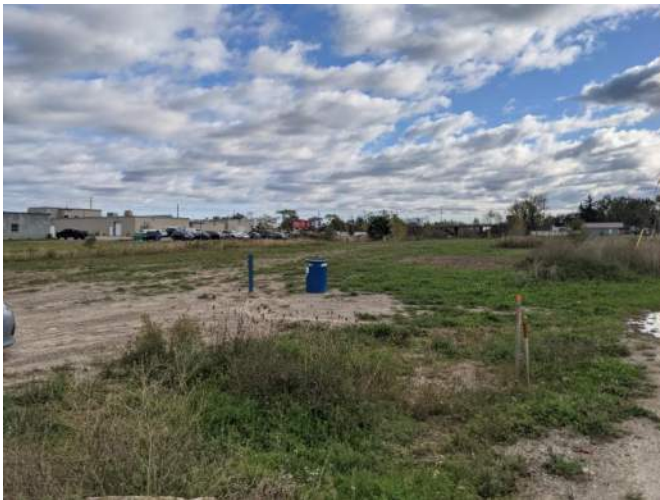
**Photo 3: View of Site from southwest corner facing northeast.**

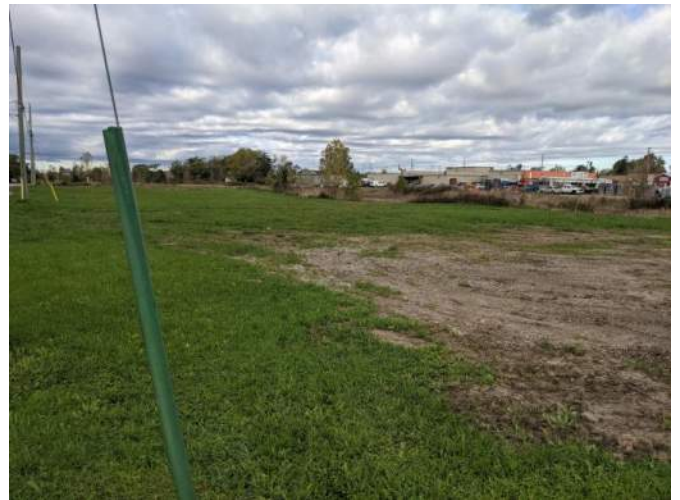
**Photo 4: View of Site from southeast corner facing northwest**

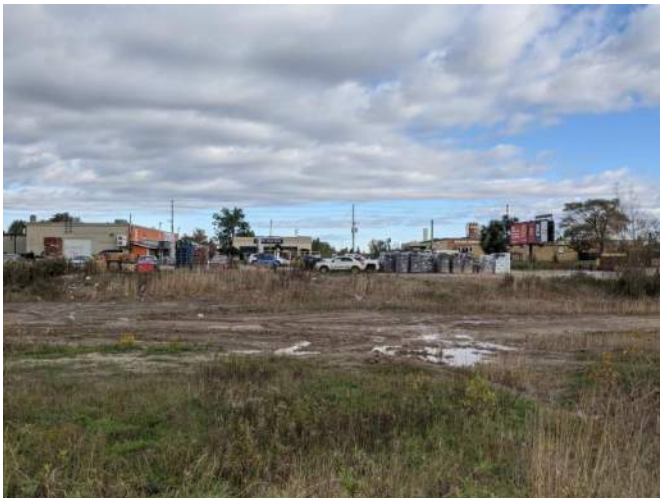
**Photo 5: View of vacant railway lands and commercial property (1030 Talbot St) adjacent north of the Site.**

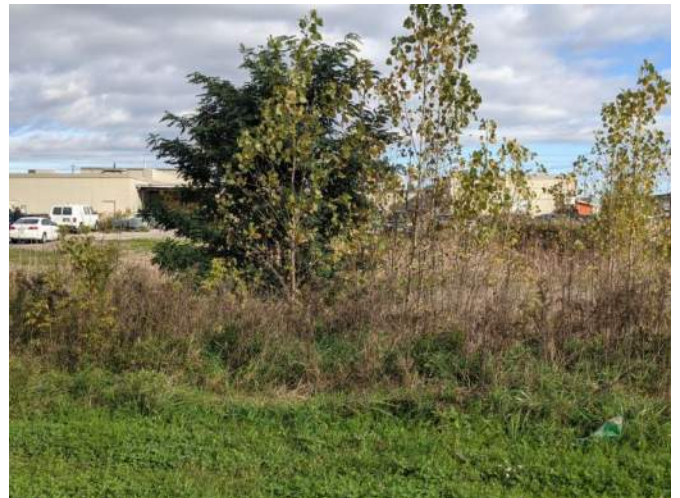
**Photo 6: View of vacant railway lands and commercial property (1026 Talbot St) adjacent north of the Site.**

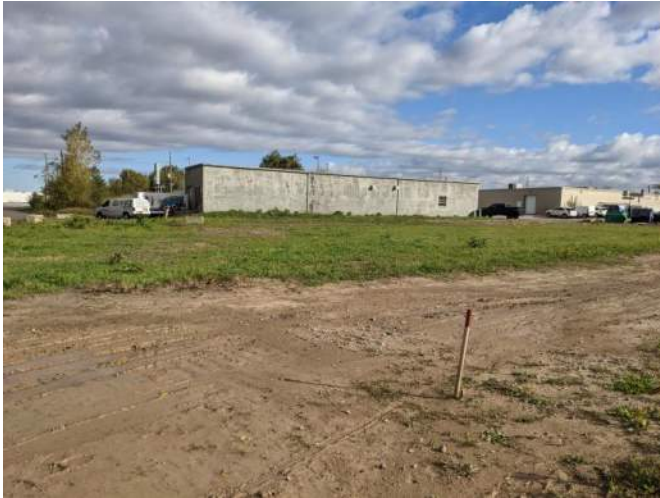
**Photo 7: View of vacant railway lands and commercial property (1026 Talbot St) adjacent north of the Site.**

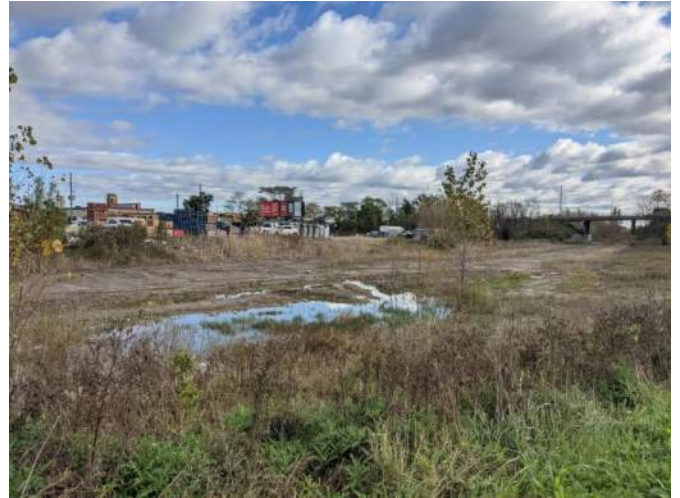
**Photo 8: View of vacant railway lands with stripped spurs adjacent to the northeast of the Site.**

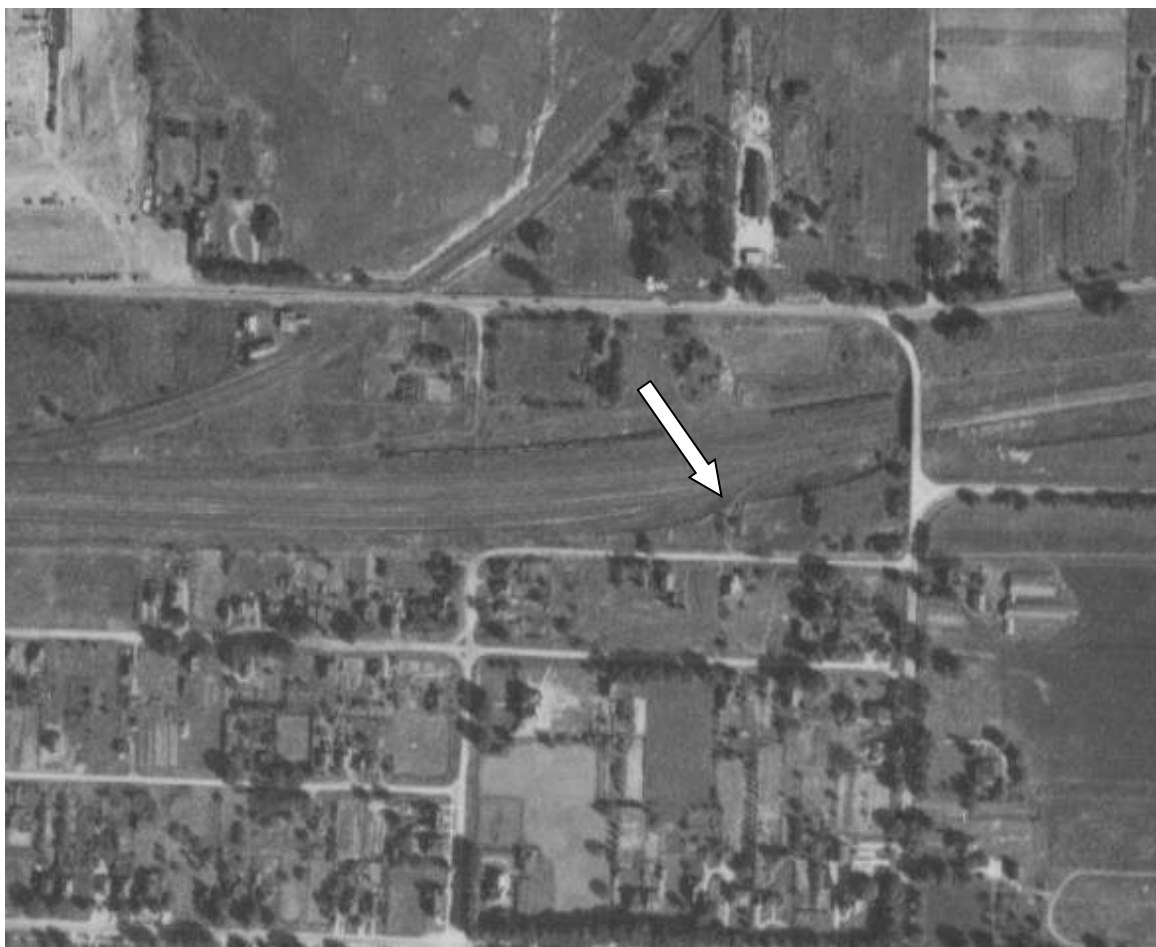
1945 Aerial Photograph (Arrow Indicates Site)

| Aerial Photograph | Details |
|---|---|
| 1945 | <ul style="list-style-type: none"> <li>• The Site was occupied by multiple railway lines.</li> <li>• Some residential developments were observed south of the Site with agricultural land to the southeast.</li> <li>• Properties to the north were primarily agricultural land with sparse commercial properties observed to the north and northwest of the Site.</li> <li>• Railway lands were observed to the north, east and west of the Site.</li> </ul> |

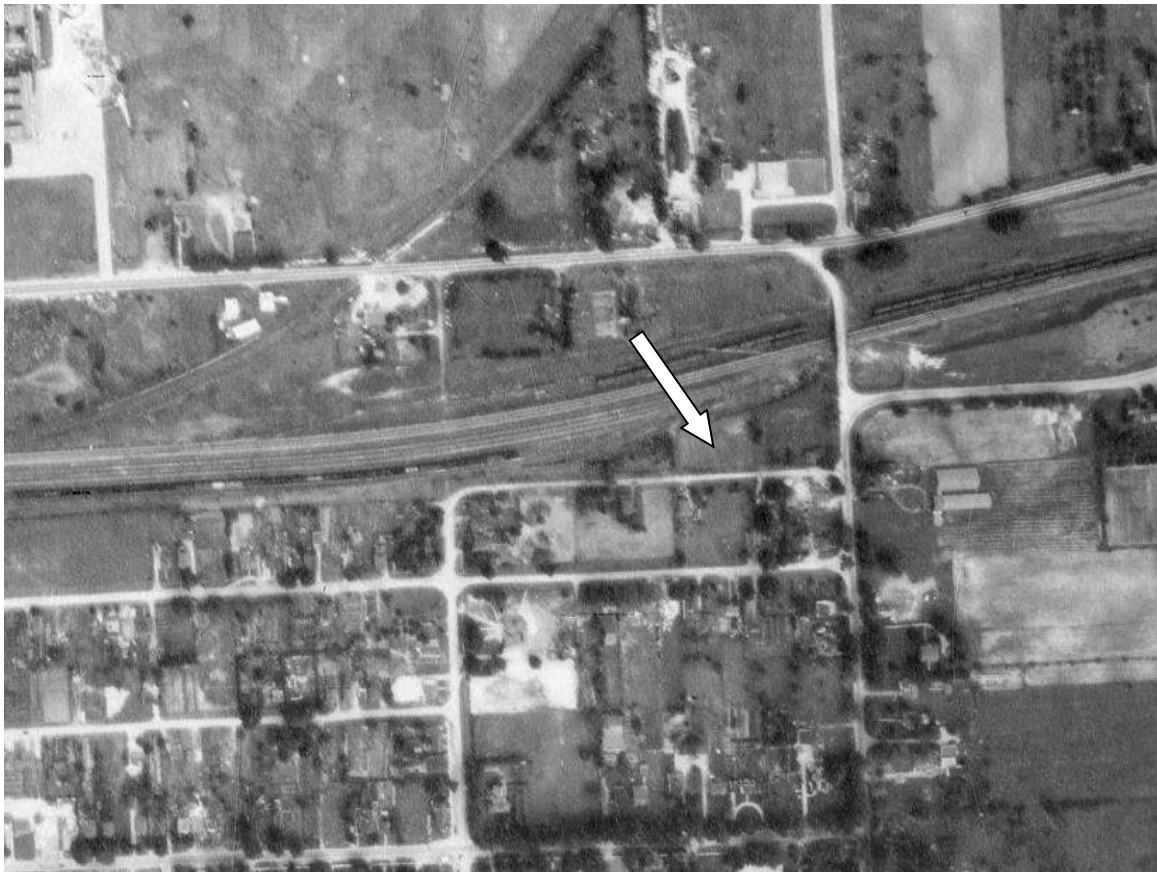
1950 Aerial Photograph (Arrow Indicates Site)

| Aerial Photograph | Details |
|---|---|
| 1950 | <ul style="list-style-type: none"> <li>• No significant changes were noted on-Site.</li> <li>• An increase in commercial/industrial development was observed to the north and northwest of the Site.</li> <li>• An increase in residential development was observed to the south of the Site.</li> </ul> |

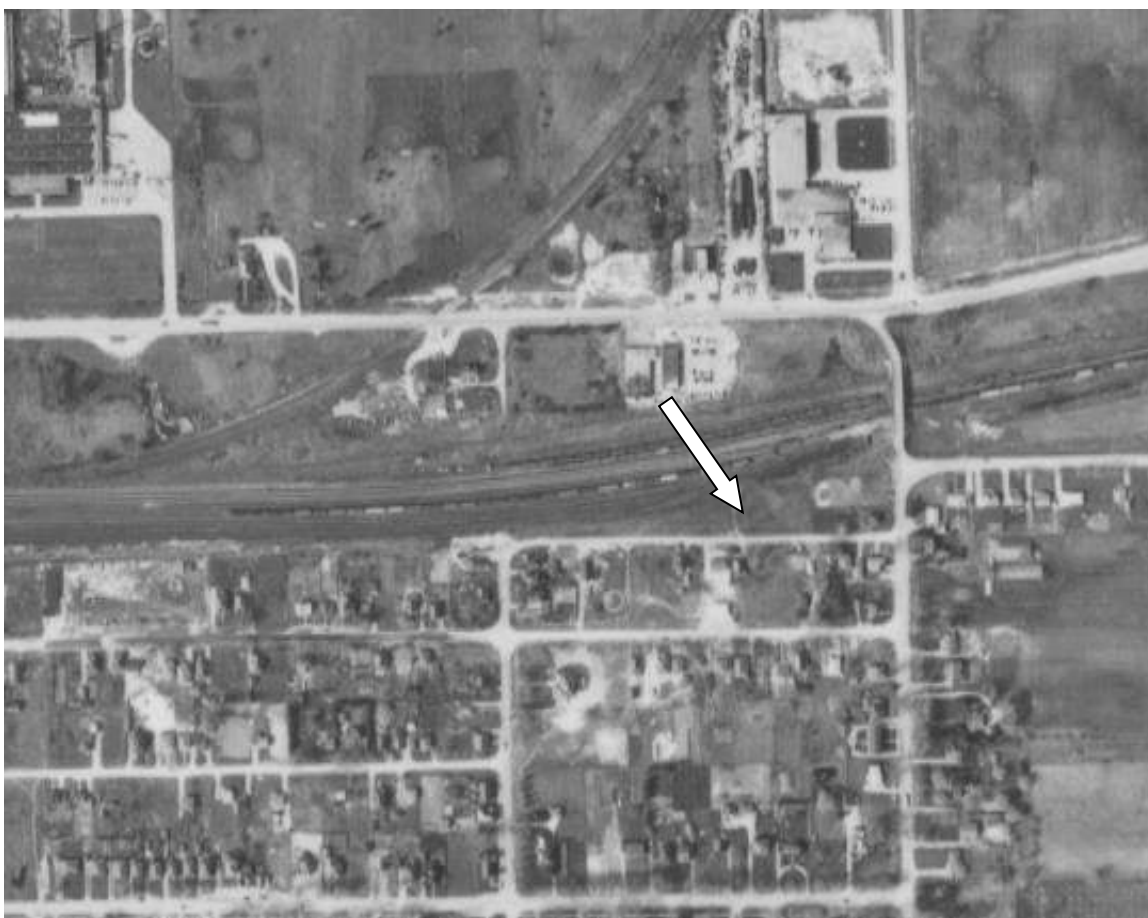
1960 Aerial Photograph (Arrow Indicates Site)

| Aerial Photograph | Details |
|---|---|
| 1960 | <ul style="list-style-type: none"> <li>• No significant changes were noted on-Site.</li> <li>• An increase in commercial/industrial development was observed to the north of the Site.</li> <li>• Some commercial/industrial developments to the north expanded.</li> <li>• An increase in residential development was observed to the east, south and southeast of the Site.</li> </ul> |

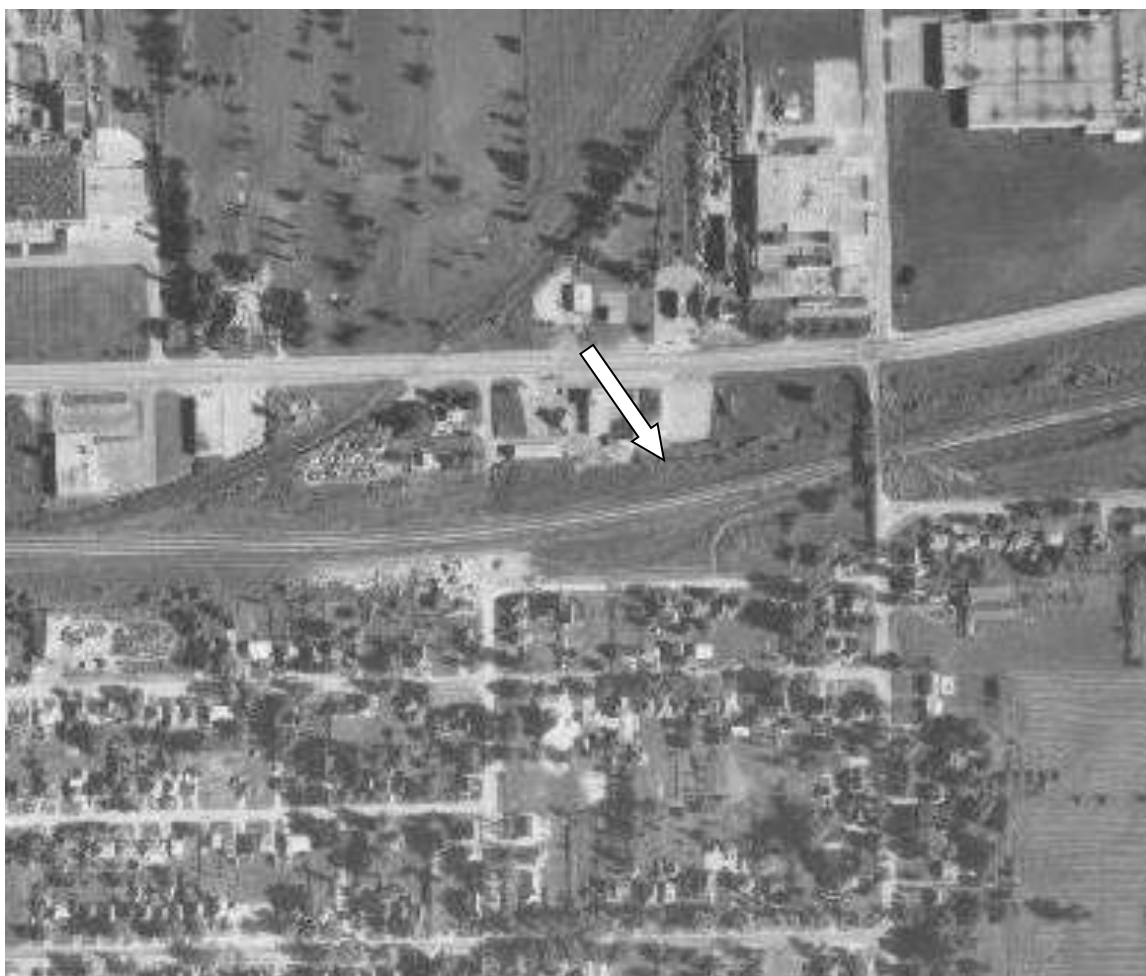
1972 Aerial Photograph (Arrow Indicates Site)

| Aerial Photograph | Details |
|---|---|
| 1972 | <ul style="list-style-type: none"> <li>• Railway operations on the southern portion of the Site were no longer present. Majority of the Site was now vacant railway land.</li> <li>• Evidence of ground disturbance was noted in the southwest portion of the Site.</li> <li>• An increase in commercial development was observed to the north and northwest of the Site.</li> <li>• Evidence of significant vehicle storage was observed to the northwest of the Site.</li> <li>• The industrial property at the northwest corner of Fairview Avenue and Talbot Street (north of the Site) expanded and resembled a large manufacturing facility.</li> <li>• An additional large industrial facility was observed at the northeast corner of Fairview Avenue and Talbot Street (northeast of Site).</li> <li>• An increase in residential development to the south of Site was noted.</li> </ul> |

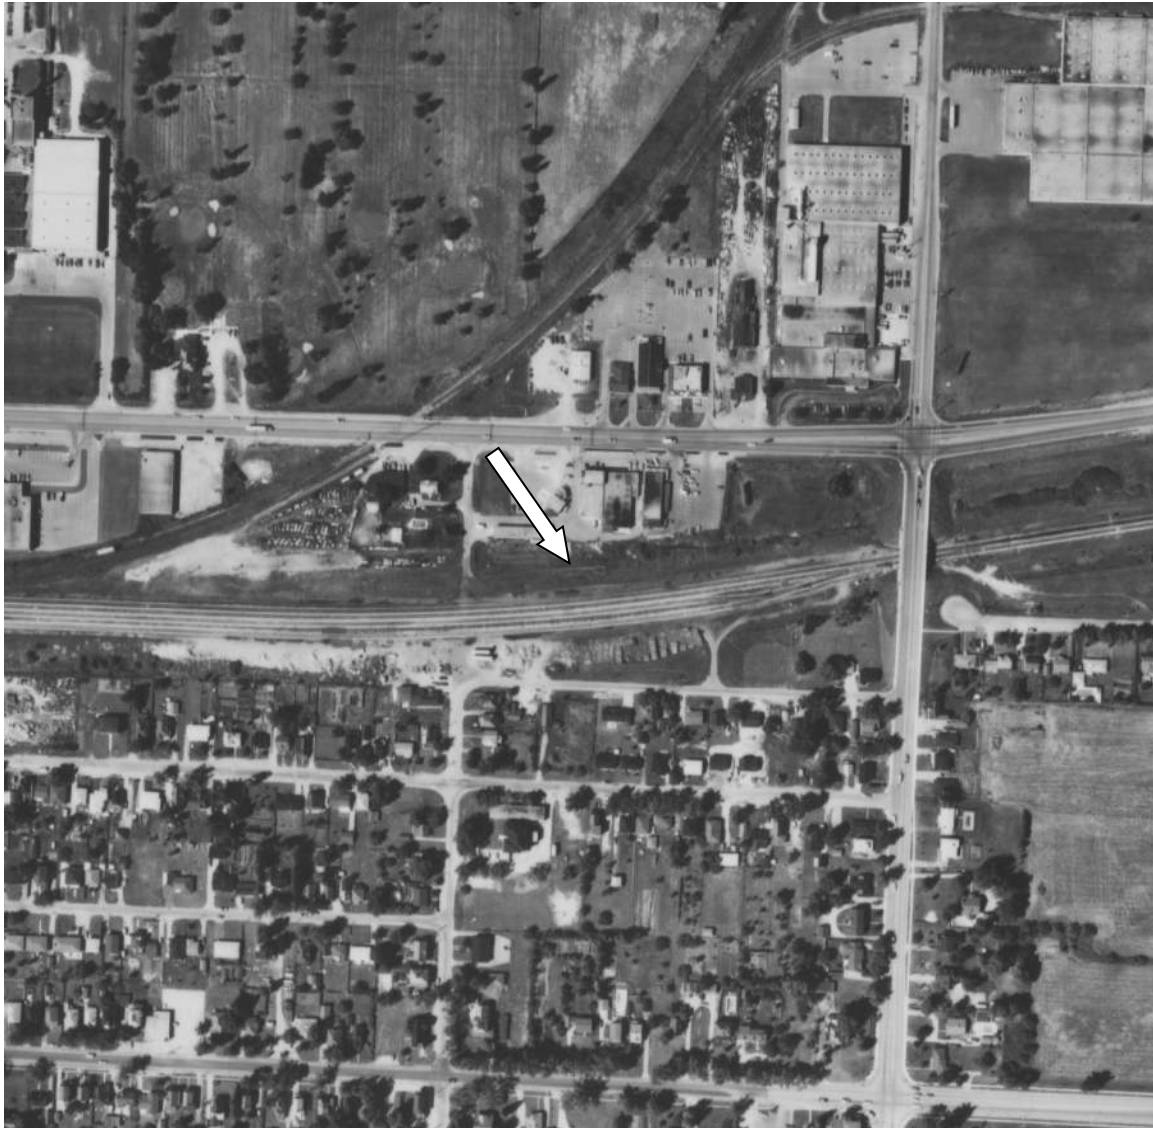
1978 Aerial Photograph (Arrow Indicates Site)

| Aerial Photograph | Details |
|---|---|
| 1978 | <ul style="list-style-type: none"> <li>• The ground disturbance in the southwest portion of the Site expanded.</li> <li>• Evidence of railway cars and/or materials storage was observed on Site.</li> <li>• A slight increase in commercial development was observed to the north of the Site.</li> <li>• An institutional building was observed to the south of the Site on the southeast corner of Park Avenue and Steeles Street.</li> </ul> |

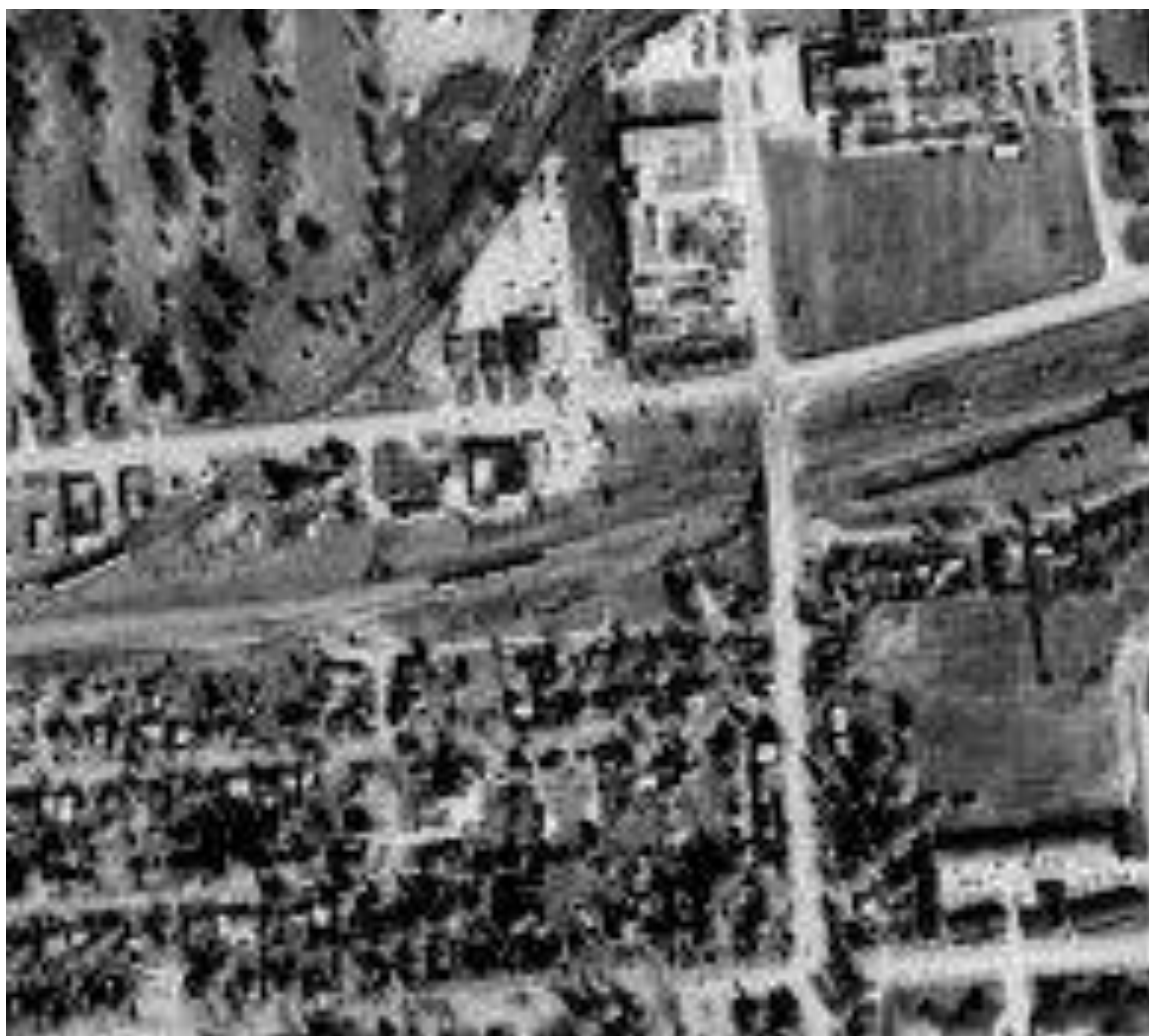
1989 Aerial Photograph (Arrow Indicates Site)

| Aerial Photograph | Details |
|---|---|
| 1989 | <ul style="list-style-type: none"> <li>• No ground disturbance or evidence of railway cars or materials storage was observed on Site.</li> <li>• An increase in medium density residential development was observed to the southeast.</li> <li>• Some details are indistinguishable due to size and scale or aerial photograph.</li> </ul> |

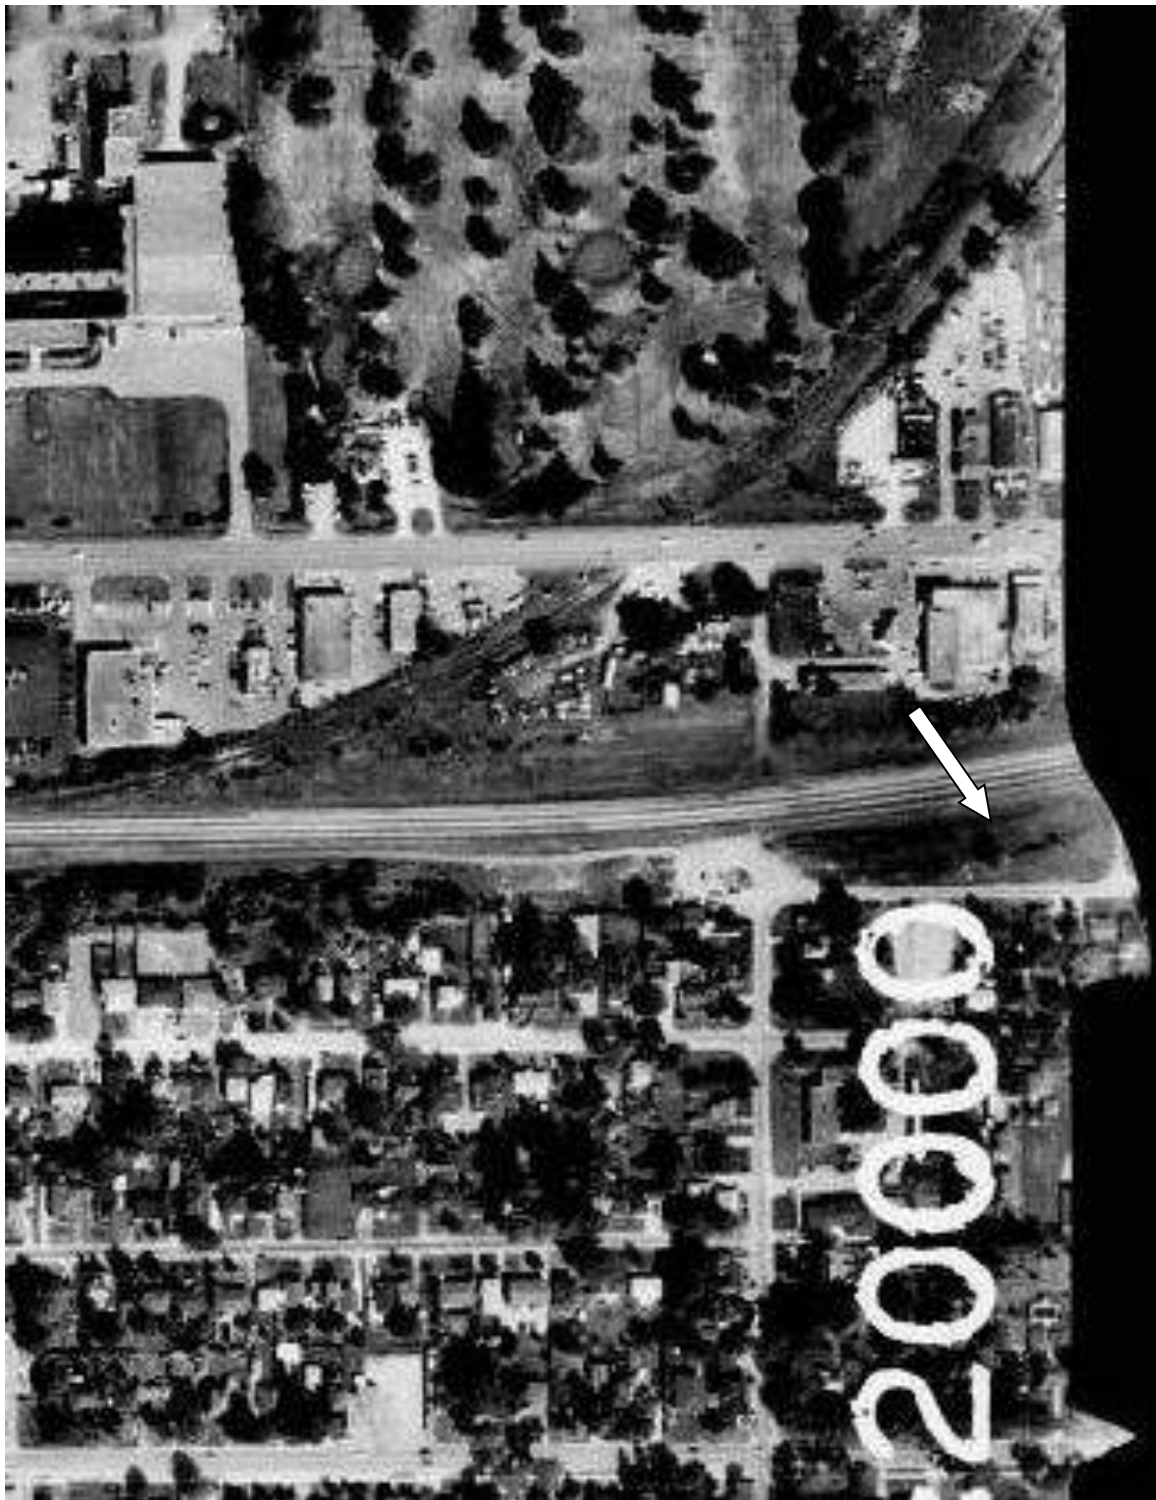
1995 Aerial Photograph (Arrow Indicates Site)

| Aerial Photograph | Details |
|---|---|
| 1995 | <ul style="list-style-type: none"> <li>• No significant changes were noted on-Site.</li> <li>• A small structure was observed on the property adjacent west of the Site.</li> </ul> |

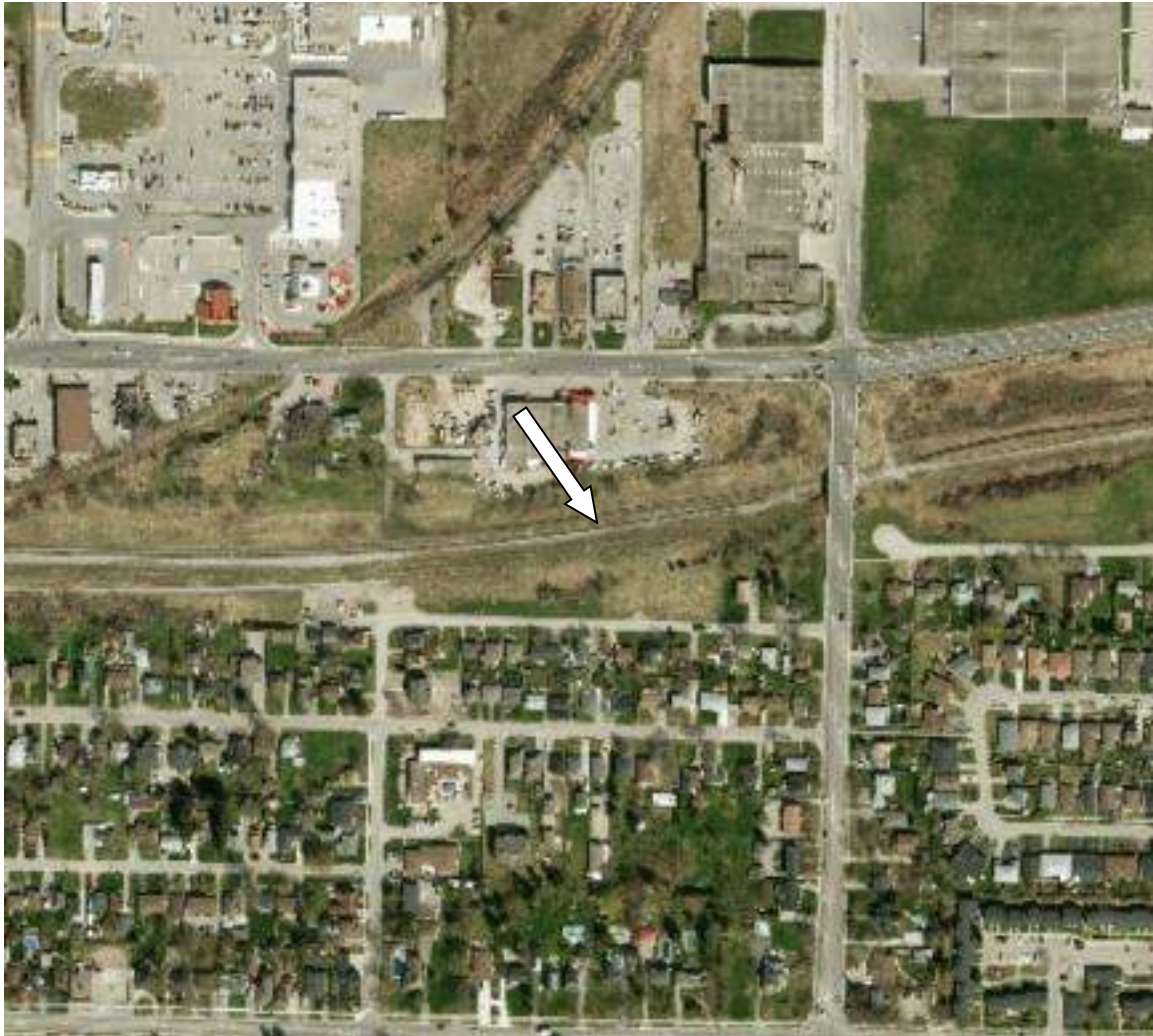
| Aerial Photograph | Details |
|---|---|
| 2006, 2010 | <ul style="list-style-type: none"> <li>Only one railway line was observed, which partially ran through the north portion of the Site. It is unclear whether the railway lines previously observed were removed on the 1989 or 1995 aerial.</li> <li>The property adjacent east of the Site was developed for residential/small commercial purposes.</li> <li>An increase in residential developments was observed to the east of the Site.</li> <li>An increase in commercial development was observed to the northwest of the Site.</li> <li>The property adjacent to the southwest of the Site contained a parking lot and several vehicles.</li> </ul> |
