# Functional Servicing Report

Warehouse Street Development, St. Thomas

***Warehouse Street Development – Functional Servicing Report***

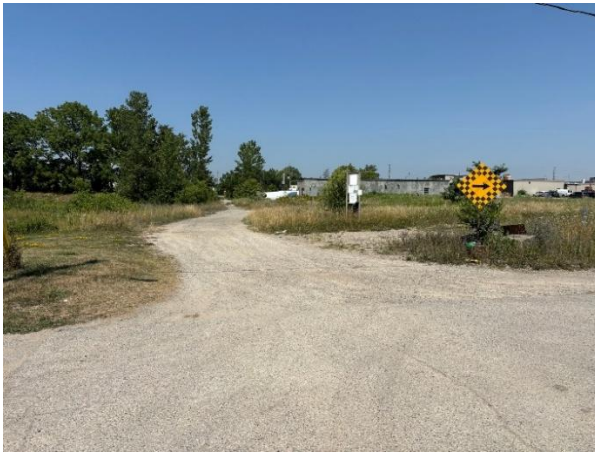
Photograph 1 – Undeveloped Park Avenue extension, looking northeast from the Warehouse/Park Avenue intersection.

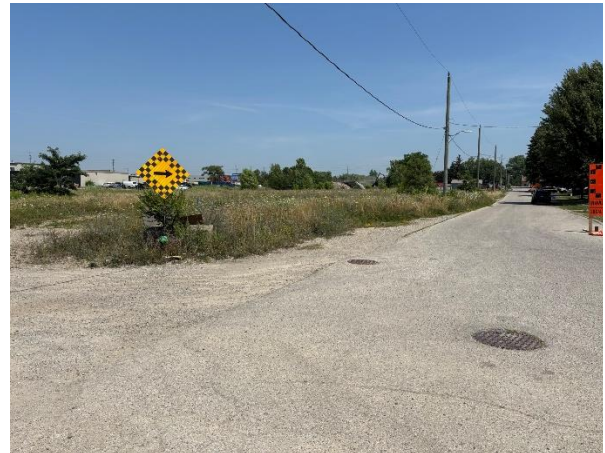
Photograph 2 – Existing Warehouse Street, looking east from the Warehouse Street/Park Avenue intersection.

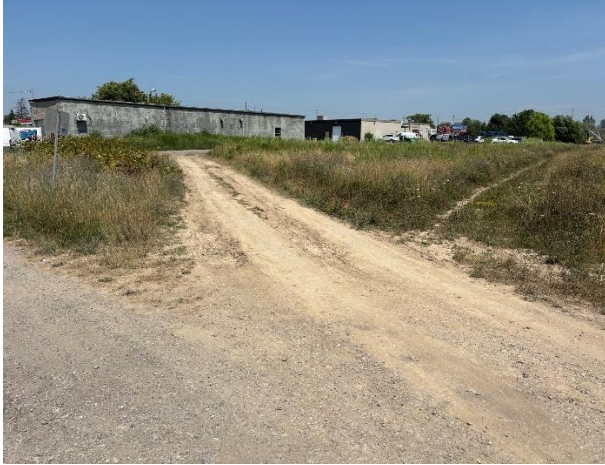
Photograph 3 – Site viewed from undeveloped Park Avenue, looking northeast.

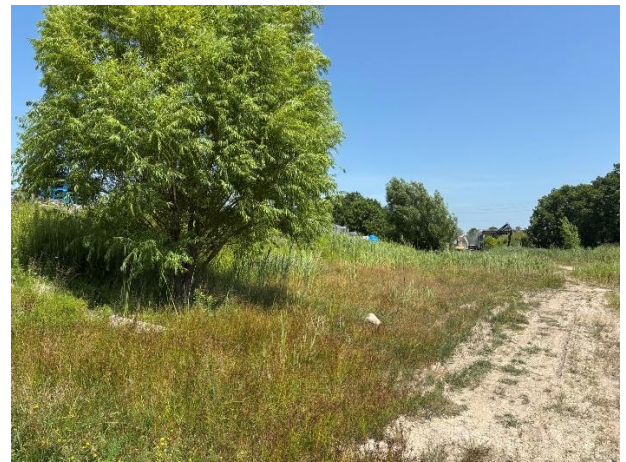
Photograph 6 – Existing low-lying area in the north section of the Site, looking east towards the Fairview Bridge removal works.

According to the April 2021 topographic survey prepared by Archibald Gray & McKay Ltd. (AGM), the site generally drains toward the south and southwest. The north and northeast portions of the site feature a low-lying area that collects drainage from external northern and eastern lands. Given the potential for alterations to the natural topography since the completion of the 2021 survey, an updated topographic survey is recommended to inform the detailed design.

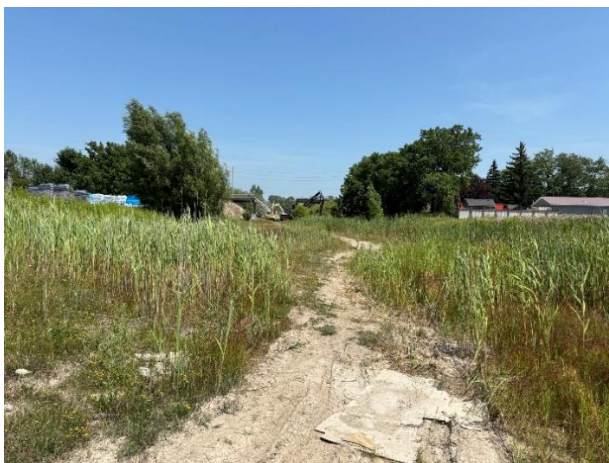
Photograph 7 – Existing low area in the north section of the Site, looking east towards Fairview Bridge removal.

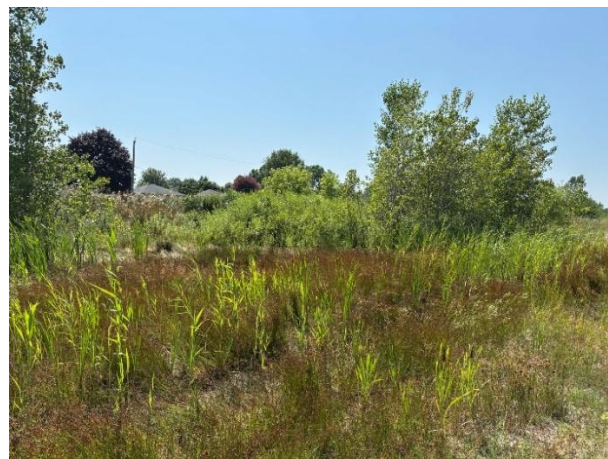
Photograph 8 – Existing low area in the north section of the Site, looking south towards existing Warehouse Street.

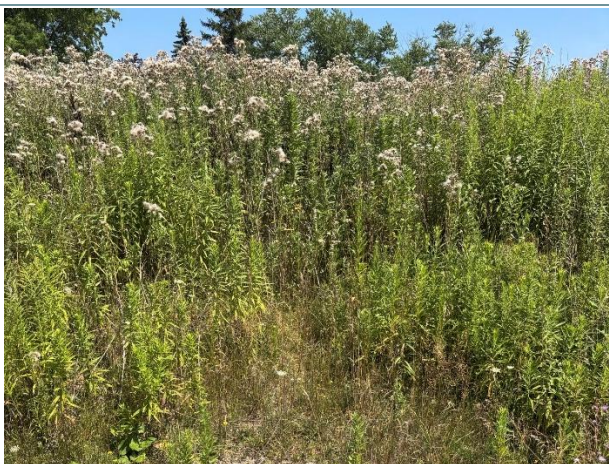
Photograph 9 – Existing low area in the north section of the Site, looking south towards existing Warehouse Street.

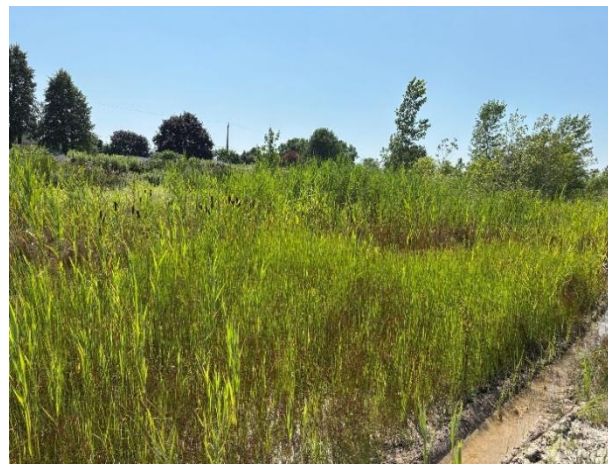
Photograph 10 – Existing low area in the north section of the Site, looking SW towards Warehouse/Park Avenue.

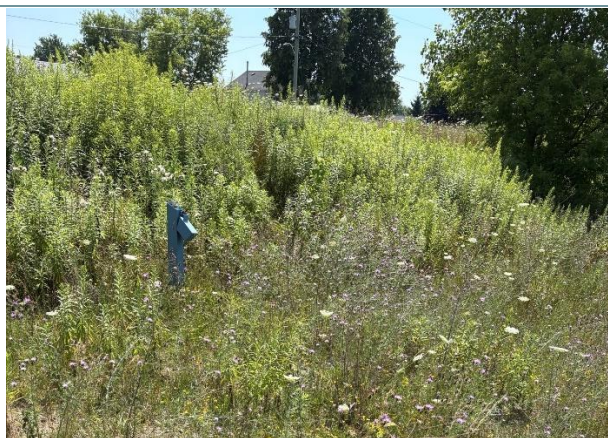
Photograph 11 – Existing monitoring well.

There are currently four monitoring wells on site, drilled as part of the Phase Two ESA prepared in 2023 for the previous owner. These monitoring wells provided groundwater elevation and flow information and help inform the suitability of stormwater infiltration infrastructure for the site, which requires a 1.0 m separation between the highest expected groundwater elevation and the bottom of the SWM facility.

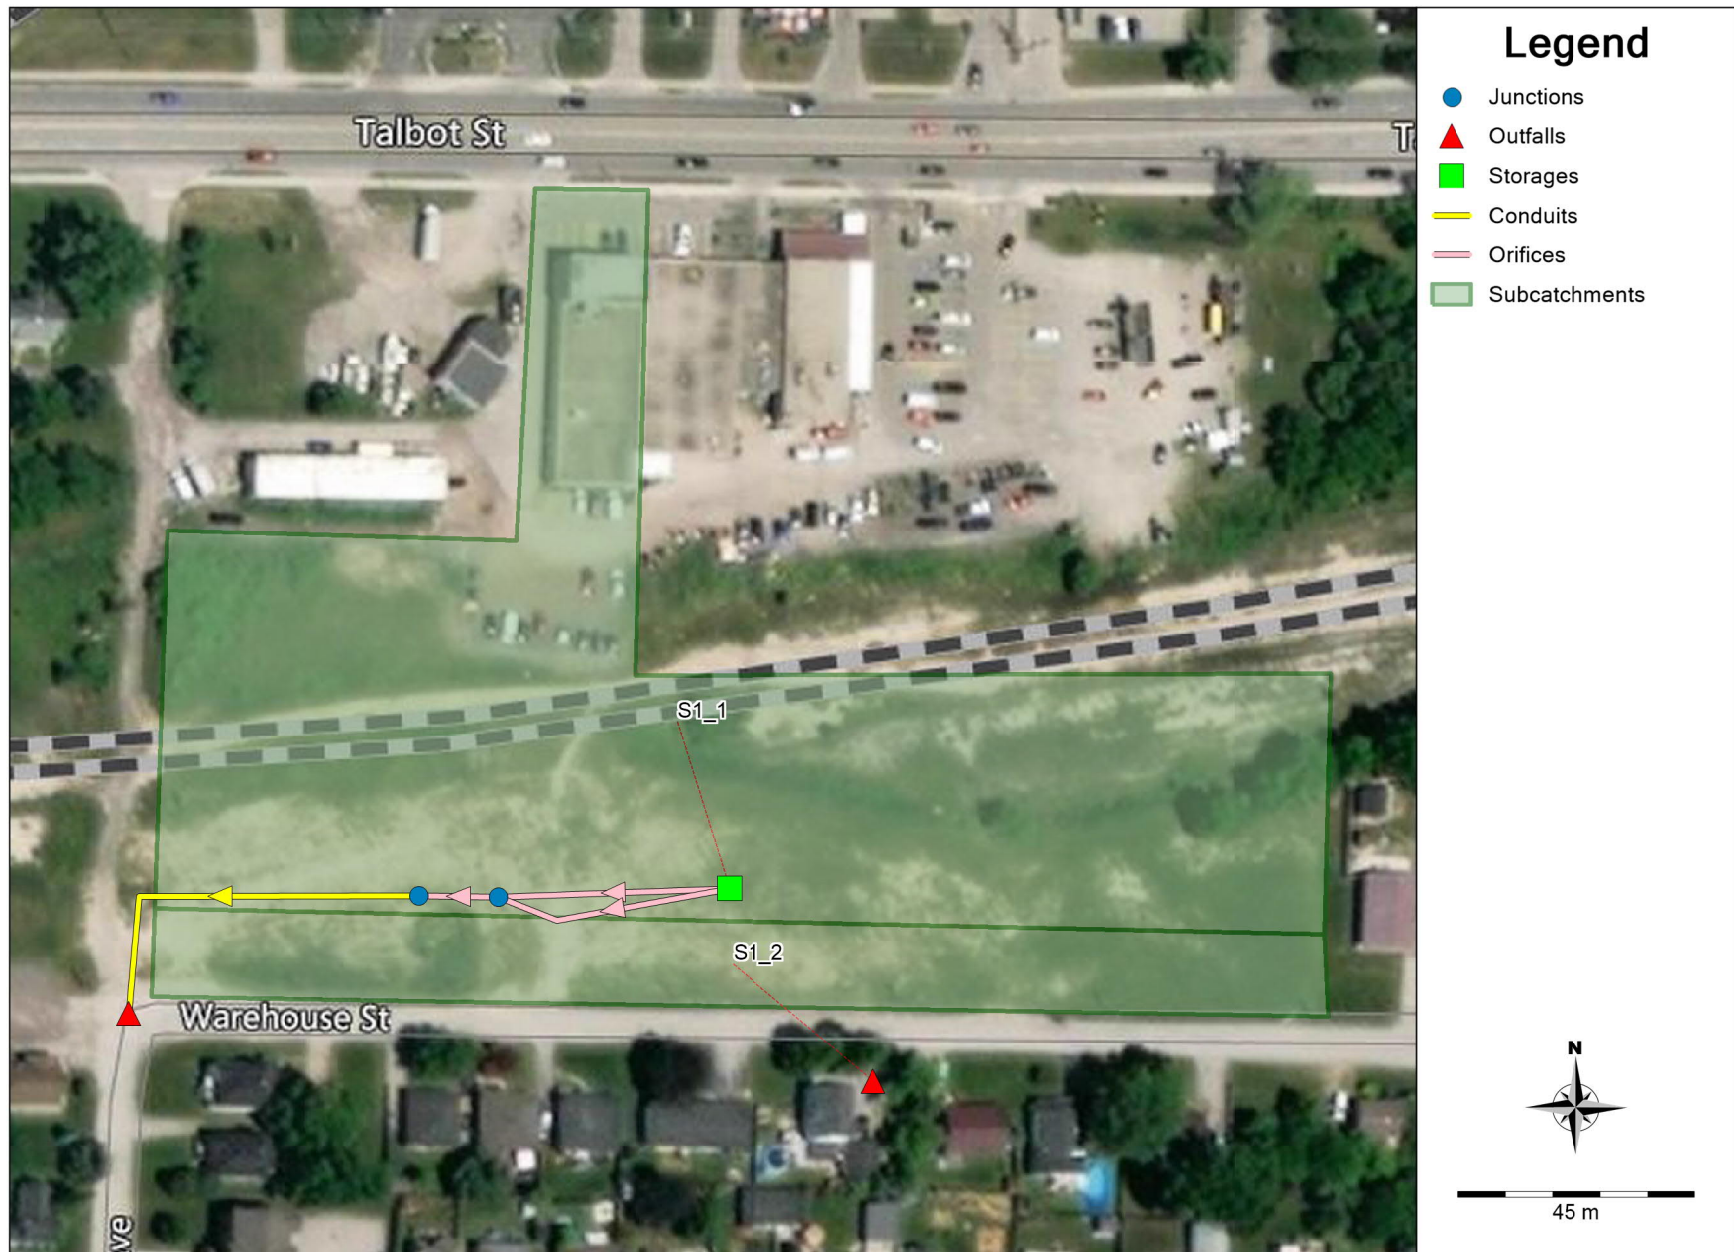
## Proposed Conditions PCSWMM Schematic
